MAWSON'S HUTS CONSERVATION EXPEDITION 2002

EXPEDITION REPORTS

CONSERVATION ARCHITECT'S REPORT

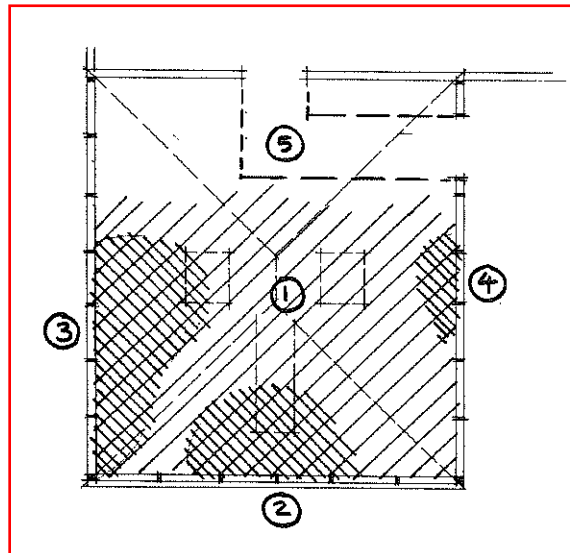
1. A thin layer of soft snow / ice shown by the single hatching covered the whole of the ice platform excavated during the last expedition.
2. A build up of soft snow ice was located just below the dormer vent. Clear openings could be seen through and around the edges of the vent. It is noted that the vent is lined on the inside with original boarding.

3. The largest deposit within the Workshop was along the eastern wall. Evidence suggested that the snow had entered the roof space (between the ceiling and roof cladding) along the northern wall roof junction and entered the interior via the collapsed section of ceiling lining to the east and north wall.

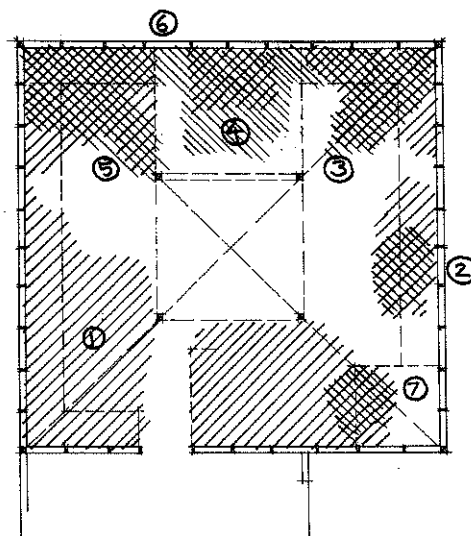
1. Nominal location of older ice deposit. The older sections of solid ice shown with the single hatch remain mostly free of any new deposits of soft snow / ice.

2. An amount of snow / ice was deposited on the older ice accumulation to the central bunk on the western wall. Light could be clearly seen through the ceiling and external roof cladding along the rafters in this location.

7. An accumulation of soft snow / ice was recorded on top of the dark room. Failure of some of the new cover battens was identified as the most likely source.

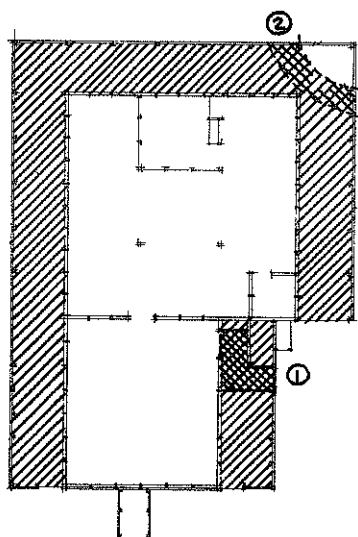
Of interest is the amount of ice that was ablated from the southwest corner of the verandah due to the failure of a number of wallboards on the south (east end) of the wall.

1. Ice excavated to gain access to the interior of the Main Hut
2. Area ablated due to wind action through the south wall.

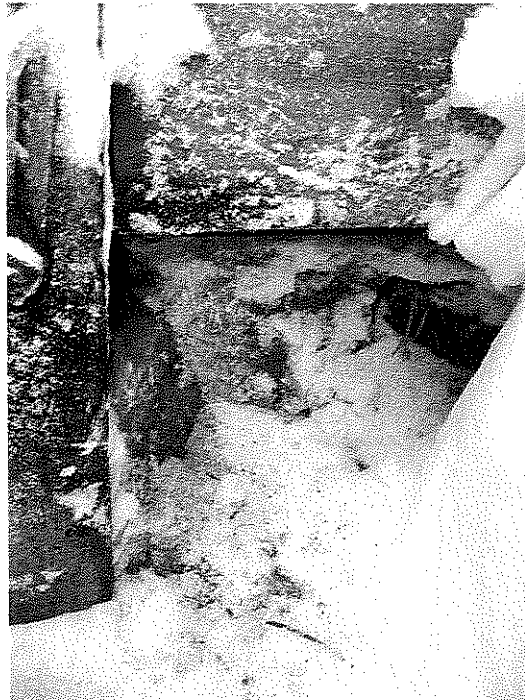
SOLID ICE UNDER FLOOR STRUCTURE

Solid ice was been encountered under the floor structure of the Main Hut at this corner. This ice is above the level (approx 300mm) of the surrounding melt ice level encountered. This profile could suggest that the ice under the floor structure has not experienced any significant melt in recent time (eg during the Ian Godfrey visit). This could however only be tested by taking ice samples for further analysis.

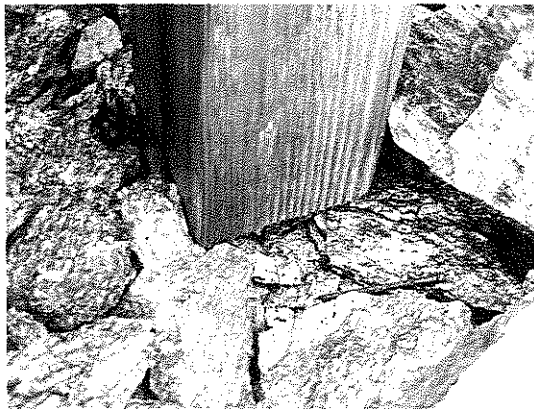
VERANDAH POST DETAIL – WEST
ELEVATION

It has been noted from our inspection the posts to the verandah exposed during the time of the expedition show no form of direct mechanical connection to the ground (either by being embedded into a footing or cleated/fixed to the surface rock. It is presumed that the verandahs are held in place by the cantilevering action of the roof structure.

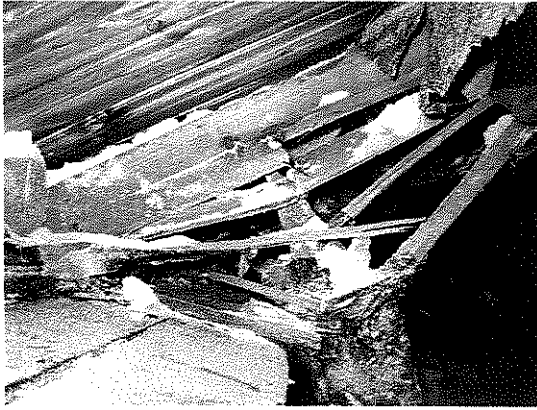
RAFTER 1 (NORTH EAST)

The strength of the broken rafters had been substantially reduced and would require upgrading with additional timber to reinstate the original structural integrity of the roof frame.

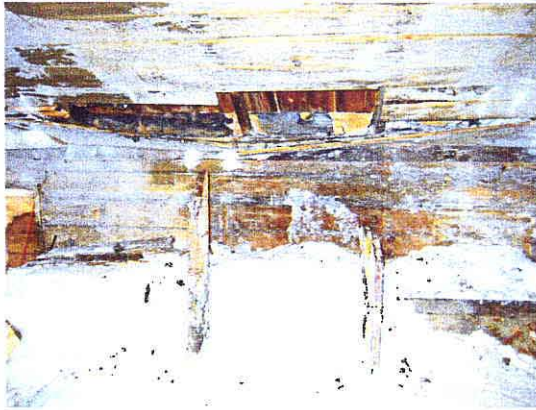
- The exposed sections of the collar ties indicated that the timbers were badly fractured and in short lengths
- The remanent sections were buried deep into the ice mass and at the time there was no clear direction that the balance of the ice mass was to be removed during this expedition.
- The structural integrity of the roof could be guaranteed with the use of continuous new members.

REMANANT ENDS OF COLLAR TIES
PROJECTING FROM ICE MASS BELOW
ORIGINAL FIXING LOCATIONS

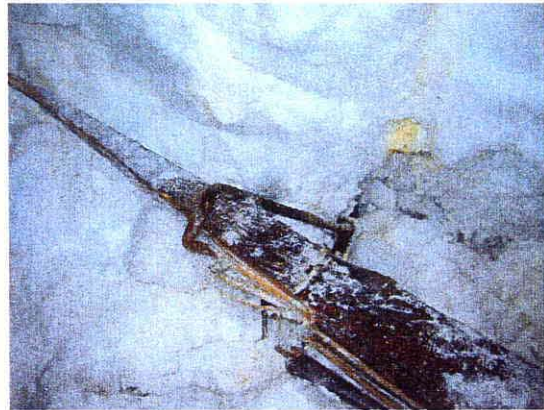
FRACTURED CONNECTION AT LOCATION
OF COLLAR TIE JUNCTION

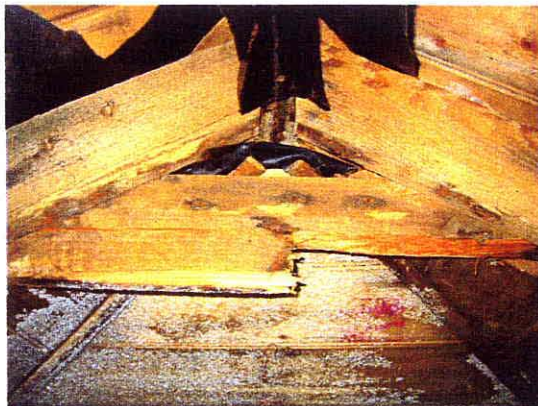
SOUTH APEX COLLAR TIE

- The detail (proximity to the incoming hip beams) prohibited the stitching of an addition section to the sides of the original on the northern collar.
- The structural integrity of the roof could be guaranteed with the use of continuous new members.
- The collars needed to line up with the new ties below to be able to reinstate the hanging straps to the original detail.

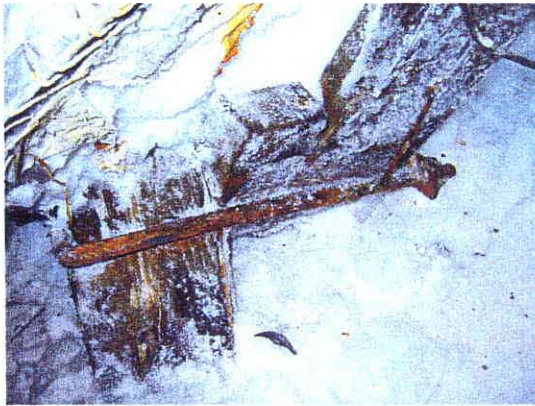
'U' BOLTS STILL FIXED TO BROKEN COLLAR TIES IN THE ICE

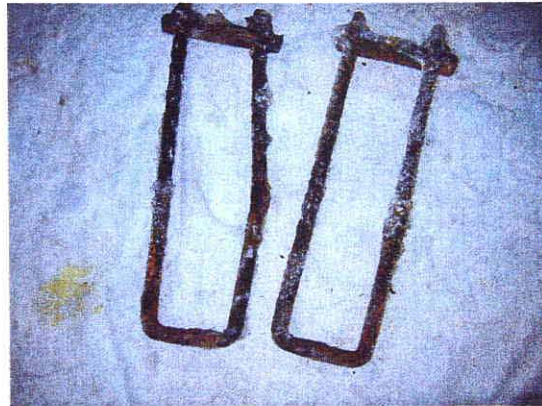
RECOVERED BOLTS INDICATING NOM. BENDING DUE TO FAILURE OF COLLAR TIES

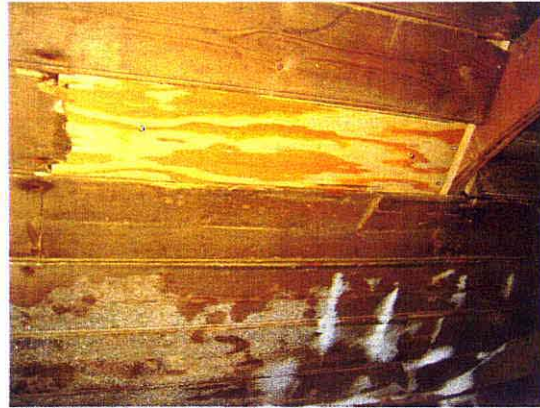
Additionally, a section on the south plane could be located. It is most probable that this piece has previously been excavated and no longer exists on site. A temporary panel of plywood has been installed to seal the ceiling lining but a new section of material should be installed as above.

PLYWOOD PANEL TO MISSING SECTION –
SOUTH PLANE

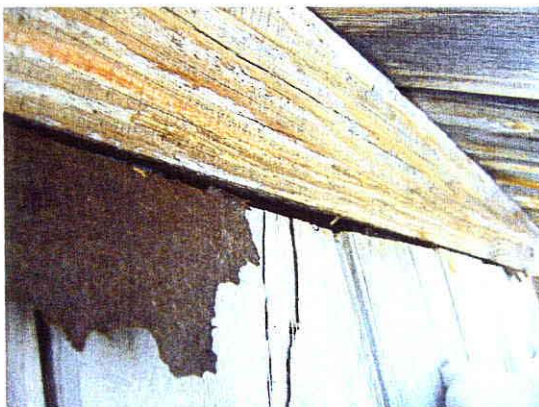
GAP IN JUNCTION

A cover batten was fixed over the join for the full length of the north wall. The batten was fixed over a strip of bituminous impregnated foam and secured using stainless steel screws.

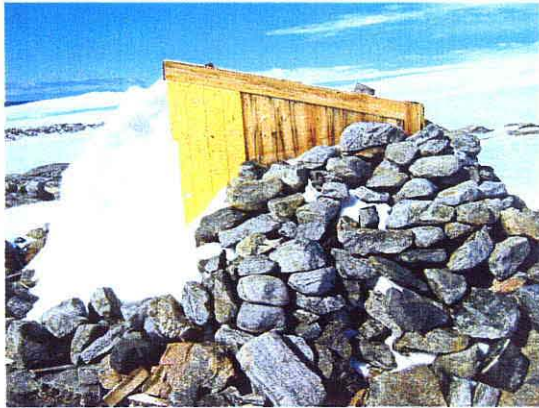
The section to the west wall was over-clad with new boards down to the rock line where only nominal corrosion has occurred.

SECTION OF OVERCLADDING TO WEST WALL – NORTH END
