MAWSON'S HUTS 2002

FIELDWORK REPORT

Prepared for the Australian Antarctic Division

MAWSON'S HUTS FIELDWORK

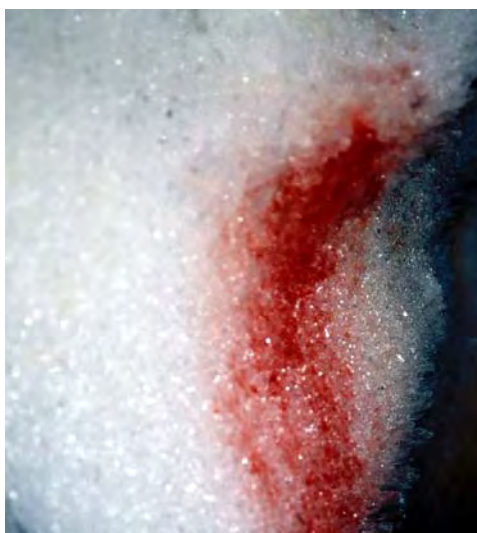
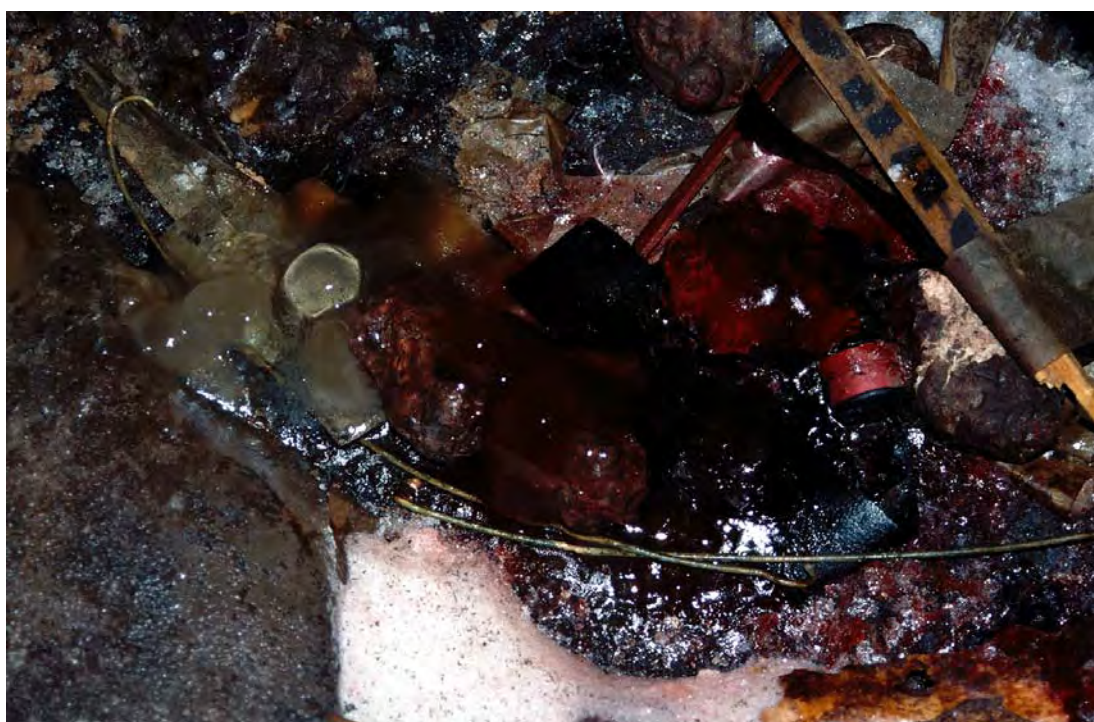
Figure 13: *Stained ice above Hurley's bunk 2002*

Figure 14: *Stained artefacts on the floor below Hurley's bunk 2002*

As the thaw continued, a raspberry coloured liquid dripped from the bunk immediately above Hurley's, staining both the snow and ice with which it made contact and potatoes and other artefacts located on the floor below (see Figures 13, 14).

An additional direct impact of the higher temperatures experienced this summer was the damage caused by melt-water saturating artefacts and structures. In the Main Hut, the outer layers of newspapers on the shelves on the northern wall of Mawson's room, were saturated by water dripping from melting snow and ice that had accumulated above the ceiling of Mawson's room and on the adjacent platform timbers. Although it is anticipated that the paper will naturally freeze-dry during the cooler autumn and winter seasons there is a slight risk that some of the pages may fuse together. Other paper and wooden artefacts were similarly saturated and all are likely to be affected by disfiguring mould formation. Damp and wet metal artefacts will corrode more rapidly. Melt water from a large mass of accumulated snow on the bunk immediately above Hurley's, mobilised an unknown, bright pink substance which then stained the snow below it as well as artefacts that were on the floor below. Potatoes and other objects on the floor are now stained pink!

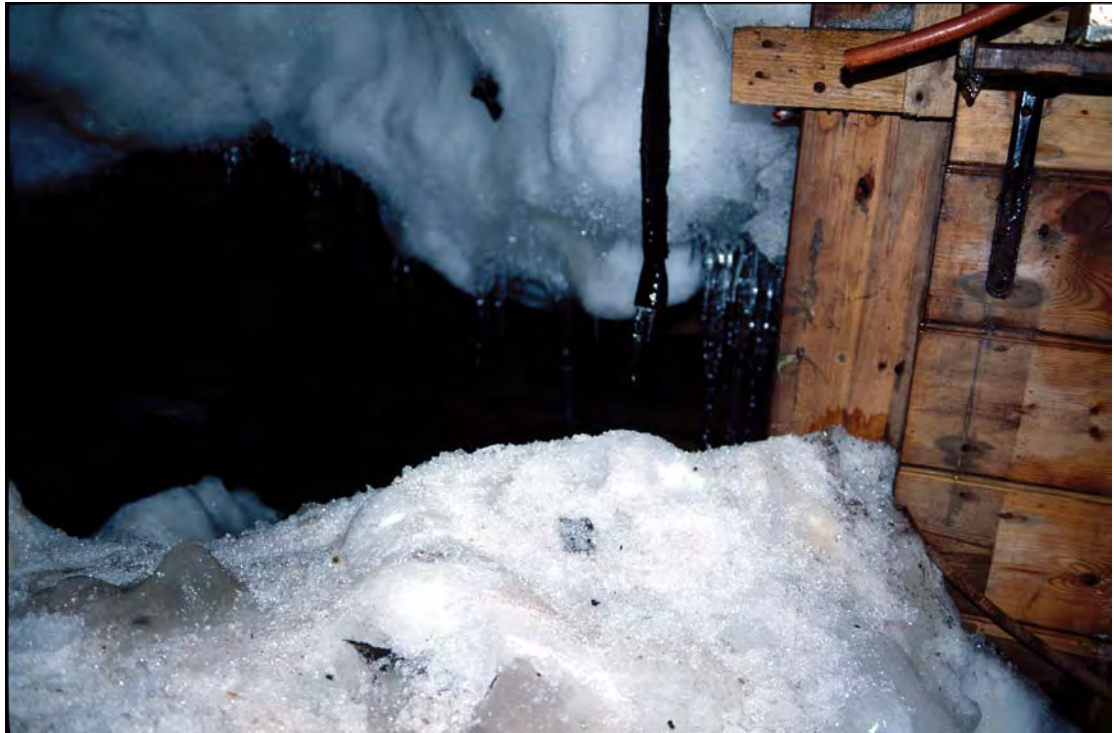
- the south-eastern corner. During the 2000/01 summer it was possible to access boards that lined Mawson's room on the eastern side. These were now covered with overhanging snow and melting ice (Figure 15).
- Mawson's room – snow now covered Mawson's chair and considerable areas of the floor and the shelves around the room (Figures 16, 17)
- Snow was found on the tongue and groove boards stored on the southern edge of the platform.

Figure 15: *View to the south east corner of the Main Hut 2002*

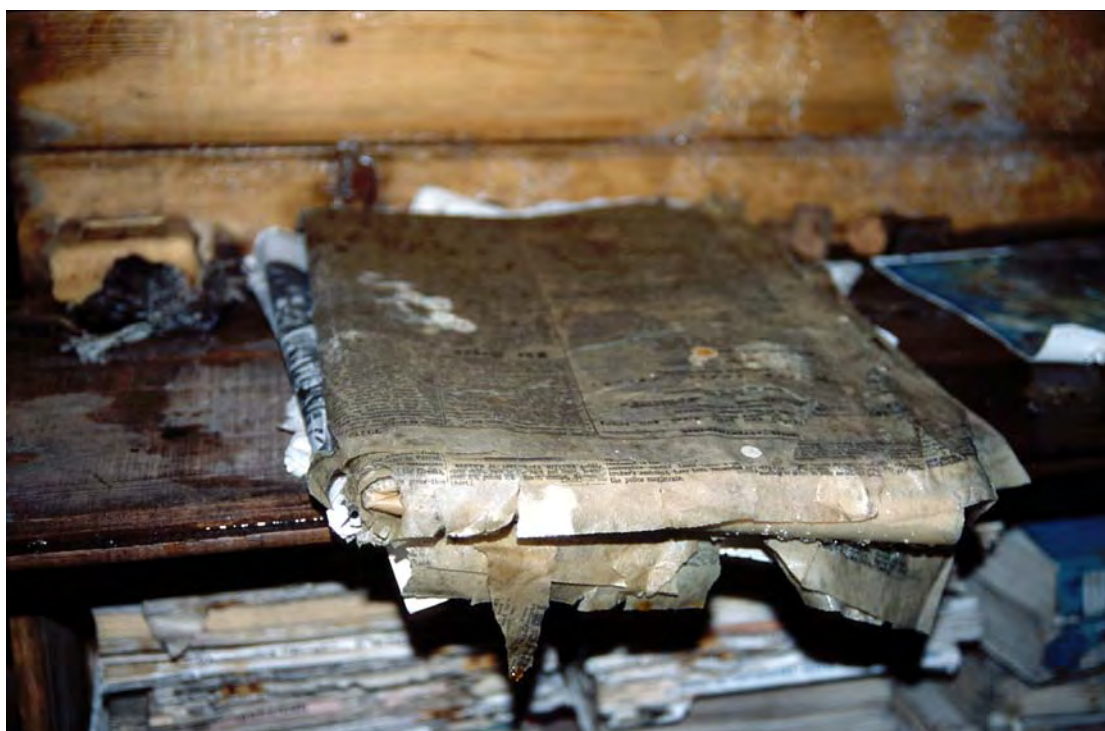
In addition, melt from areas above the northern, outer wall of Mawson's room had dripped onto books, newspapers and other artefacts located on the shelves below. The newspapers in particular, are now in a more delicate condition than when they were dry (Figure 19). Nothing was done to treat these waterlogged artefacts as it was considered best to leave them to naturally freeze-dry when cooler conditions prevail in the Hut. They are however, more susceptible to mould attack. To minimise further damage to these artefacts, residual snow and ice was removed from the boards above, which were then moved further away on the platform to dry. When dried they were replaced but with a layer of black plastic on top of them to prevent a similar recurrence in future warm summers.

Figure 19: *Wet newspaper - shelves outside Mawson's room 2002*

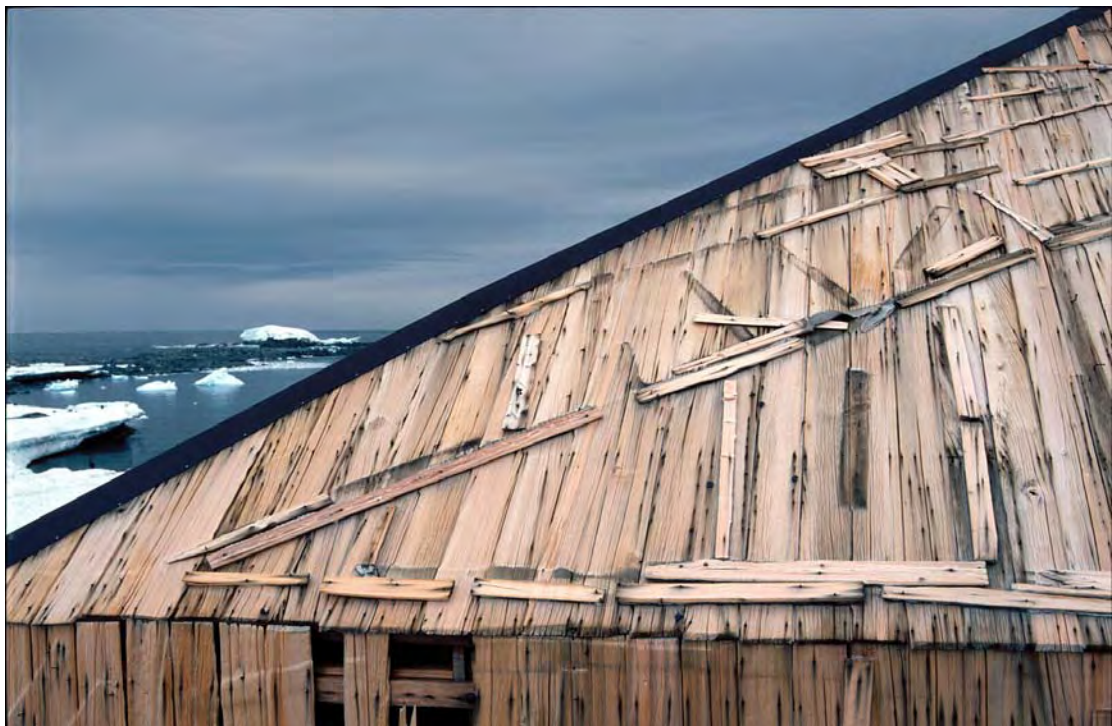
Figure 23: *South-facing roof of the Main Hut 2002 showing missing battens*

Table 1: Comparisons of roofs and walls of the Main Hut 2000/01 and 2001/02

Surface	Missing Battens	Loose Battens (rotating)
South roof	2	2
South wall*	-	-
West roof	2	2
West wall	-	2
East roof	2	3
East wall	-	-

- The roof of the Main Hut be over-clad to protect the original timbers, battens, sail cloth and rope from further physical damage and loss and to stop the further ingress of snow.

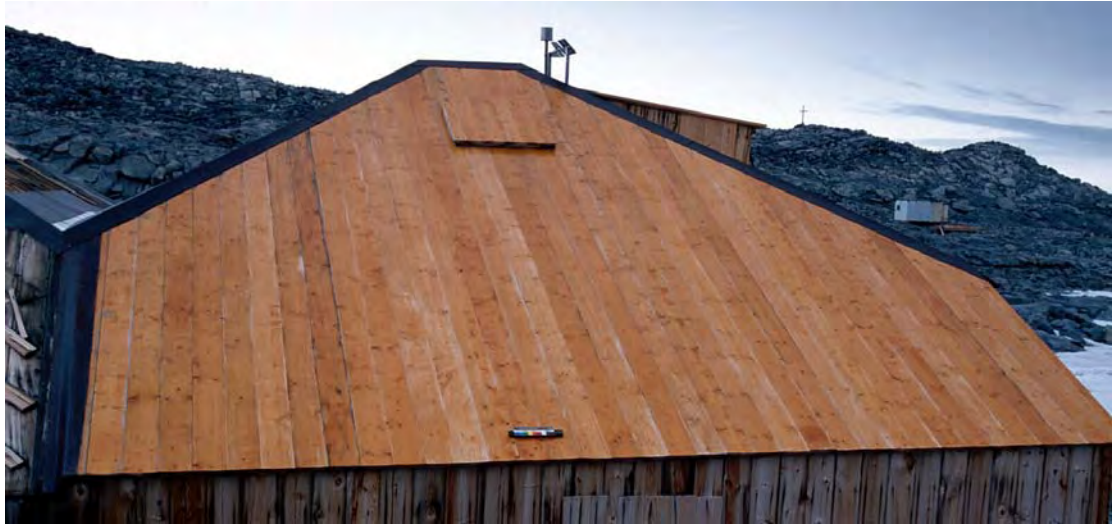
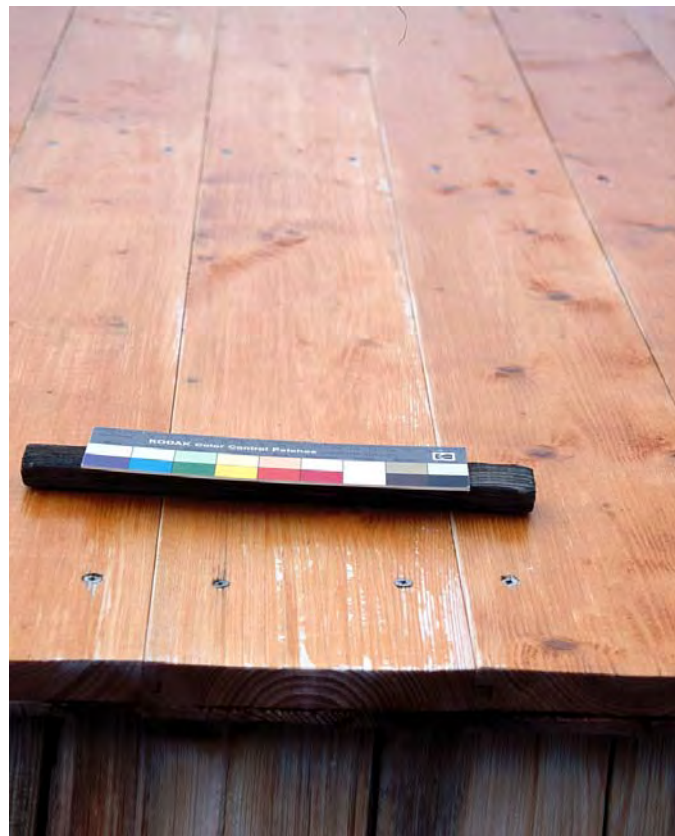
Photographs were taken to illustrate the effects of weathering on the Intergrain finish of the Workshop roof. Although all surfaces are starting to deteriorate, the Intergrain finish still provides protection for the underlying wood in most places. Most deterioration has occurred near the ridge capping and at other places where either moisture retention is enhanced or physical abrasion has been greatest. As chemical breakdown by sunlight is most significant in the presence of moisture, areas of greatest exposure to these agents generally deteriorate at a faster rate. The loss of the Intergrain finish from the eastern roof surface is illustrated below (Figures 24, 25).

Figure 24: *East-facing roof of the Workshop 2002*

Figure 25: *East-facing roof of the Workshop 2002*

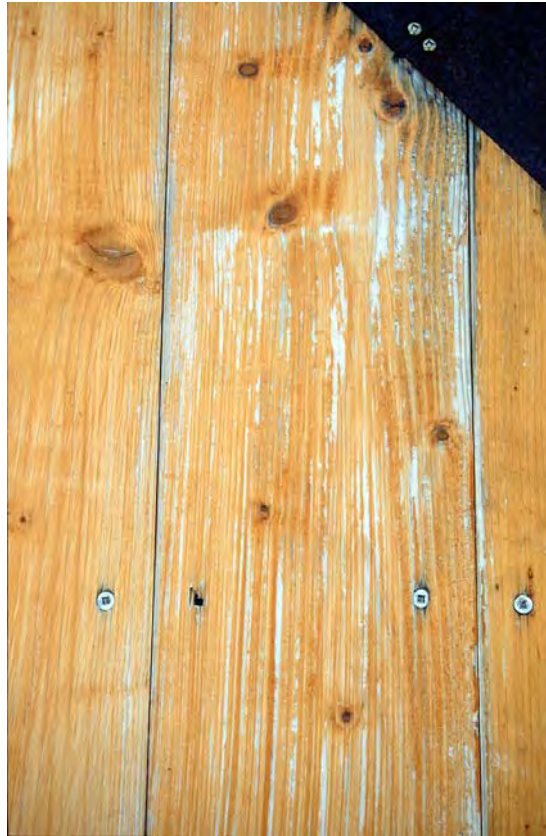
It is significant that on the southern workshop roof both chemical deterioration and physical abrasion are occurring (Figure 26). Isolated parts of this surface, which bears the brunt of the katabatic winds, have developed small ridges and troughs due to loss of wood substance from the less dense earlywood regions of the pine.

Figure 26: *South-facing roof of the Workshop 2002*

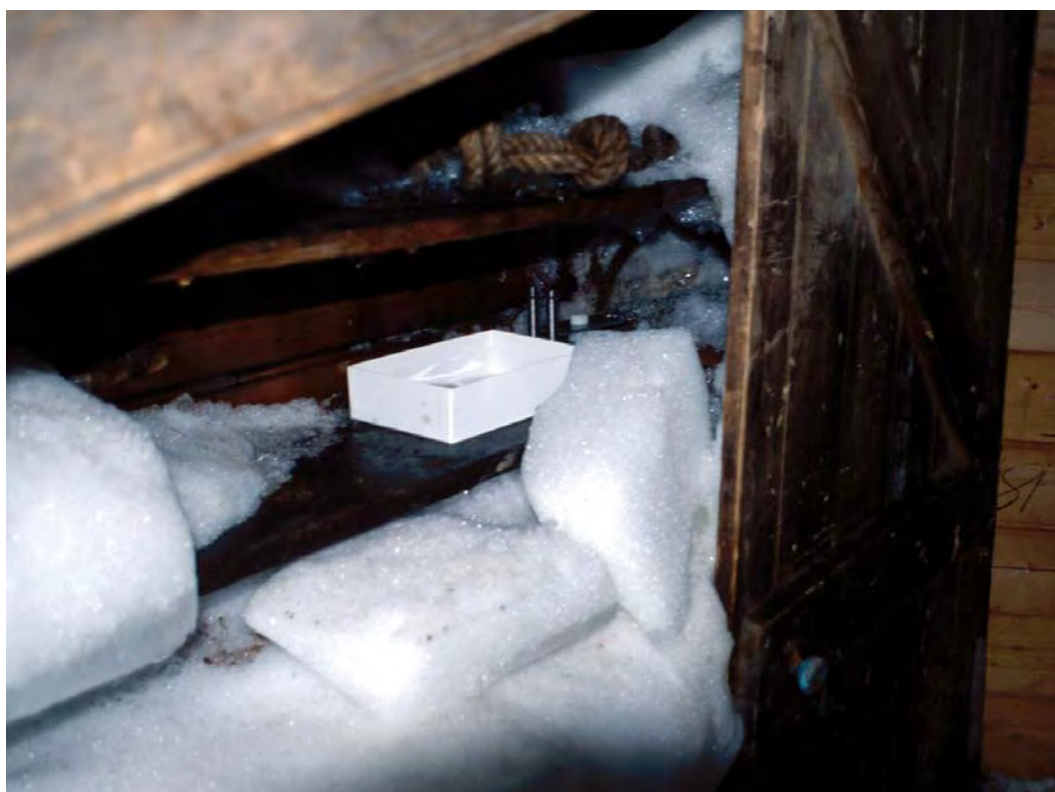
Figure 29: *Monitoring equipment in the Workshop (southern wall shelving)*

- Workshop – southern wall – cells and artefacts are on a shelf just inside the entrance to the workshop. This area is almost completely 'surrounded' by snow and ice. It is an area in which the shelving brackets appear to be corroding at a higher rate than those in more open, ice-free areas (Figure 29, MH 7, 2709).

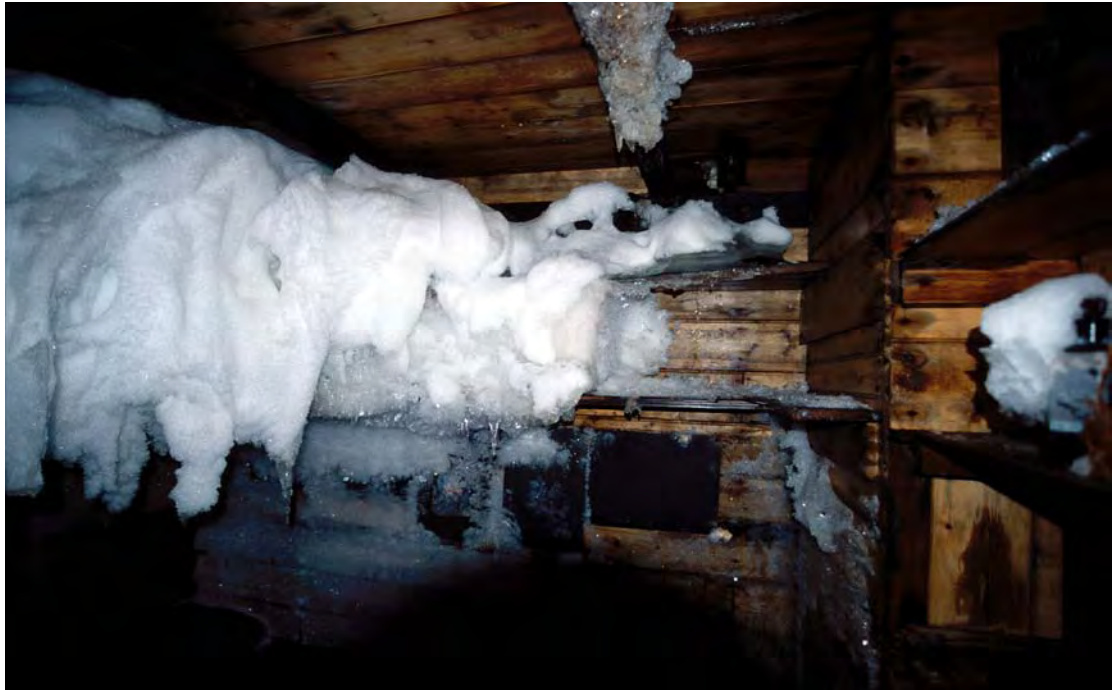
There was a considerable build up of snow and compacted, solid ice in Mawson's room. There was a substantial amount on his chair and on the shelving around the room. It appeared that there had been significant snow ingress since January 2001, with loose snow overhanging the bed. The top shelf on the southern wall appeared to be bowing under the weight of this accumulated snow and ice (Figure 30).

Figure 30: *Snow and ice on shelving on the south and east walls of Mawson's room 2002*

After consulting Rob Easter of the Antarctic Division it was decided that the snow and compacted ice should be removed to minimise further damage to the shelving, the brackets and possibly also to the bed and pillow below. As the only possible source of ingress was the accumulated snow and ice on the ceiling of this room, some of this was removed prior to removing snow and ice from the room itself.

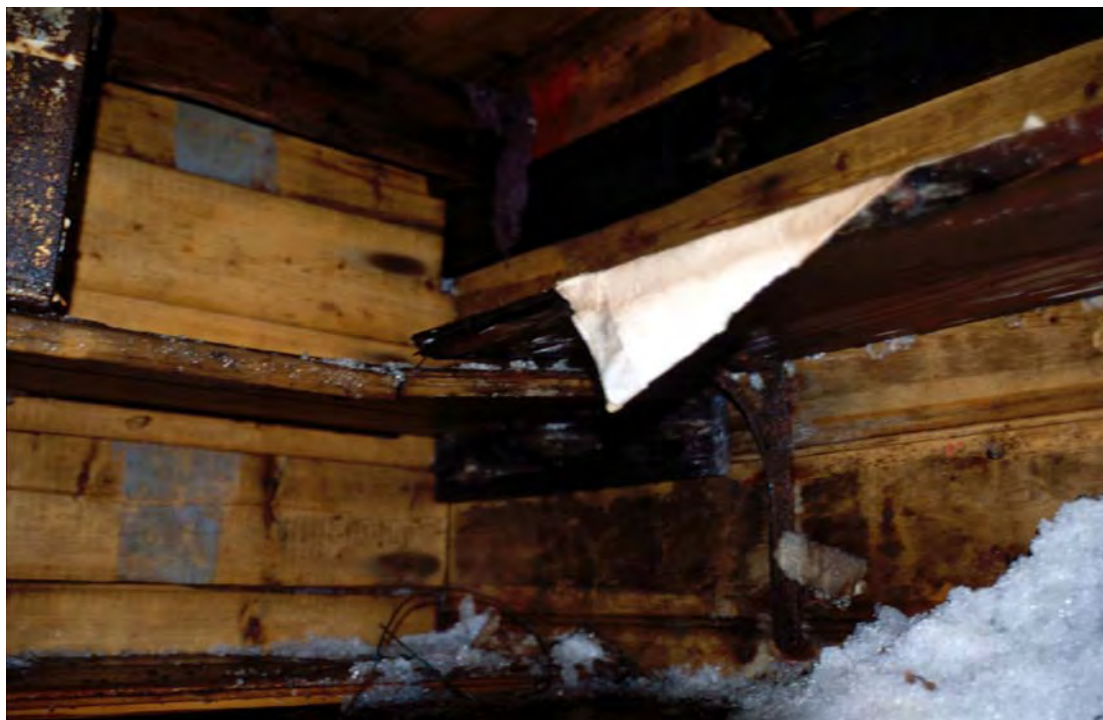
A total of 370 kg of snow and ice was removed from the area above Mawson's room with a further 280 kg removed from the shelving in his room (Figure 31) and 75 kg from his chair and the surrounding floor areas. Heavy duty plastic was used to cover Mawson's bed and pillow to prevent any accidental damage from falling snow and ice during this latter ice removal process. Damaged shelving was revealed when most of the snow and ice was removed from these areas (Figure 32).

Figure 32: Damaged shelving in Mawson's room 2002

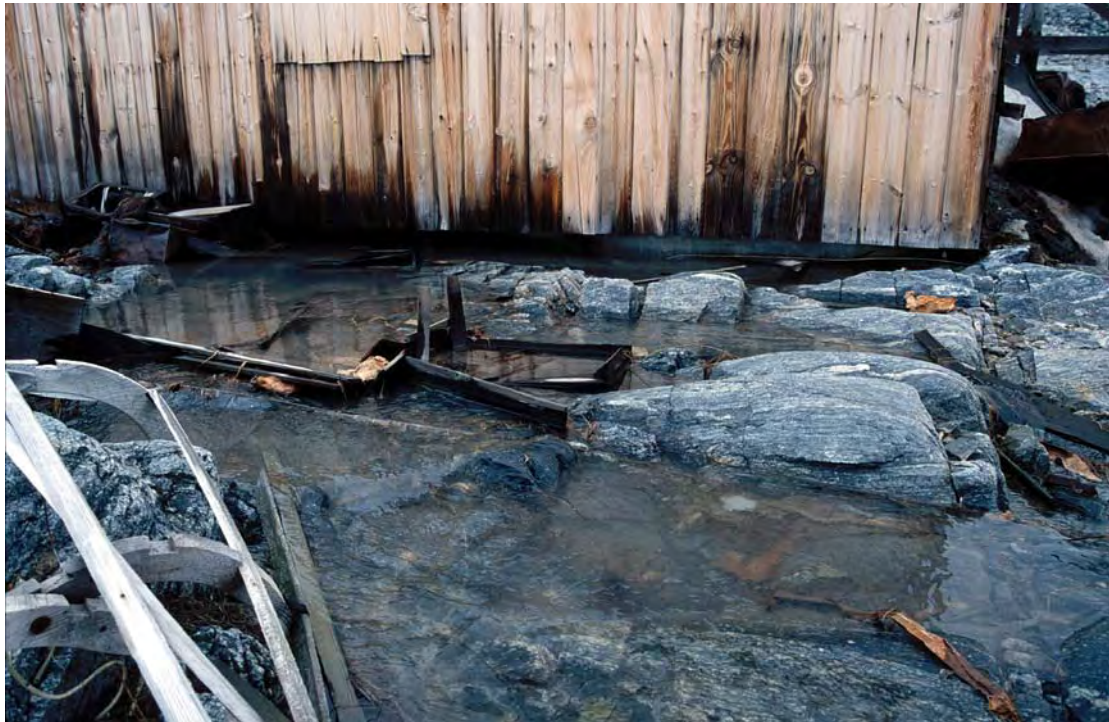
presence of a melt stream flowing from under the hut, at the junction of the Main Hut and the workshop, there is still a considerable mass of ice that is firmly attached to the building foundations. Where possible, distances from the extremities of the building to the solid ice core were determined using a length of wood and measuring tape (NE and NW corners of the Workshop only).

Figure 34: North-east corner of the Workshop veranda showing residual ice below the wall 2002

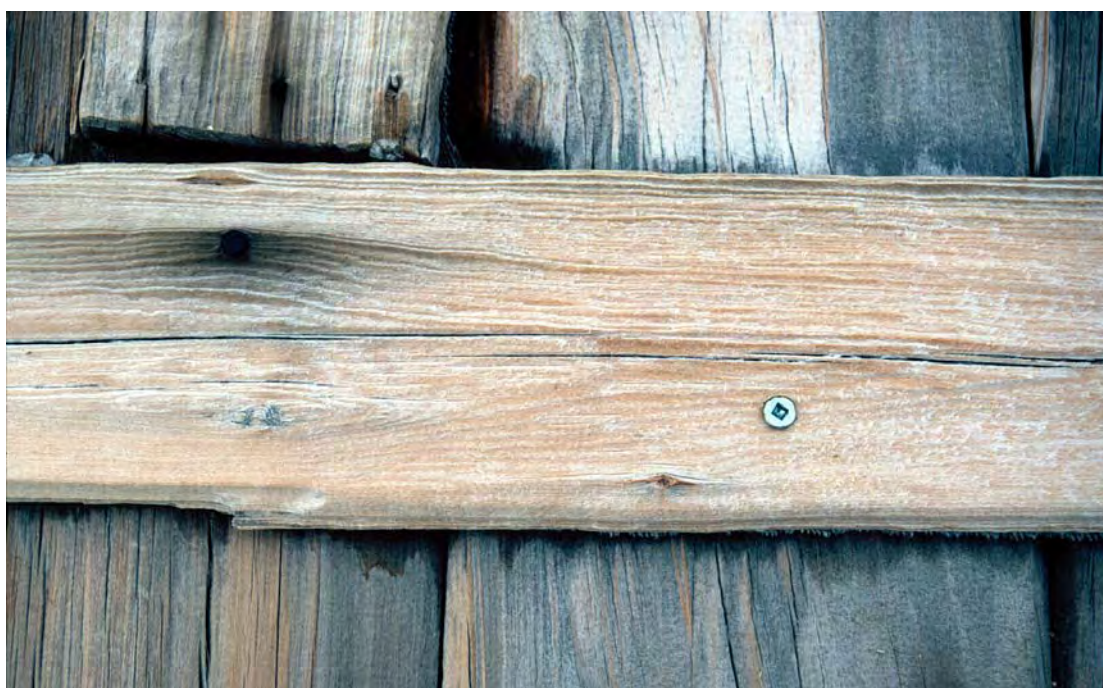
Figure 42: *Securing of a split batten – south roof of Main Hut 2002*

As there were insufficient appropriate fastenings and tools to prepare and attach replacement wood to cover holes in the tongue and groove timbers of the south-facing roof of the Main Hut, repair work was limited. The highest priority was assigned to reattaching loose and/or split battens that were at risk of being blown from the roof under blizzard conditions. An inspection of the southern, western and eastern sections of the Main Hut roof revealed a number of battens that were attached at one end only. These were given priority. This was necessary because of the limited number of appropriate fastenings that were available. Easily identifiable, modern screws were used to attach 5 battens to the southern roof, one to the western roof and 3 to the eastern roof (Figure 42). In some instances loose battens were not in their original positions (as indicated by weathering patterns, nails and nail holes). They were repositioned prior to reattachment.

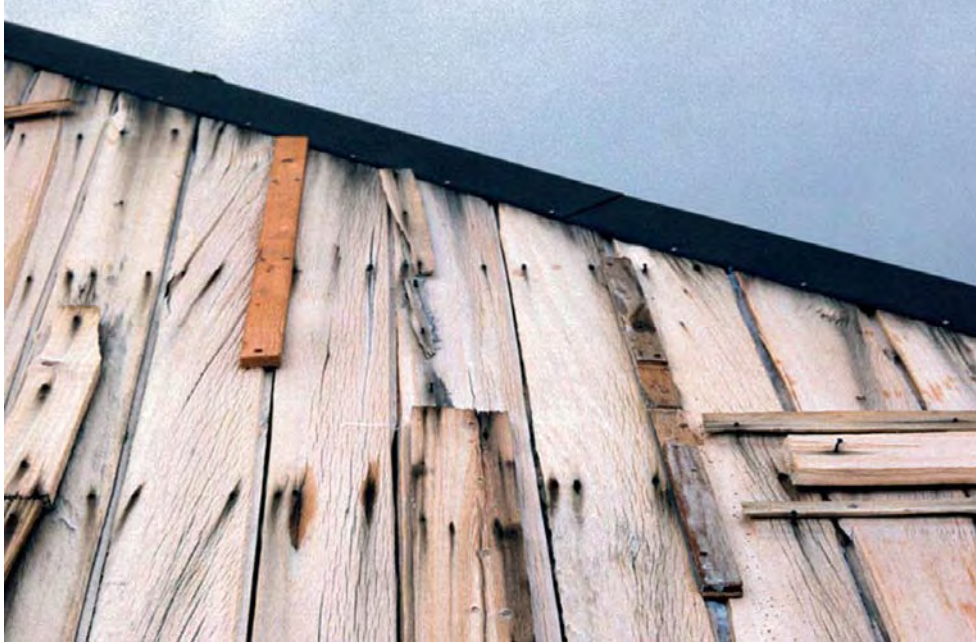
Sections of the southern roof of the Main Hut appeared to have deteriorated considerably since the summer of 2000/01. In particular 4 joins, approximately 2.6 m, 1.5 m, 0.8 m and 0.4 m in length respectively, were identified as being in urgent need of repair. These gaps in the tongue and groove timbers were found in an area of the roof above and slightly to the east Mawson's room, an area in which increased snow accumulation had been observed inside the Main Hut. It was considered important to prevent further ingress of snow in this area of the building as the build up on the ceiling of Mawson's room is leading to damage inside the room itself.

Figure 43: *Repair to the south roof of the Main Hut 2002*

Three lengths of modern wood were found and screwed to the existing roof to cover the two largest gaps in the roofing timbers (Figure 43). Two of these pieces had to be joined to cover one gap. A small amount of silicone was used to seal the join of these pieces. Additional silicone was also used to cover a hole near the ridge capping for which no timber or fastenings were available (Figure 44).

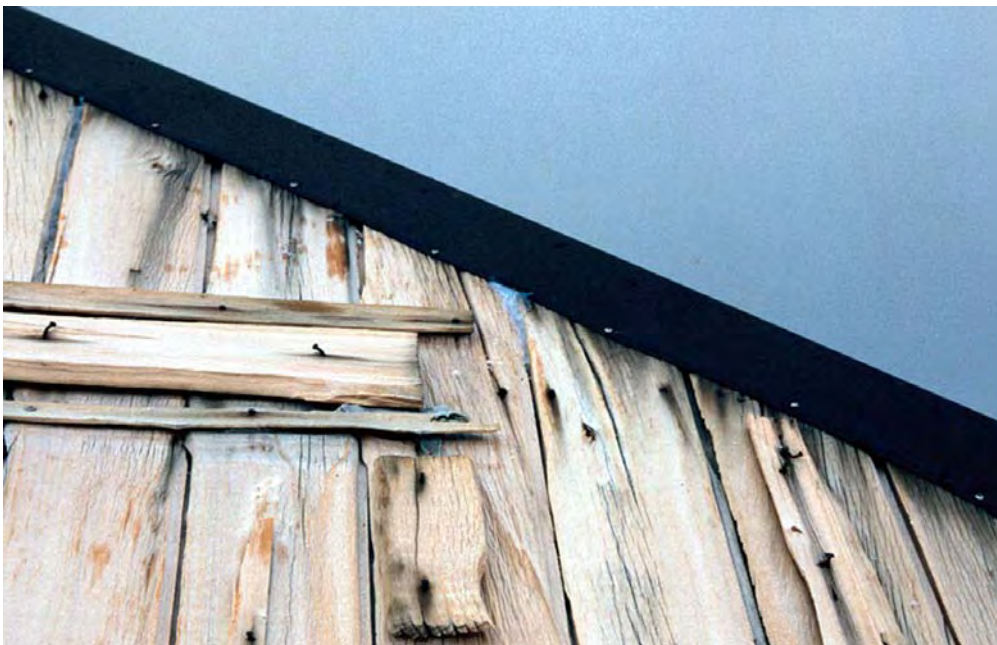
Figure 44: *Silicone repair to the south roof of the Main Hut 2002*

As silicone had been used as a temporary repair measure during the 2000/01 season, it was considered reasonable to also use it in this instance, in the absence of any preferable alternative.

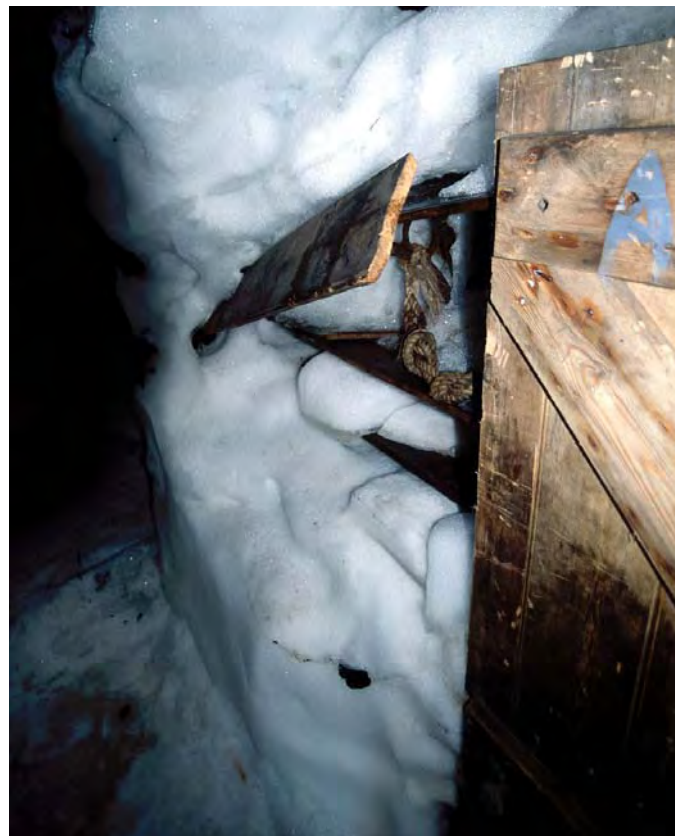
Katabatic winds and windborne snow and ice have contributed to and will continue to cause quite rapid deterioration of the external wooden building components, especially those with a southerly aspect. Associated with this physical deterioration of the building fabric is an increase in the amount of snow and ice entering the building. Contrary to some previously expressed opinions, this ingress is far from being a benign protector of the internal structures and artefacts that remain in the interior spaces. Melt – freeze cycles produce ice that encapsulates objects and structures and applies physical stresses to load-bearing features. In the past this, and the sheer mass of accumulated snow and ice, have led to the collapse of the platform in the Main Hut, breakage of some structural timbers and tongue and groove boards in the ceiling of the Workshop, the collapse of shelving and the deformation of shelving brackets (Figures 45, 46).

Figure 45: *Damaged shelving on the south wall of the Workshop 2002*

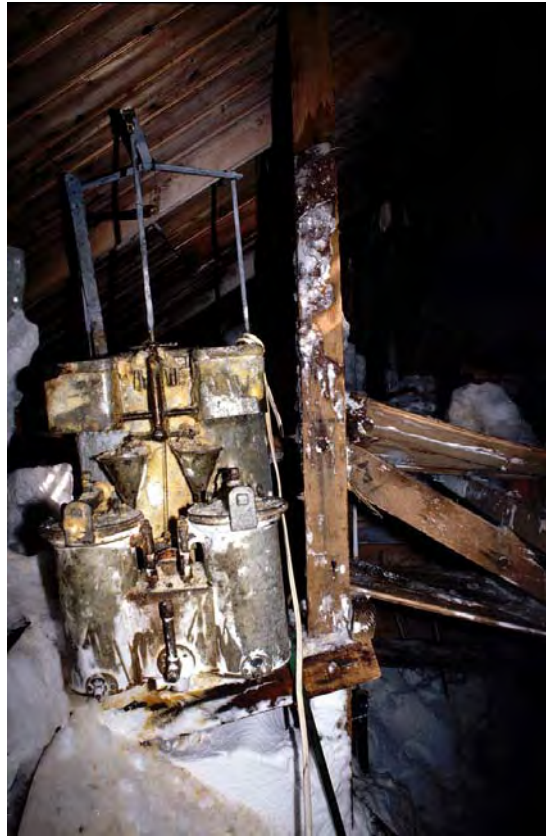
Figure 46: *Broken platform timbers in the Main Hut 1997/98 (©A McGregor)*
