Mawson's Huts Historic Site

Management Plan 2007-2012

Australian Antarctic Division

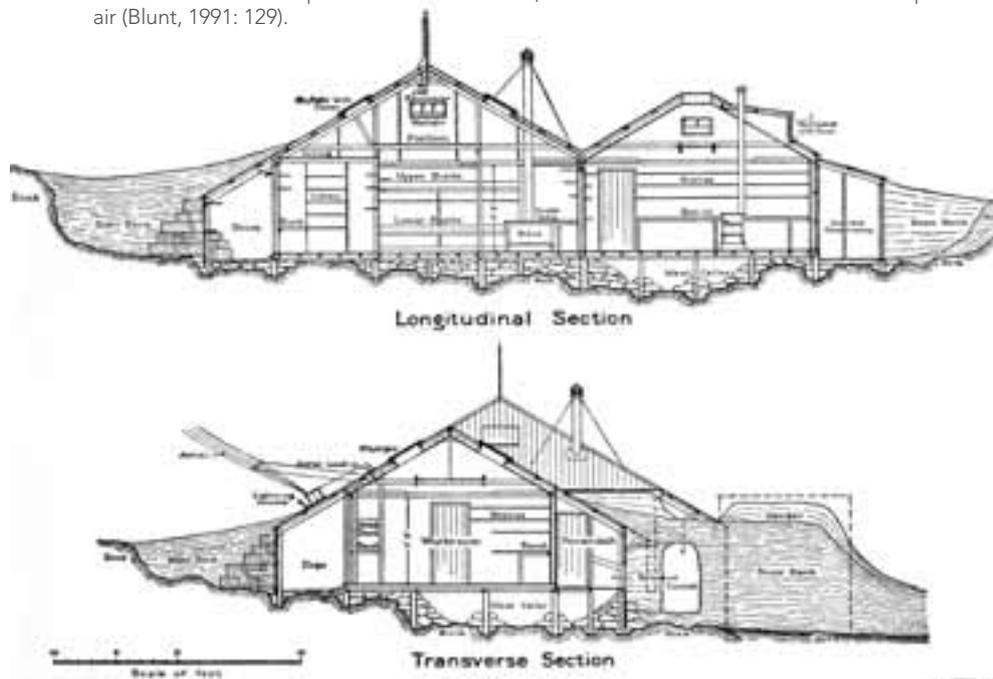
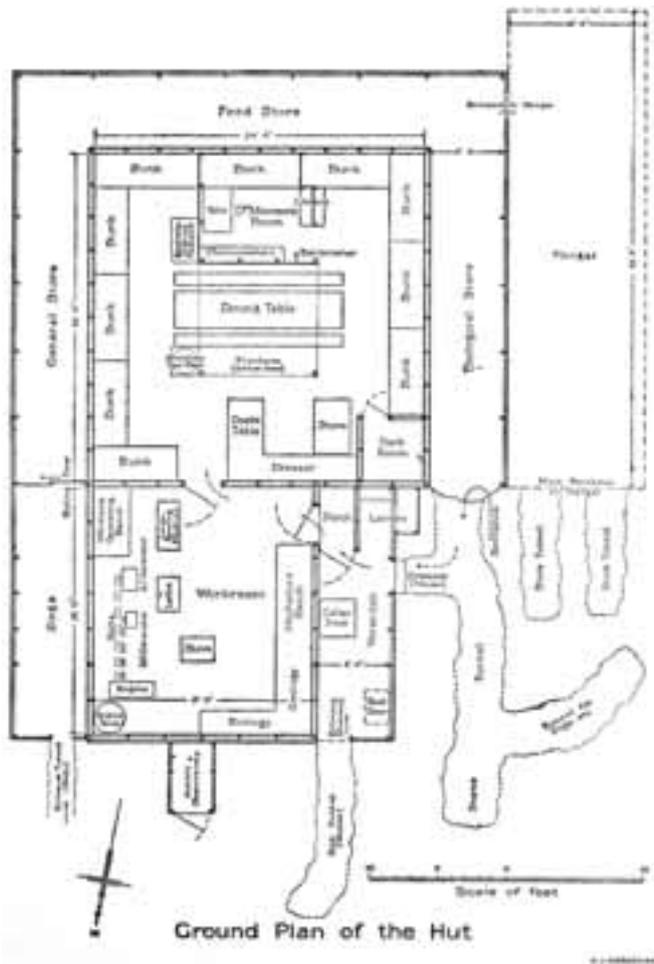
ILLUSTRATIONS:
Alfred Hodgeman's plans
of the Main Hut (from
Home of the Blizzard)

The Main Hut consists of two prefabricated Oregon timber huts with foundations set in 50 tonnes of loose rocks in February 1912. Structural timbers are bolted together with tongue-and-groove Baltic pine used for internal and external cladding. A 1.5 m wide verandah surrounds the structure on three sides.

There is no direct external access. Entry is via the workshop, which is attached to the northern side of the living section. The rectangular workshop, prefabricated by Messrs Anthony (Melbourne), 5.5 m by 4.9 m, has a hipped roof and two skylights. The western verandah contains access to the cellar and roof as well as a latrine.

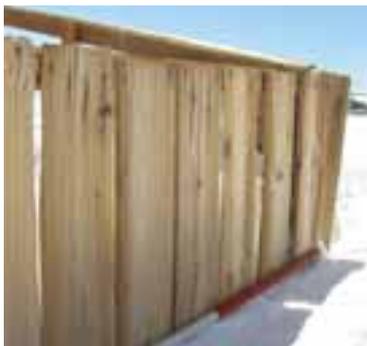
Linda Clark, 2002:
Magnetic Absolute Hut (AAD)

The Absolute Magnetic Hut, erected in February 1912, is a deteriorated ruin consisting of only a complete south wall with portions of the east wall and the framing of the north and west walls. The frame was constructed of leftover Oregon timber with timber boarding and tar paper lining. The plan is 1.8 m square, sited on a rock shelf and originally anchored to the ground. The skillion roof was removed by BANZARE expeditioners in January 1931.

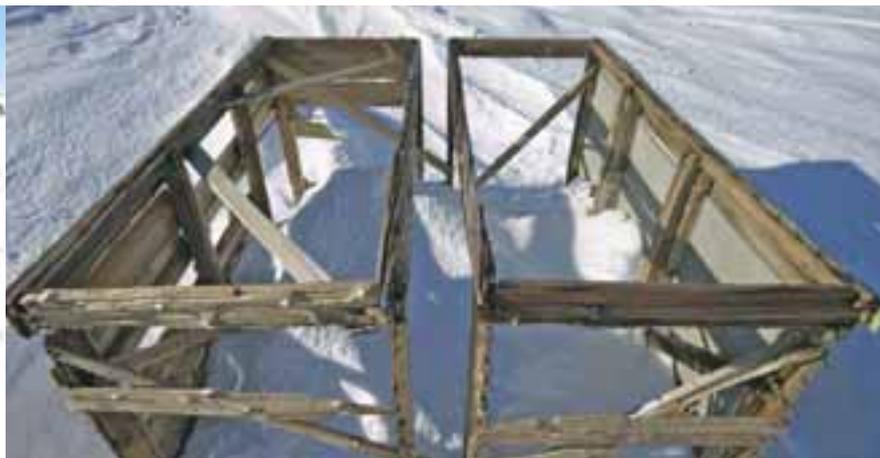
Simon Mossman, 2006: Transit Hut (MHF / AAD)

The Transit Hut is the roofless ruin of what was originally known as the Astronomical Observatory, built on a rock ledge in May 1913 to house a theodolite to take star sights. The Oregon timber frame braced by metal shelf brackets was lined with packing case timber and clad in sheepskin and canvas. The structure had one door in the northeast corner.

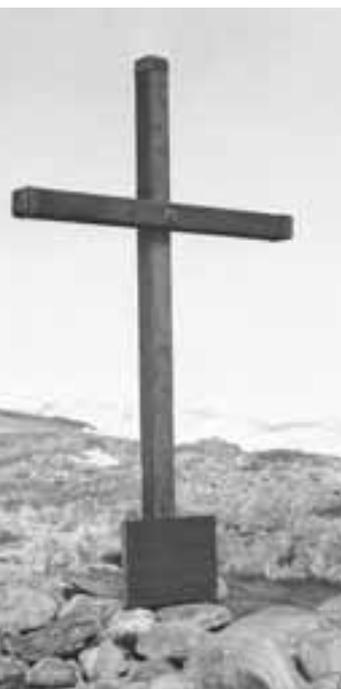
Frank Hurley, 1913 (Memorial cross to Mertz and Ninnis erected at Cape Denison (Australasian Antarctic Expedition, 1911-14 collection, State Library of NSW)

Memorial Cross and Plaque

The memorial cross to Ninnis and Mertz, built by Bickerton, was erected on Azimuth Hill, to the northwest of the Main Hut, in November 1913. The upright and cross bar were fabricated from remnant timber—apparently from the radio masts—of approximately 170 mm by 170 mm. The upright projects 3.4 m above the surrounding rocks and is capped by a 65 mm wide metal collar. The crossbar is 2.2 m long with a 65 mm wide collar at each end. The crossbar is fixed to the upright 2.2 m above the rocks.

The crossbar has been blown off numerous times. It was re-attached in 1931 by BANZARE, in 1978 by ANARE and a third time by the AAP Mawson's Huts Foundation expedition in 1997-98. A plaque attached to the cross, probably made of wood from the dining table, was inscribed by Hodgeman: 'Erected to commemorate the supreme sacrifice made by Lieut. B.E.S. Ninnis, R.F. and Dr. X. Mertz in the cause of science A.A.E. 1913 A.J. Hodgeman'. The plaque is a replica of the original, which was removed to Australia in 1977 and returned to the site in 1978, and then removed in 1985 and replaced by a reconstruction in 1986.

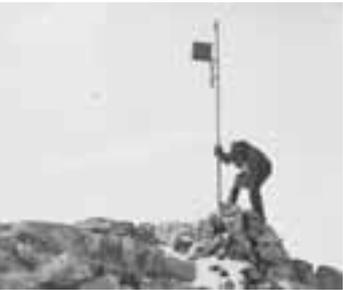
Frank Hurley, 1912: The Puff-anemometer, Cape Denison (Australasian Antarctic Expedition, 1911-14 collection, State Library of NSW)

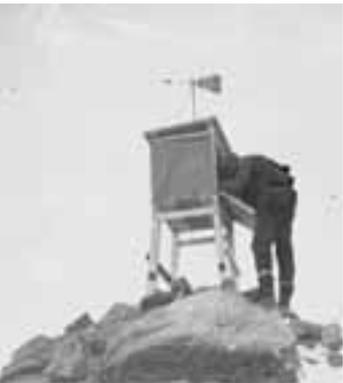
Frank Hurley, 1912: The wind direction recorder, Cape Denison (Australasian Antarctic Expedition, 1911-14 collection, State Library of NSW)

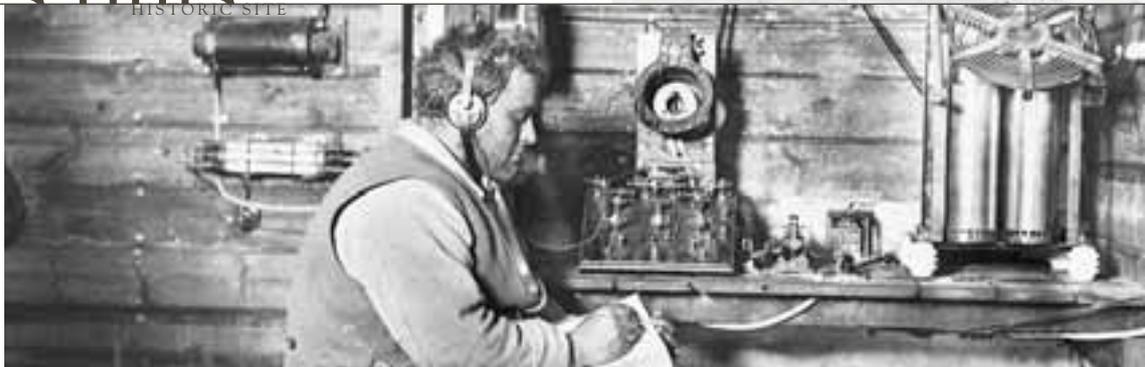
Frank Hurley, 1912: Hannam and the wireless instruments at Cape Denison (Australasian Antarctic Expedition, 1911-14 collection, State Library of NSW)

The establishment of radio communications and the installation of the necessary equipment at the Main Base at Cape Denison was not an easy task. Two radio masts were erected by late August 1912, and a temporary aerial enabled messages to be sent to Macquarie Island by 25 September, until one of the masts was broken by wind in October. The wireless operator was based in the workshop, and later in the living section of the Main Hut, where warmer and drier conditions improved the operations of the equipment. The reconstructed apparatus successfully sent messages, but was not able to receive them. Two-way communication resumed in February 1913.

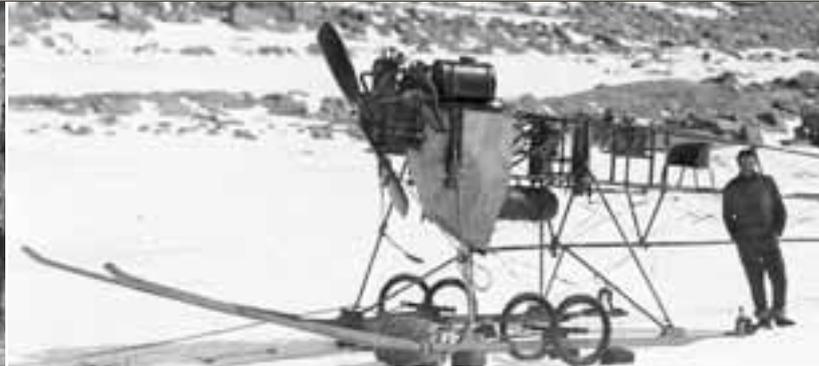
Frank Hurley, 1912: Bickerton repairs the Air-tractor in the Hangar: L to R Bage, Ninnis, Bickerton (Australasian Antarctic Expedition, 1911-14 collection, State Library of NSW)

Mawson obtained an REP Monoplane from Messrs Vickers & Co for the expedition. It was hoped that this relatively rare machine would generate much-needed publicity during the preparation for the expedition and, when in Antarctica, assist with exploration (Blunt, 1991: 102). However, the aeroplane was damaged during a test flight in Adelaide (with Wild on board), and was modified for use as a wingless 'air tractor'. The expeditioners appreciated the irony of using a state-of-the-art aeroplane engine to haul conventional sledges.

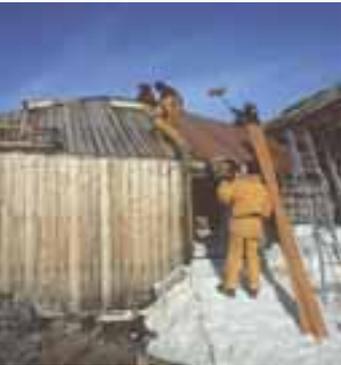
PHOTO: Alasdair McGregor,
1997-98: Over cladding roof of
workshop with new Baltic pine
(iMAGEAntarctica, AAD)

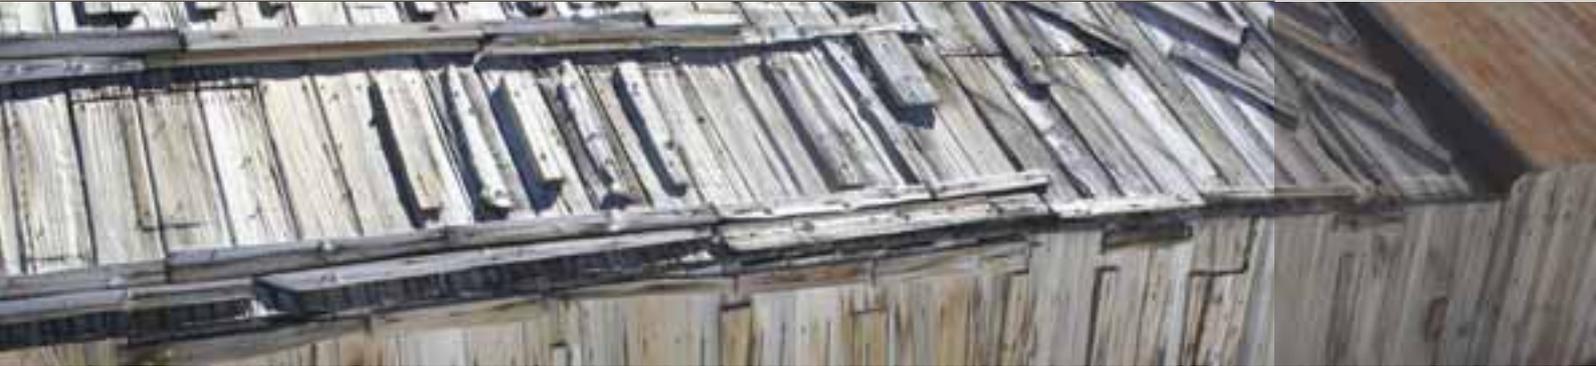
The original roof claddings of the Main Hut and Magnetograph House are elements of high integrity in poor condition—the eroded original roof boards are now encapsulated beneath new timber over-cladding. Abrasion of the roof cladding by wind-driven ice, coupled with the large spans between supports for the cladding, meant that the roofs on the workshop of the Main Hut and the Magnetograph Hut were close to failure when inspected in 1997. In the decade since, both roofs have been over-clad. This intervention secured the structural integrity of the buildings at the cost of some of the value embodied by a feeling of time elapsed and exposure to the elements.

The walls and roof, both inside and outside, were of tongued and grooved pine-boards, made extra wind-proof by two courses of tarred paper. As rain was not expected, this roofing was sufficient. There were four windows in the roof, one on each side of the pyramid. We should thereby get light even though almost buried in snow.

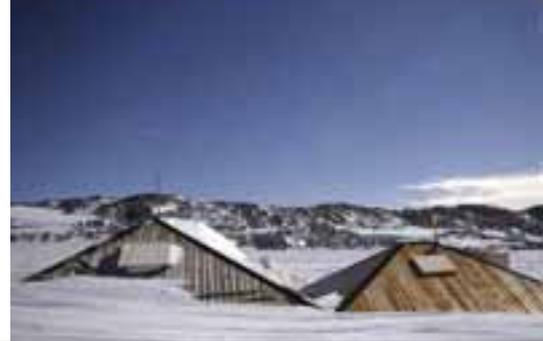
Simon Mossman, 2006:
Living section before over-cladding
(MHF / AAD)

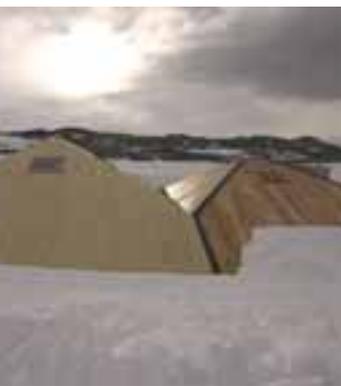
Simon Mossman, 2006:
Living section after over-cladding
(MHF / AAD)

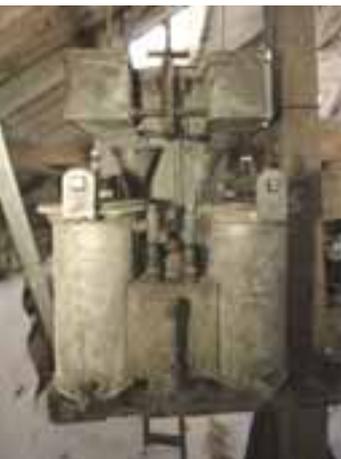
Simon Mossman, 2006: Acetylene plant, Main Hut (MHF/AAD)

The condition of objects inside the Main Hut is variable: some are in good condition, while others are sound other than mould stain (on paper and fabrics) or surface corrosion (on metal). Objects in poor condition include boxes almost entirely consumed by mould, food remains in a state of advanced decay, the damp detritus congealed on the dark room floor, and tins represented only by rust rings.

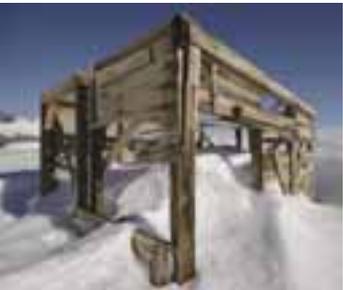
Simon Mossman, 2006: Transit Hut: (MHF / AAD)

Site management to date has viewed the Transit Hut and Absolute Magnetic Hut as standing ruins requiring minimal intervention. However, recent works parties (e.g. Godfrey, 2002) reported that elements of the Transit Hut were so eroded that the whole structure was becoming marginal, and that the wall boards on the Absolute Hut were so thin that only the ice embedded around the boards stopped them from detaching.

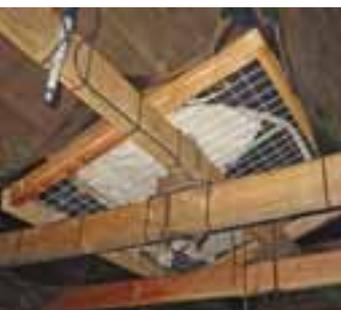
Linda Clark, 2002: Part of air tractor stored inside hut (AAD)

The pioneering use of wireless telegraph and the first attempt to use an aeroplane in the Antarctic are unique aspects that set apart the AAE from other Heroic Era expeditions. However, over time most of the material evidence of the technologies has been lost, probably due to wind. The few remains demonstrate a high degree of creative or technical achievement, and therefore should be identified and assessed. Drawing on reports to come from on-site work, specific management recommendations will be required for their ongoing conservation.
