Mawson's Huts Foundation

2008–09 Expedition Report

MAWSON'S HUTS CONSERVATION EXPEDITION 2008/09

EXPEDITION REPORT

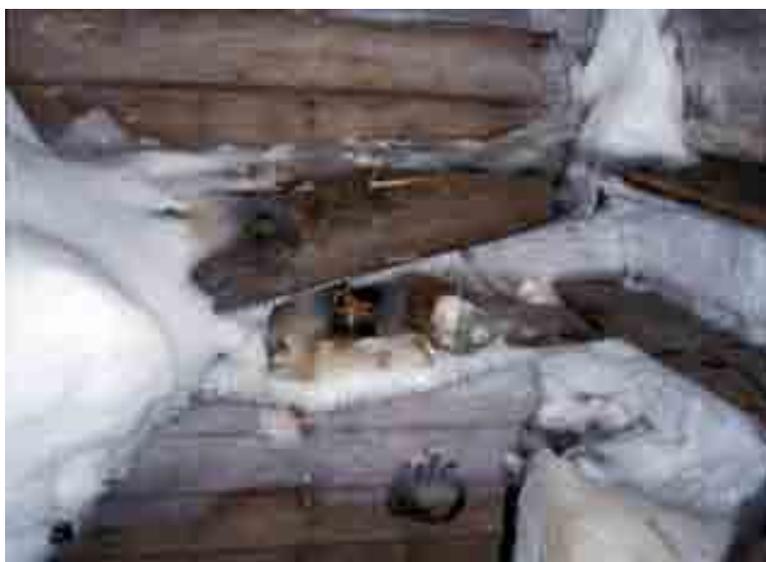
This recommendation applies particularly to shelves, many of which have been damaged by accumulated snow and ice buildups. Care is needed with this work as many damaged shelves still hold artefacts embedded in ice and snow (eg above Mertz's bunk, in the workshop etc).

Damaged and sloping shelving in the south east corner of the workshop

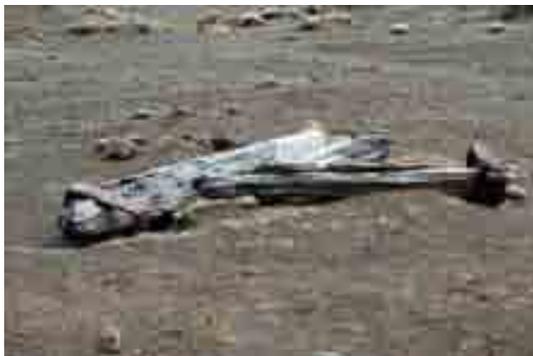
The expedition team visited the site of the AAE wireless station on North Head, Macquarie Island. Very little physical evidence remains of the station. The remains of a radio mast and very small corroded lengths of iron cables are all that remain in one area. No remains were found of the second mast. Similarly, an inspection of the sites of the engine and wireless huts revealed little other than some (possibly) structural timbers and wires. Tussock grass has slowly encapsulated this site, covering features, such as dressed stone foundations, that were previously described in 2003⁴. The time available on the island did not allow for a thorough inspection to be made.

Remains of wireless mast

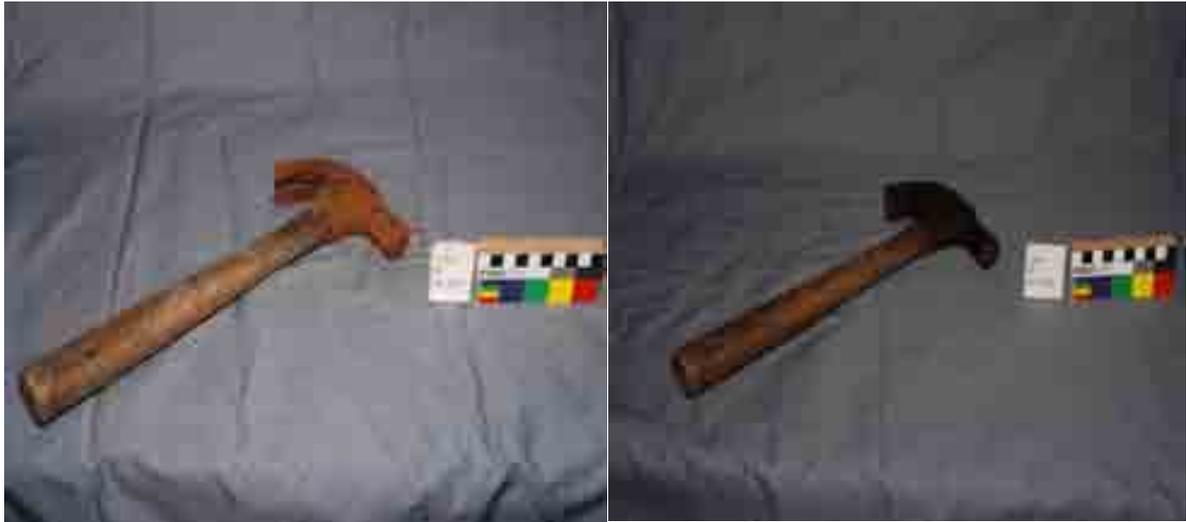
The metal objects, which were predominantly iron, were treated by removing loose corrosion, treating the metal surface with a metal inhibitor and coating with either a wax or resin layer to protect the surface from the high relative humidity inside the huts. An example of one of the metal treatments carried out is a hammer excavated from the workshop. Although the wooden handle of the hammer was in good condition, the iron head had suffered from extensive surface corrosion. Conservation treatment consisted of removal of loose surface corrosion, followed by stabilisation of the iron surface with tannic acid and coating with polyethylene wax. The photos show before and after treatment results.

Hammer before treatment

Hammer after treatment

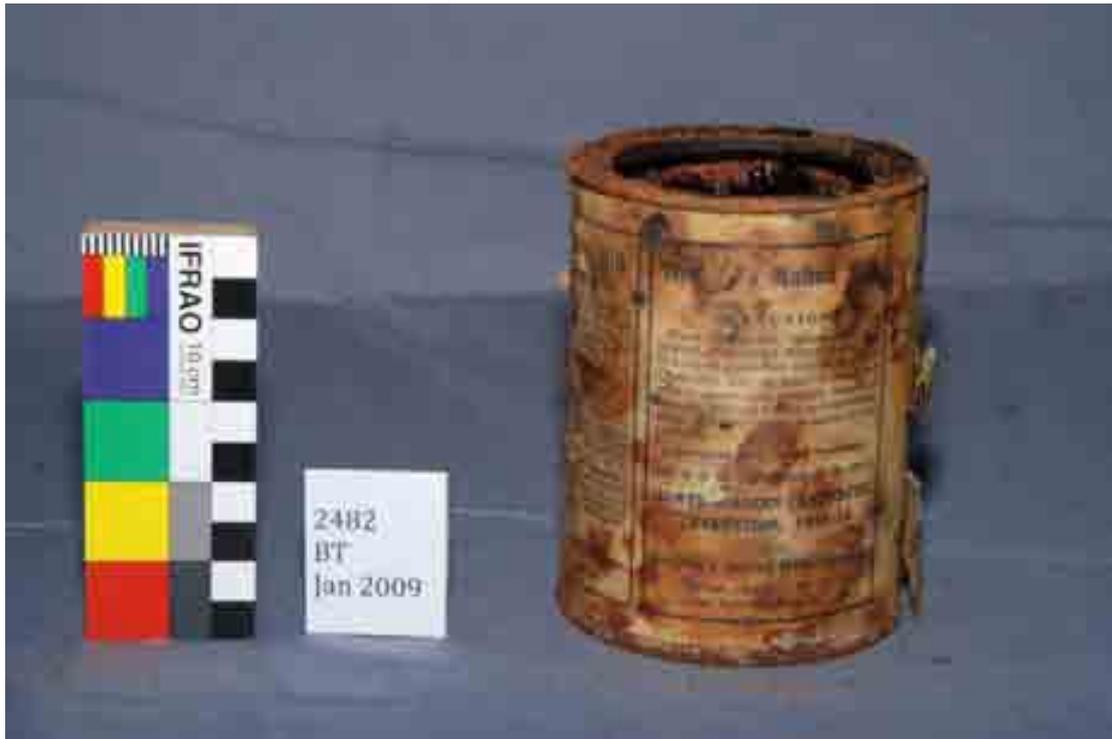
One of the issues identified in the 2007 Conservation report⁵ was that associated with the conservation treatment of cans still containing food or other substances, particularly those which were liquid at room temperature or contained substantial amounts of water. Only one such can was treated in the lab this season. The can, with a paper Horlicks Malted Milk label, was moved to the lab for treatment and after thawing, was found to contain linseed oil. Fortunately the can did not have any holes or punctures and the contents did not leak after thawing. The paper label was reattached and the contents were left intact before the can was frozen and returned to the hut; freezing prior to transport prevented spillage on the journey back.

Historically this can also provides evidence of the support that Mawson received from companies such as Horlicks. The label is inscribed "*Put up in tin cans expressly for the use of the Australasian Antarctic Expedition 1911 – 1912*".

Can of Horlicks Malted Milk containing linseed oil

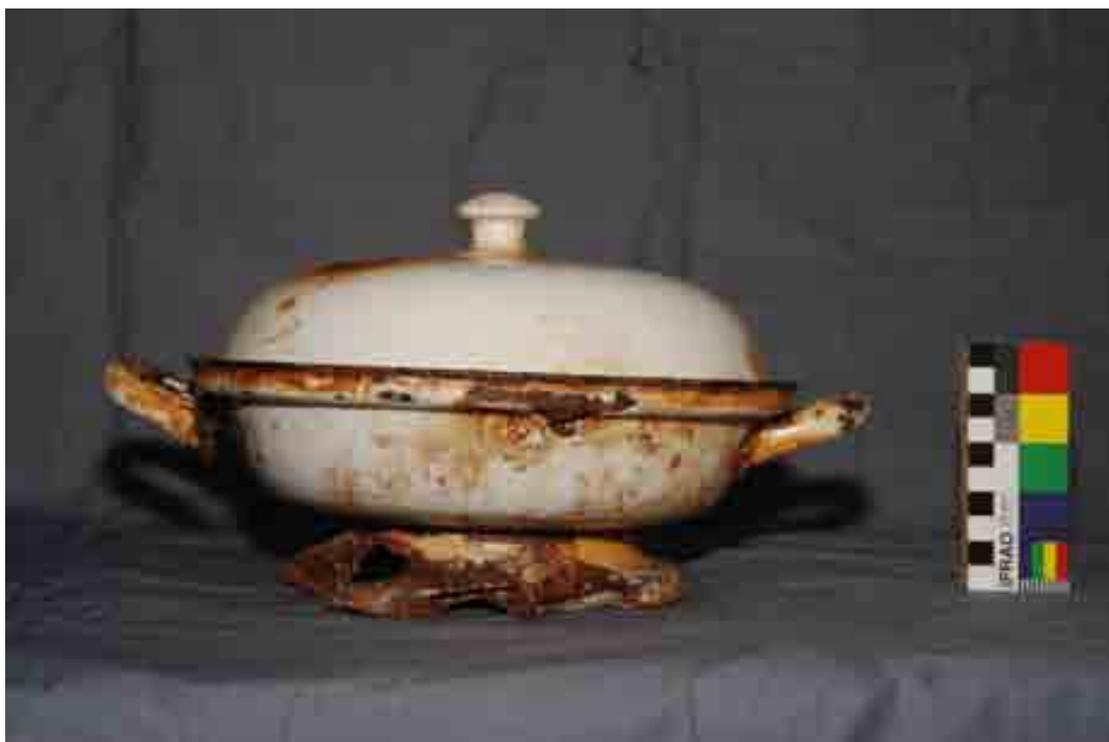
Some of the metal objects from the workshop had suffered impact damage from a chisel during excavation and in most cases it was not possible to reduce this damage, as the metal was resistant to being reformed. The following image shows an enamel dish whose foot had been deformed by a chisel's impact.

Enamel dish with chisel marks on the foot

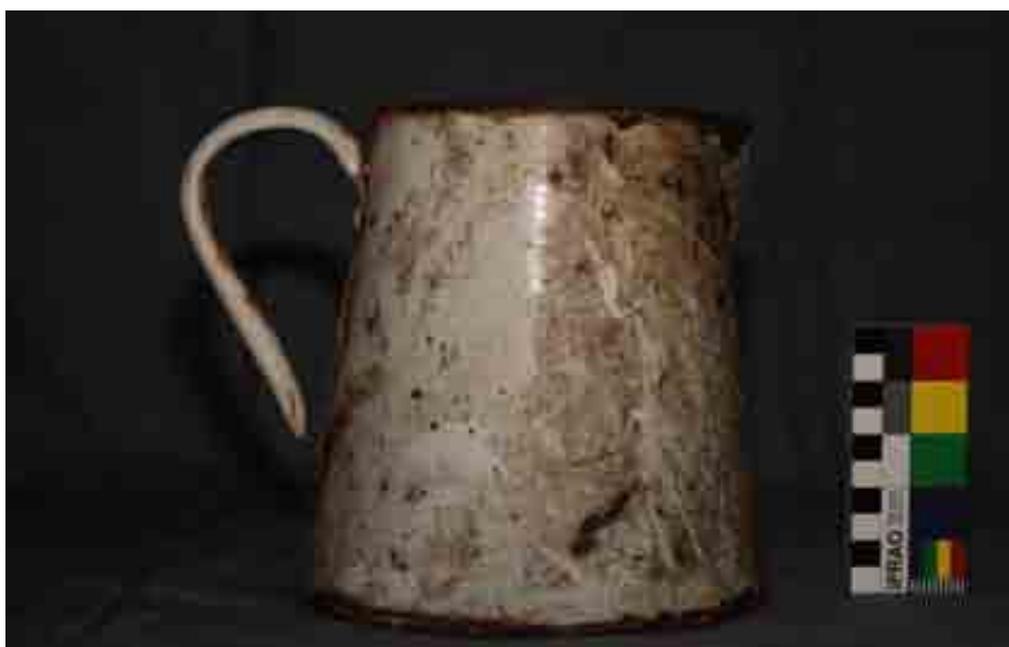
Many of the enamel objects still showed evidence of the use to which they had been put after they had been retired from the kitchen and moved to the workshop. The surfaces of much of the enamelware were covered in grease and oil residues. Treatment of these objects focused on the stabilisation of areas of exposed metal while leaving the oil and grease residues intact. The following image shows the grease residues on the outside of a large enamelware jug.

Enamel jug with intact oil residues after conservation treatment

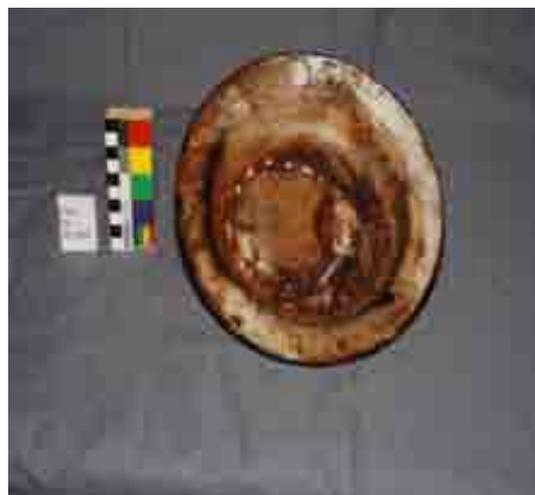
Enamel plate after treatment

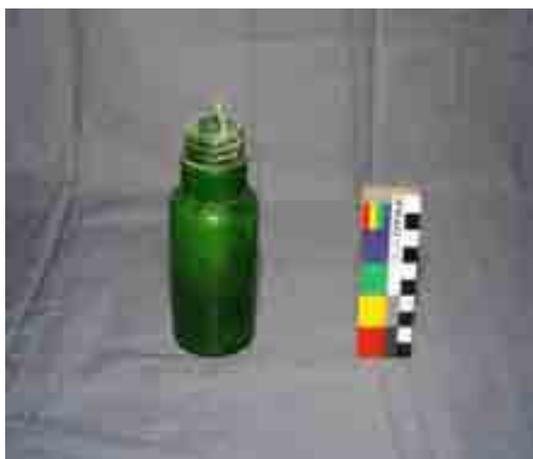
The glass objects were not overly cleaned as the residues visible on the exterior and interior were as a result of their use by the expedition. The following images show an example of a lightly cleaned glass jar.

Glass jar containing a feather before treatment

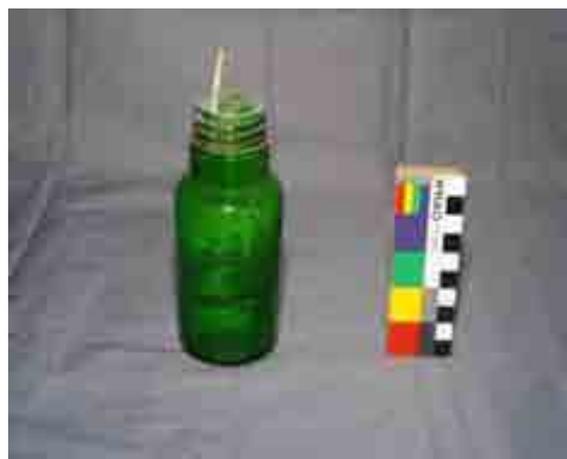
Glass jar after very light cleaning

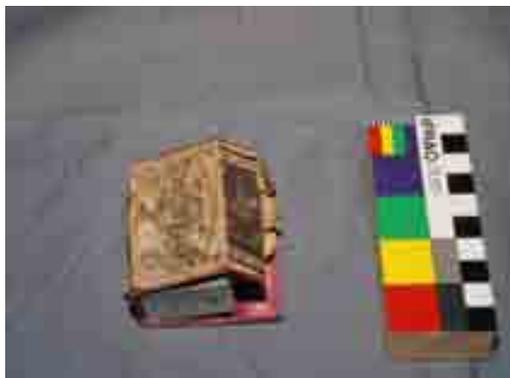
Few paper based objects were found among the Ledingham objects, with the exception of two cardboard matchboxes and a fragment of a newspaper from 1912. The matchboxes had collapsed due to the failure of the original adhesive and the boxes had sprung apart. Treatment consisted of reassembling the boxes and re-adhering the failed joins so that the boxes were once again structurally sound.

Matchbox before treatment

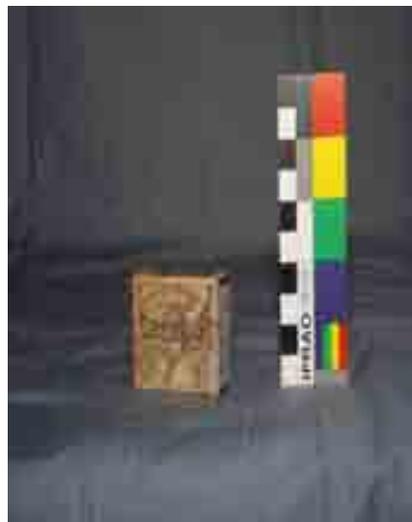
Matchbox after treatment

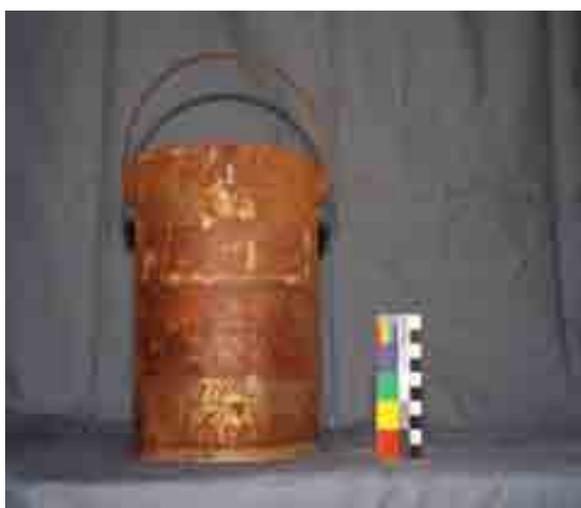
One of the many interesting objects discovered this year was a corroding tin. Surface cleaning revealed a label, which showed that it had once contained 'skinning powder' supplied by a Furrier in London. This powder would probably have been used to preserve the skin specimens collected by the AAE. This object also highlights some of the risks involved with this collection. In the 19th and early 20th century, skinning powders used to preserve skins were often based on arsenic compounds.

Skinning powder tin

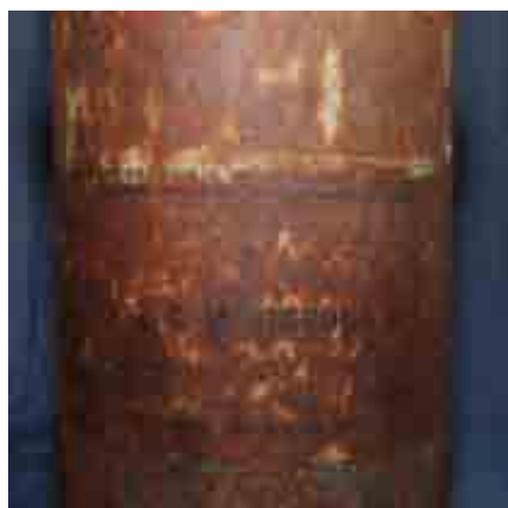
Detail of skinning powder tin label

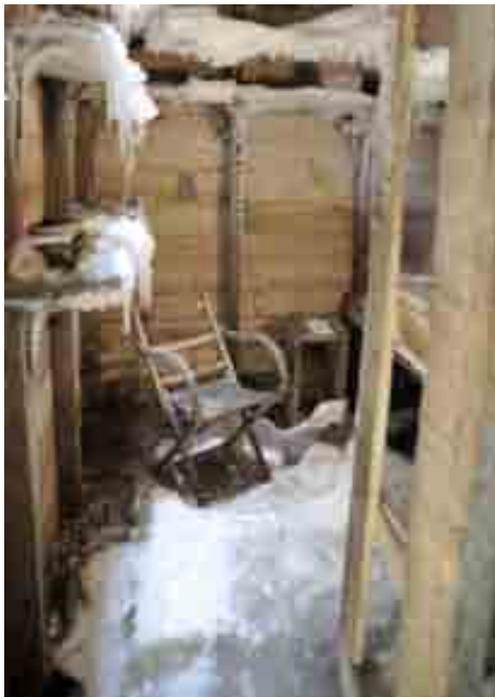
The floor in Mawson's cubicle consisted mostly of hard clear ice (melt ice) which formed a dome in the centre. This created a difficult platform to stand on in order to removal hoar frost and for positioning of the ladder when needed. Ice was removed therefore, mainly from the centre of the floor to create an even surface. This was done carefully using a cold chisel and hammer. Mawson's chair was freed from the ice and placed on the bunk during the ice removal period. A large can was excavated from beside the bed. There are many small items on the floor along the walled sections, including scientific glass tubes and fragments, tar paper, matches, general fluff, dirt and straw. These items remain on the floor. For ease of entry into the cubicle a stair was cut into the drop off.

*Floor ice before ice removal
(photo: David London)*

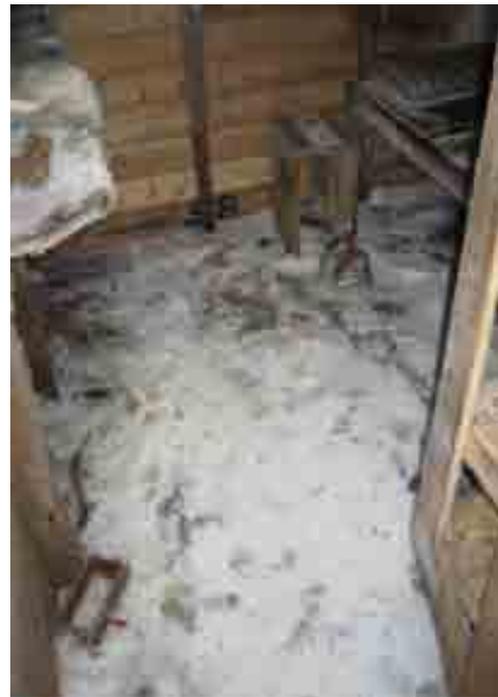
Floor ice levelled

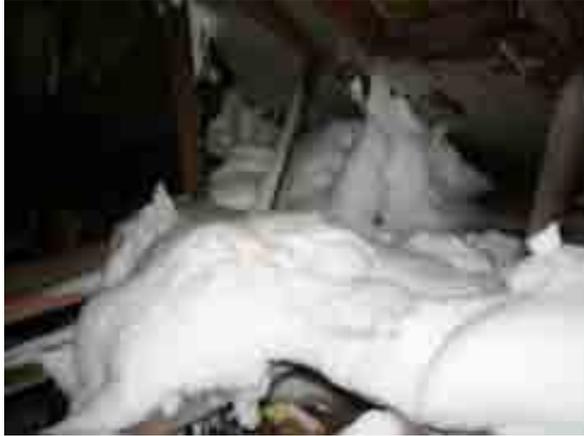
A large amount of compacted snow and hard ice was removed from the ceiling above Mawson's cubicle. Several artefacts were uncovered during this process, including a pair of boots, two glass bottles, two copper alloy cylinders, a wooden box with Dr Mawson's name printed on the side, a metal box, assorted strips of tar paper, straw and a badly corroded iron 'trough' (see below). While documented, these objects were not added to the objects' database this season.

Above Mawson's cubicle - pre-ice excavation

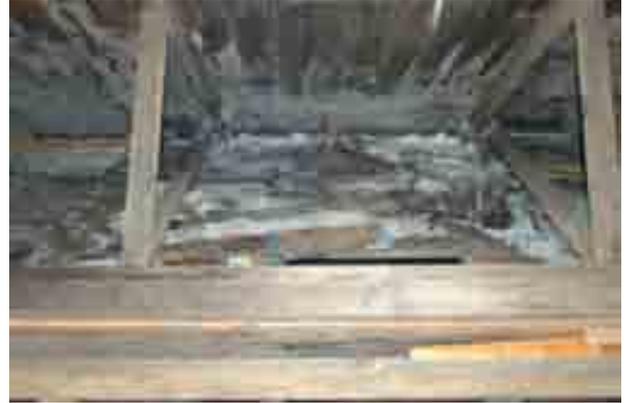
Above Mawson's cubicle - post ice excavation

There is a risk of more ingress in this area because the wall and ceiling junctions have not been sealed. A large amount of snow in the southern veranda currently prevents any ingress of drift snow. This area needs to be continually monitored until such time as access to the veranda wall/ceiling junction allows sealing work to be undertaken. This is a priority as soon as there is sufficient ablation in the southern veranda.

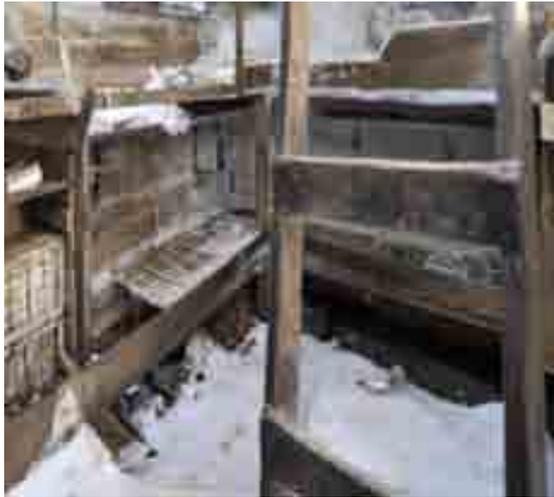
The floor ice level in Hyde Park Corner extended at the same height from the kitchen area and dropped down (~ 200mm) to floor level approximately 500mm from the southern bunks and up to 800mm from the eastern bunks. For ease of ladder access for ice excavation of the Hyde Park Corner bunks and the top of Mawson's cubicle, floor ice was removed from this corner. The ice floor was lowered to ~ 50-80mm above the floor and taken back roughly in line with the northern wall of Mawson's cubicle. Some lengths of tar paper were excavated in the process and placed on the floor near Bickerton's bunk (see images below).

*Hyde Park Corner floor ice before removal
(photo David London)*

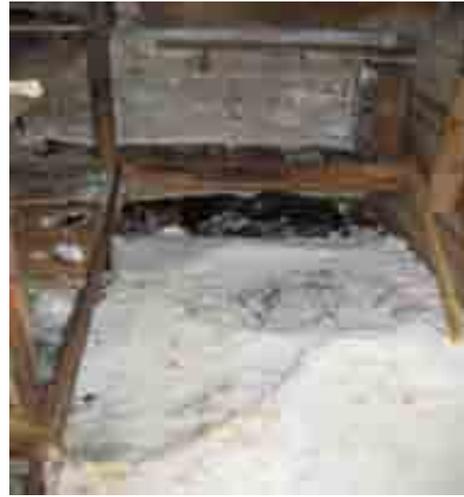
Hyde Park Corner floor ice after levelling

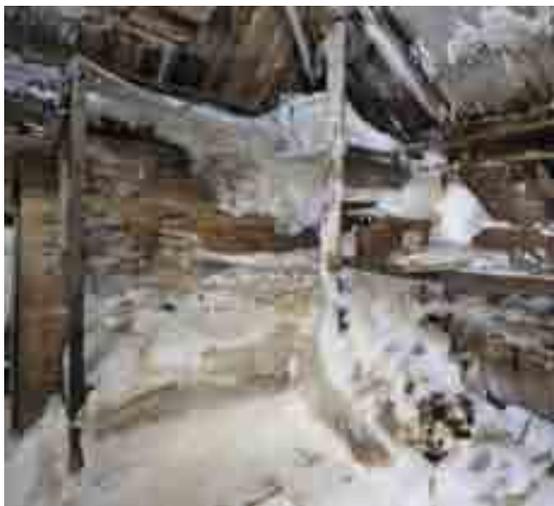
The bulk of hard ice has now been removed from Murphy's bunk, with the horizontal bunk surface almost ice-free. The walls have some ice-free areas, with the remainder of the walls covered by layers between 20 – 60 mm thick. Ice on the walls was left to ablate for a season to avoid damage to underlying tar paper and wiring. Ice still remains in the corner ceiling area and underneath the bunk. Nine objects were recovered during excavation and remain on the bunk platform (see Appendix 1 for details). The excavated milk powder tin was placed back upside down as the contents would otherwise spill from the corroded base.

Murphy's bunk before excavation

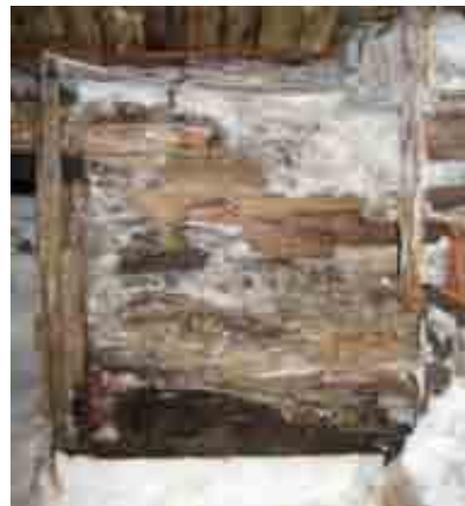
Murphy's bunk after excavation.

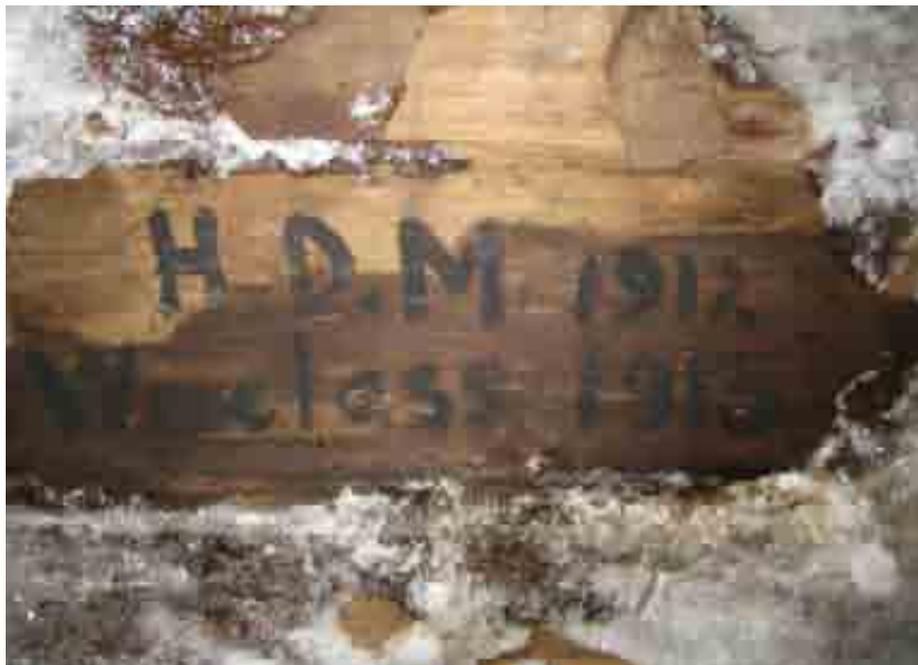
Excavation of the northern bunk wall revealed the painted lettering of the bunk occupants as follows: **H.D.M 1912** and **Wireless 1913**. This lettering, combined with the presence of three coated wires on the bunks, two on the bunk base and a third on the North West bunk post, confirmed unambiguously the location of the wireless during the 1913 period, a matter that had been the subject of some speculation. More wires may be revealed after further excavation.

Writing on the wall of Murphy's bunk

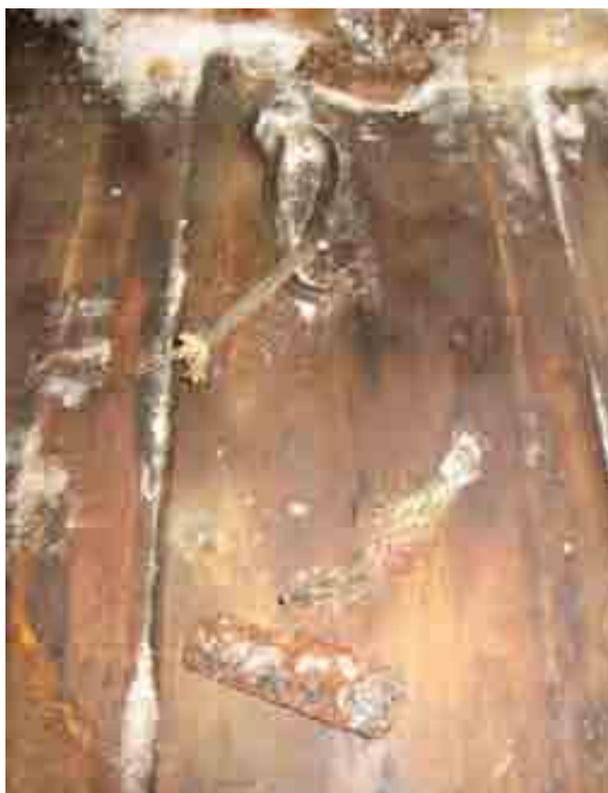
Wires exposed on Murphy's bunk

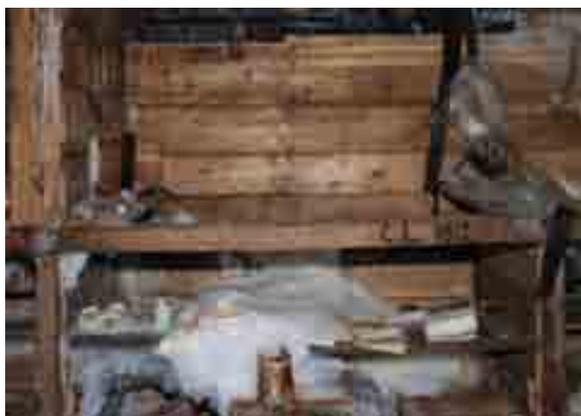
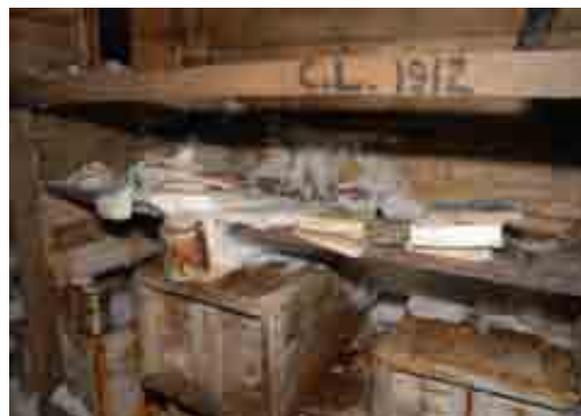
The slats used on Laserson's bunk were removed at some time in the past. The excavation of this area focused on removing ice and snow from the shelf below the bunk, as well as removing the hard ice deposits (as a result of melt water) on the slats located at the head of Laserson's bunk and the foot of Mertz's bunk.

Before excavation

After excavation

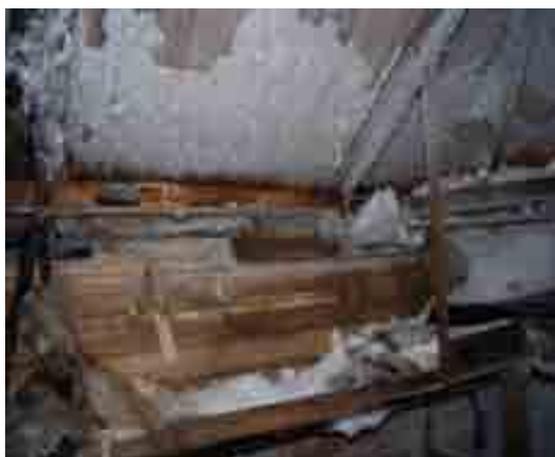
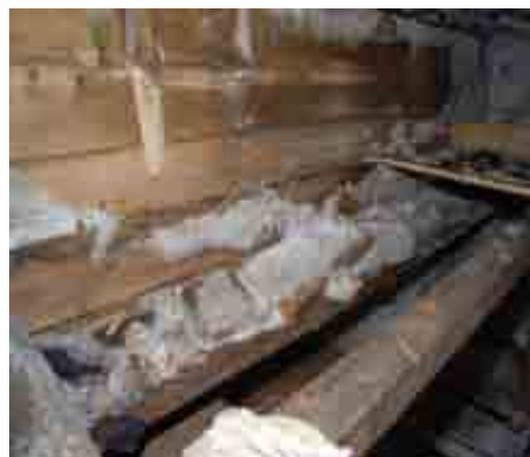
As with Laseron's bunk, most of the bunk slats on Mertz's bunk had been removed in the past and only a small area of the original bunk surface required ice excavation. Excavation of the shelf below Mertz's bunk revealed a number of artefacts. These were not catalogued this season as they were still largely embedded in the ice. It is recommended that they be catalogued when they have been mapped in their location and can be safely examined out of the ice.

Before excavation

After excavation

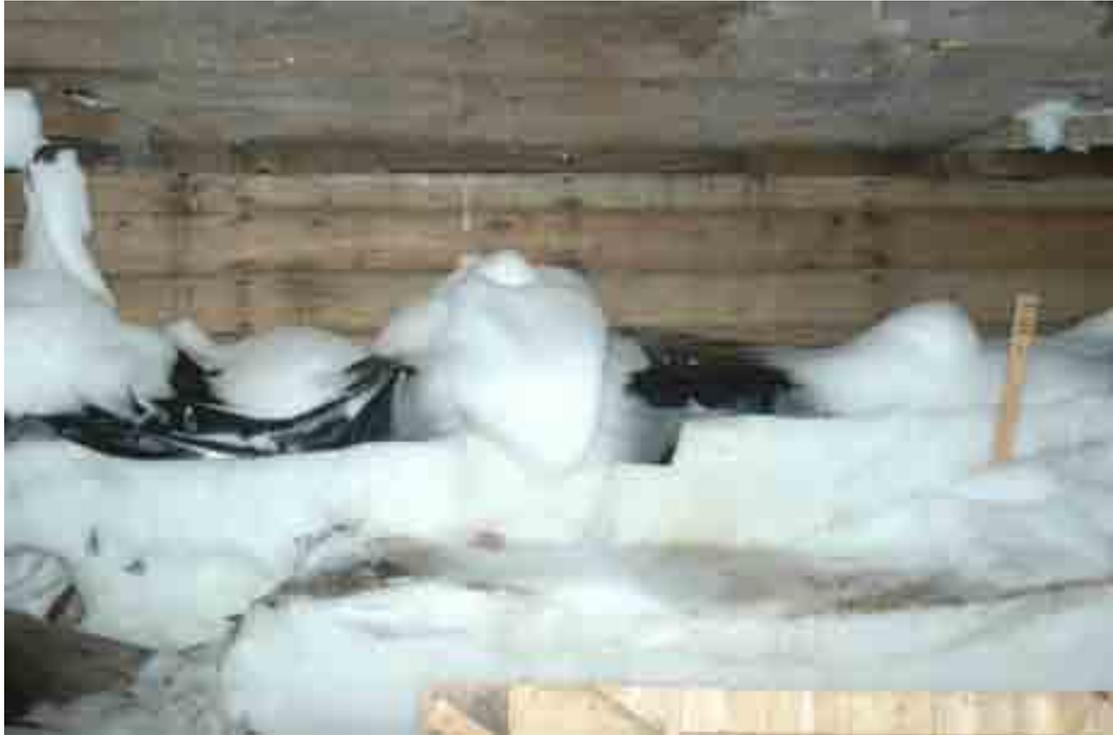
As was noted in the 2007/2008 report, the post-2002 accumulated snow was removed from the ice bench on the north wall of the workshop and plastic was laid on the top bench to monitor annual snow ingress in this area. Over 2008, fresh snow ingress occurred along the north and east internal walls of the workshop.

Fresh snow ingress on the internal north wall of the workshop

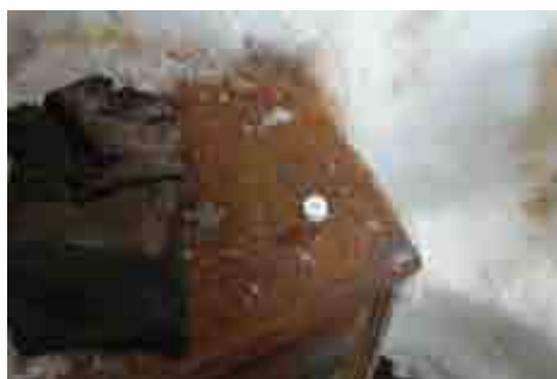
In order to compare patterns of iron corrosion occurring at Cape Denison with that of iron objects in the Ross Sea area (Scott and Shackleton's huts), samples of corrosion products and corroded iron were taken for analysis in Australia (Table 4). Because of the different environmental conditions at the respective sites, with on-shore breezes a rarity at Cape Denison, differences in chloride levels and corrosion products are expected. This has obvious conservation implications. Shown below are two of the areas from which corrosion products were taken for analysis.

Corrosion sample ex stove top, kitchen

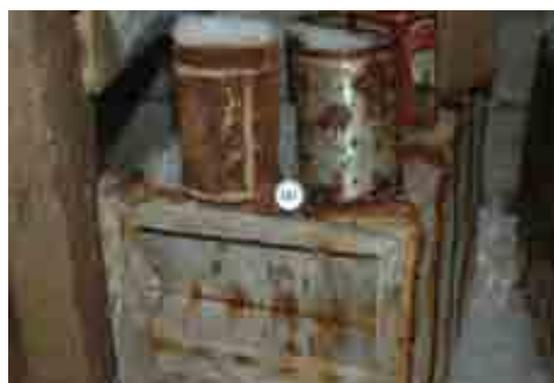
Corrosion sample, ex can, JHC 1912 bunk

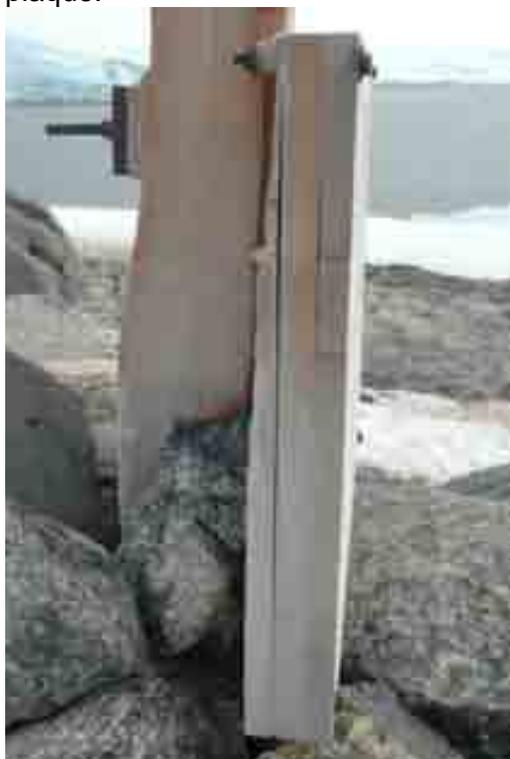
The backing board of the replica memorial plaque continues to abrade at a rapid rate. In 2 years just over 2 mm of wood was lost from parts of the backing board, a rate of wood loss consistent with that recorded in 2006. The rate of wood loss from this plaque is in marked contrast to that of the proclamation plaque which has suffered very little loss (see below). It is likely that wind-borne particles, other than snow and ice, contribute to the memorial plaque's abrasion. The wind has a considerable fetch along the rocky ridge before it reaches the memorial plaque, whereas there is little in the way of rock, dirt and penguin detritus in the area south of the proclamation plaque.

Replica memorial plaque and base of the memorial cross (view from the east)

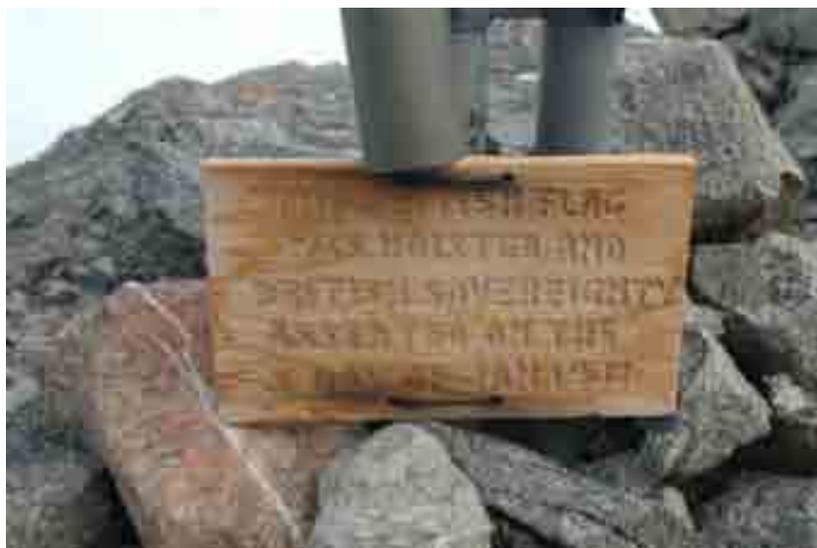
The replica plaque is in very good condition, with some staining on the front surface and minor abrasion. Despite its exposed location, there appears to be only minor abrasion by wind-borne particles, a situation that is in complete contrast to that of the backing board on the replica memorial plaque. Timber thickness data is recorded later in this document (Appendix 3).

Replica proclamation plaque

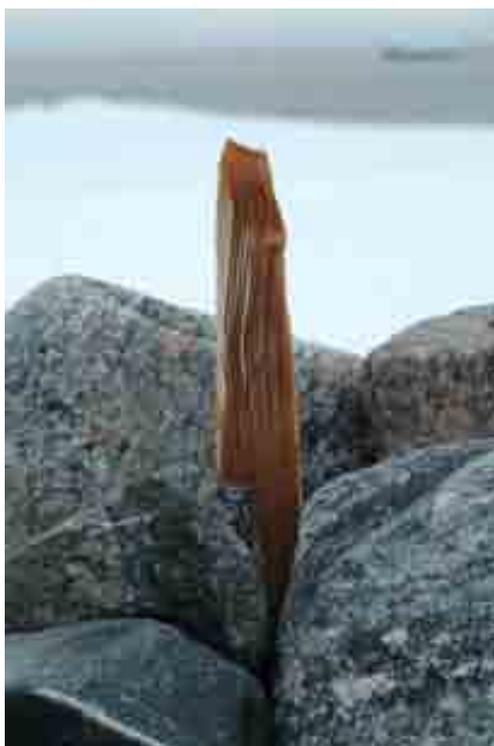
The wooden marker, located on a ridge in a rocky outcrop, was documented and thickness measurements taken so that the timber loss can be monitored in future seasons. Assuming that the marker was originally rectangular in shape, it has lost a little over half of its original thickness near its apex, with a thickness at its narrowest point near the top of 21.75 mm and a maximum thickness of 46.5mm where it is protected from abrasion by the rocks.

Survey marker, east of the absolute magnetic hut

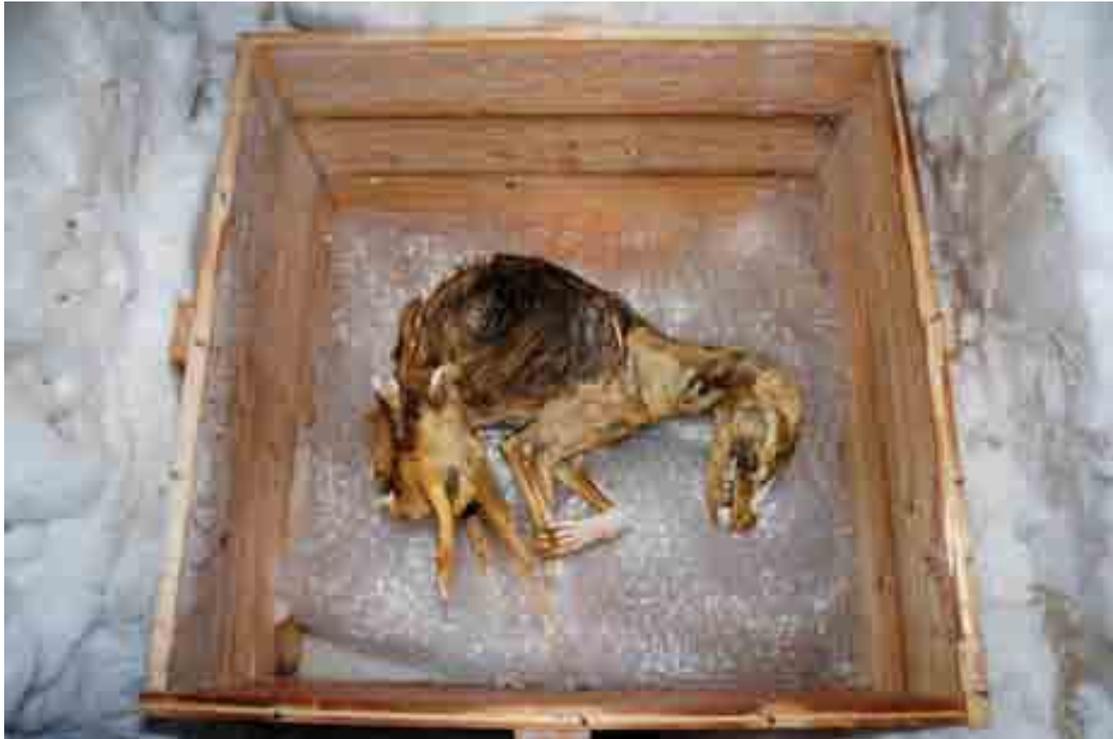
Grandmother was exhumed from his temporary coffin, underneath layers of snow and ice, in the workshop. After an examination by the team doctor and the conservation team, it was concluded that he remains in good condition and is stored in a stable environment. There was no visible evidence of further deterioration and no signs of any microbiological activity (smell, areas of active fungal and/or bacterial attack).

Grandmother in his 'coffin'

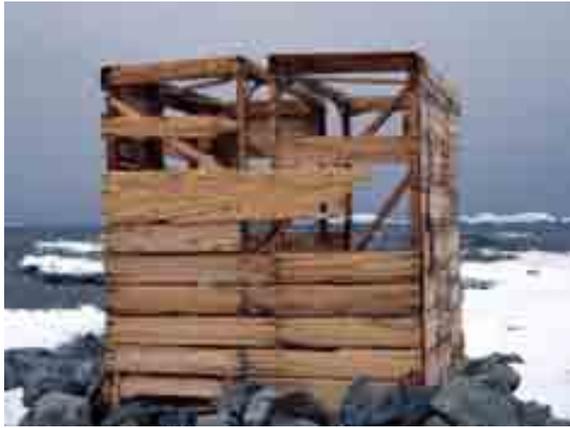
Boards and structural timbers have been lost from the north and south walls of the transit hut since January 2008, adding to the many that have been lost in the first decade of the 2000s. Four boards were retrieved from the snow on the north side of the hut and were identified for reattachment. The fastenings of several boards on the south face of the hut were loose and were refastened (see Carpenters' Report). No timbers were lost from the east wall, with two timber battens lost from the west wall since the 2007/08 expedition.

Transit hut, south wall, 2000/01

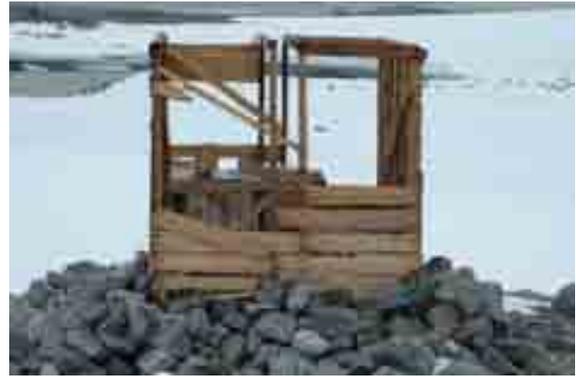
Transit hut, south wall, 2008/09

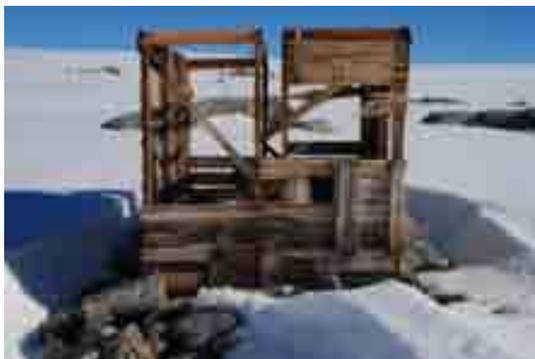
Transit Hut, north wall, 2007/2008

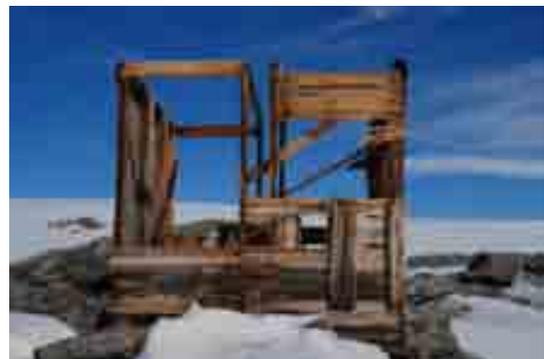
Transit Hut, north wall, 2008/2009

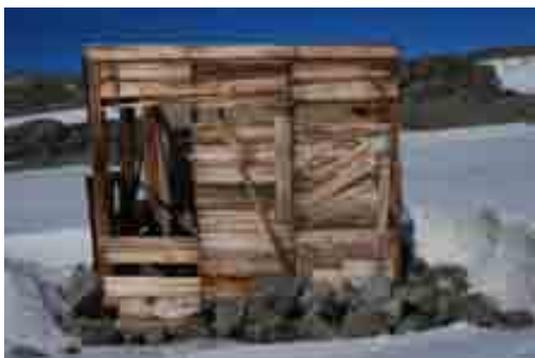
Transit Hut, west wall, 2007/2008

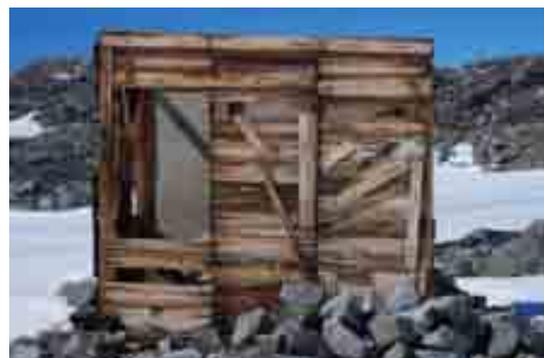
Transit Hut, west wall, 2008/2009

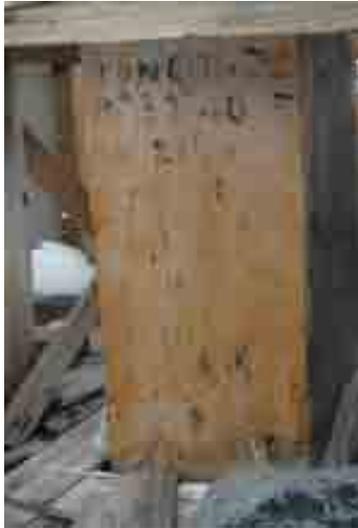
these drawbacks, there appears to be some paint loss since the earlier image was taken. It is difficult to recommend how this lettering can be protected as it is on the north face of the plinth, the best position for protection against ice abrasion. Consolidation is not considered an option as it may cause the remaining paint layers to peel when the consolidants deteriorate.

Plinth 2008/09

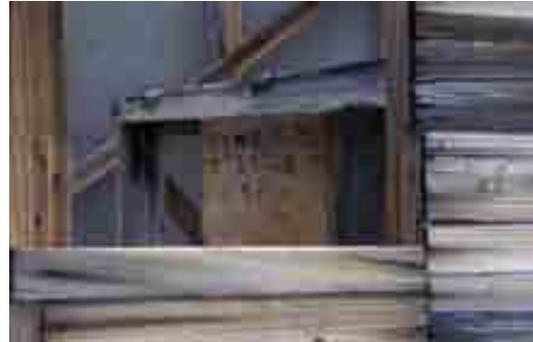
Plinth 2000/01

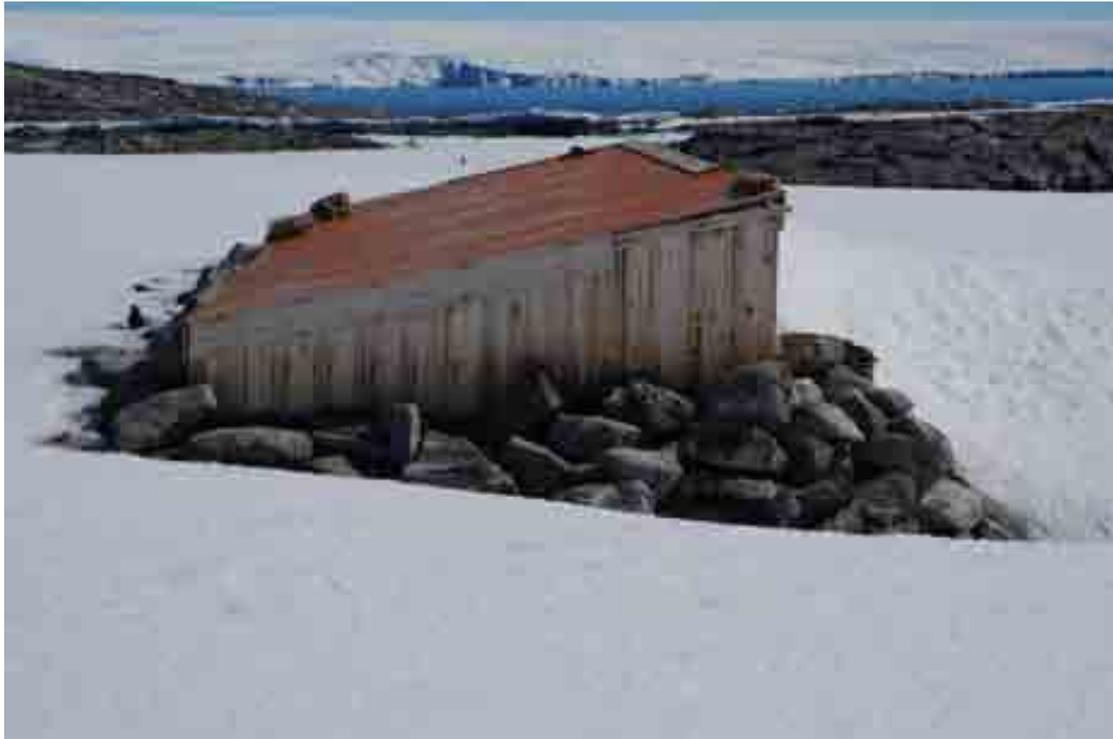
There are two rocks sitting on the roof of the hut which are visible in previous expedition photographs. Tidemarks from melt water are visible on the north face of the hut along with the remains of a dead penguin and sheepskin. The sheepskin remnants located along the northern roof edge are still firmly attached. The roof and walls which were visible are intact and still structurally sound. No loose boards were observed. The resin coating on the roof remains surprisingly intact. Entry inside the hut was not attempted due to the snow and ice build up at the doorway. Comparison photographs were not available from last year due to the height of the snow obscuring the hut at that time.

Magnetograph house – view from the east

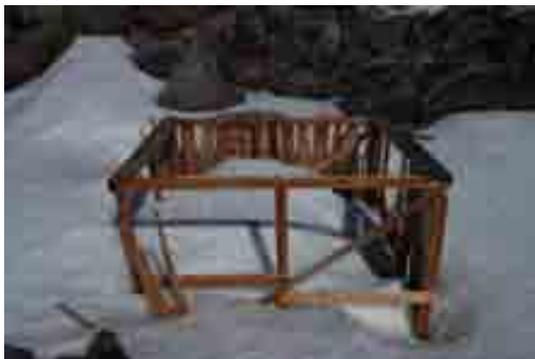
The hut was only partially exposed this year. The weight of snow has forced the wooden slats away from the frame of the hut and the fastenings of the top edges of several boards on the east and south walls have failed. The door is still intact and in position. Black painted lettering was visible on the internal surface of southern wall beam. Three loose boards were observed north of the hut in the rocks. These were not retrieved as it was unclear if they were part of the hut. Comparison with an image from 2000/01 indicates that, despite periods of burial, the timbers are slowly being dislodged from the structure

*Absolute magnetic hut – from the north
2008/09*

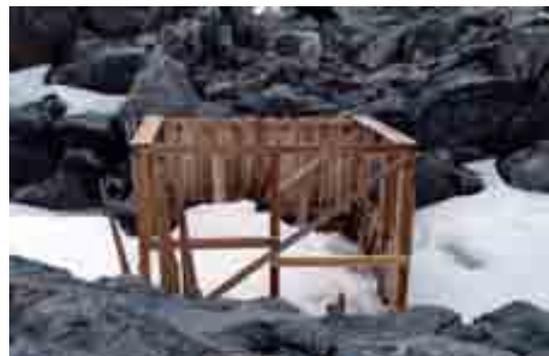
*Absolute magnetic hut – from the north
2000/01*

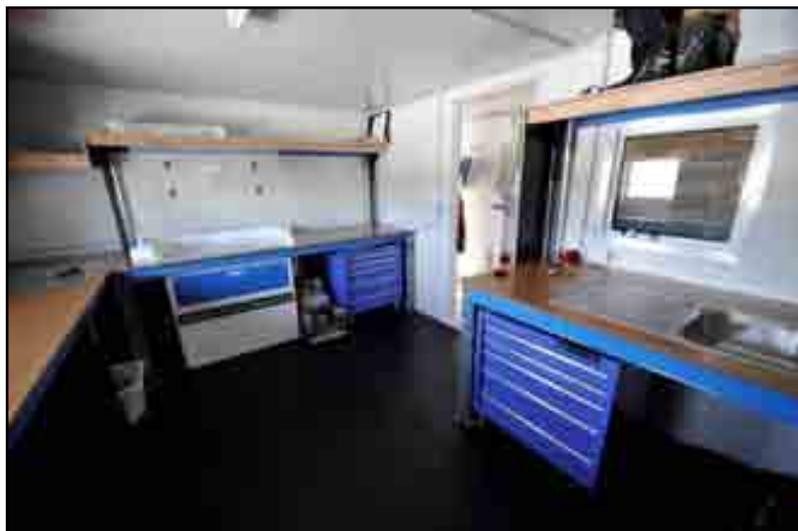
The first priority on our works plan was to fit out the new rooms in the Sorensen Hut extension. 'H' cowl roof vents and mushroom screw in wall vents were installed providing excellent ventilation to both rooms provided the wall vents are kept clear inside and out. The freezer panel floor in the new extension was over clad with 17mm plywood in the same method as the existing, providing a solid insulated surface. The interior of the new lab consists of perimeter bench units, custom made in Tasmania, using a Unistrut shelving system. The MDF bench tops were sanded and coated in Tasmania and fitted onsite. Additional head high shelves were made using pre fabricated brackets, form ply and timber from the stack near Sorensen. The conservation equipment was set up in the lab and with loads of bench and shelving space it proved to be a very user friendly work space for three conservators.

The completed lab

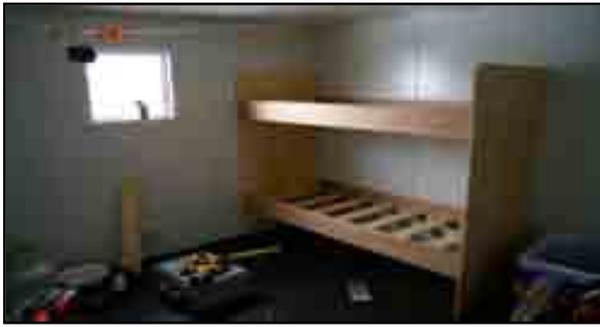
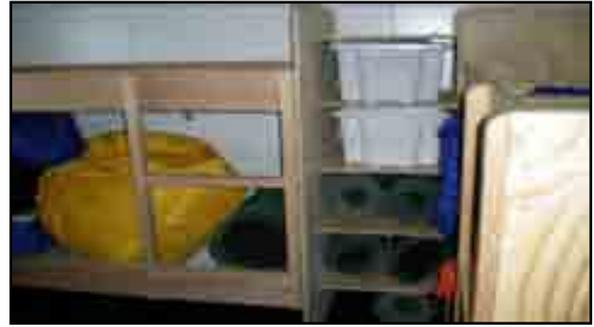
The bunkroom was the next job on the list. Three double bunk beds were built using plywood and Tasmanian oak. The timber is still raw and requires a coat of varnish. Six new mattresses were custom made to fit the bunk dimensions. The beds are designed to fit six plastic Nally bins under each lower bunk, and the remaining wall space between each bunk was filled in with shelving units made from the ply off cuts from the bed ends. These shelves were also designed to fit plastic Nally bins, providing a virtual pull out drawer system and proving to be an excellent and efficient place to stow personal gear.

The construction of the bunk room

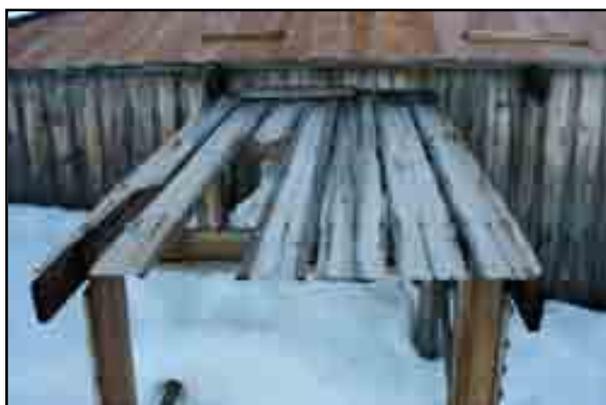
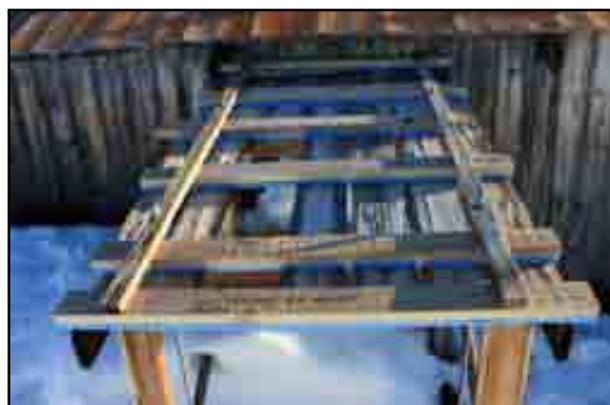
Transit Hut

The timbers on the observatory roof on the north wall of the workshop are also very thin. A temporary clamping system was assembled this season that will keep the loose boards secure until they are over clad. The photos below show the temporary restraint on the observatory roof.

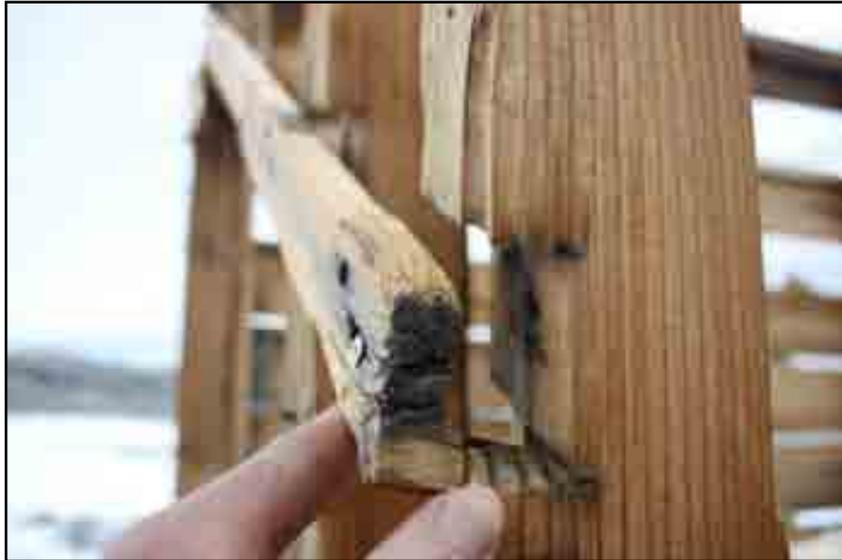
The Transit Hut has lost many boards in the past few seasons; photographs show considerably less boards as the years go on (see the Conservation Report). This season we reinstated numerous boards that had blown off but were still close by. The structure is racking quite badly in strong winds, causing many of the modern screws to shear off. To remedy this we used polyurethane which performs well as it is a very flexible product. An extra bracing piece was fixed across the top of the south wall. Although this is not a part of the original design we deemed it necessary to increase the hut's ability to withstand winter winds. Further information regarding the polyurethane techniques is available in the recommendations section in this report.

An example of one of the braces on Transit Hut with a sheared screw

- Robertson screws are not working on the Transit Hut. We've found that they are simply snapping like carrots in the cold and are not achieving retention of the boards either. This is because the thinning, ice abraded, brittle timber simply splits around the screw and sails off in the wind. Glue fixing is the only option that will work, because it fastens the whole surface of the brittle timber. Polyurethane sealant is the superior product for this purpose as it is flexible, UV resistant, bridges gaps, and is very strong. If the job is done skilfully, this method of fixing will also be less visible than screw heads. **Silicones do not work.**
