Mawson's Huts Foundation

2008–09 Expedition Report

MAWSON'S HUTS CONSERVATION EXPEDITION 2008/09

EXPEDITION REPORT

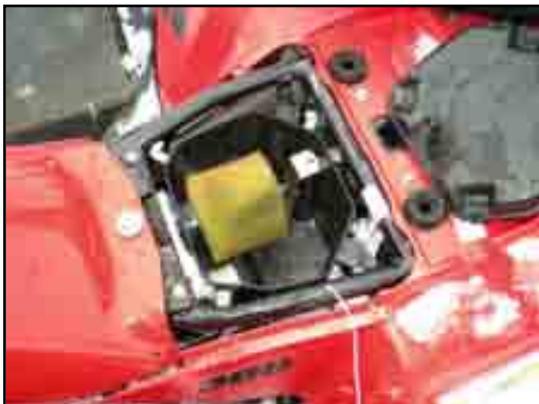
Air filter connected

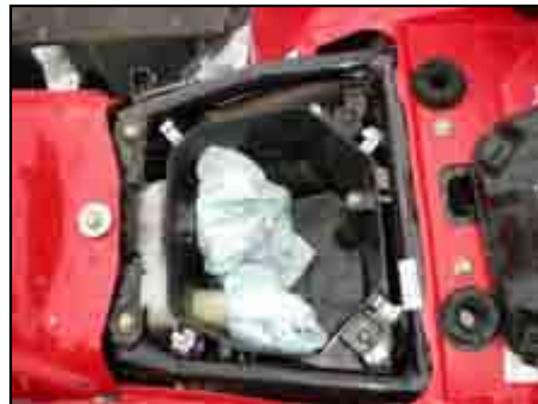
Air filter removed and intake packed with rags

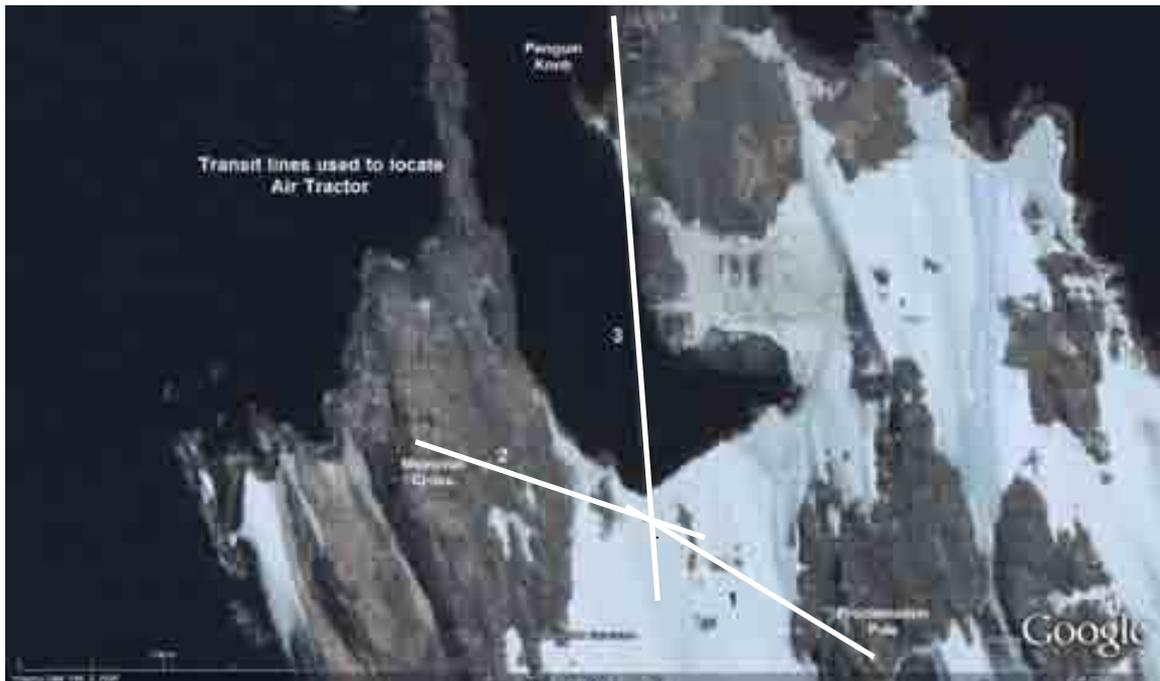
Figure 7 : Google earth picture of Cape Denison showing the three transit lines (white)) derived from a study of images from 1931 and 1976. The lines were used to pinpoint the position of the air tractor frame.

The three transits were tested on the ground and found to be very sensitive to translation, well separated from each other, and readily identifiable. They were therefore considered to be reliable indicators of the position of the air tractor frame. Given that it was known (see appropriate section below) that the ice did not move in the area (ie it is not glacial ice) then the position was accepted with confidence. This position is vital to all search efforts. A description of the three transits follows:

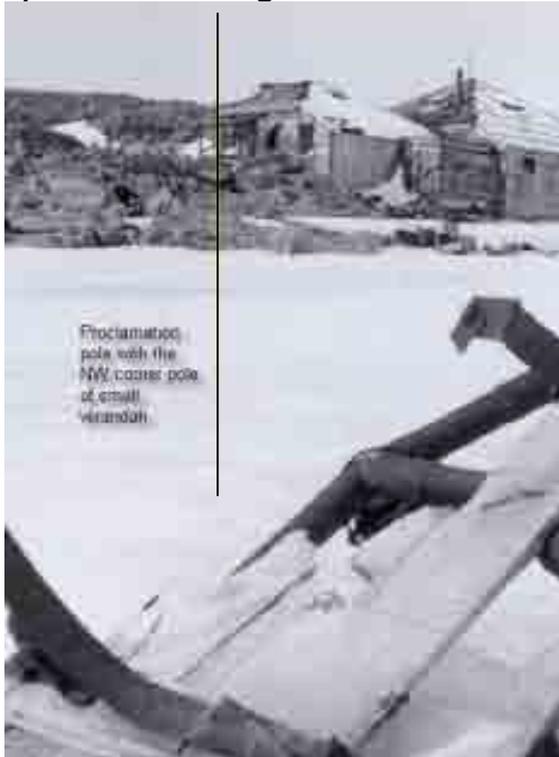
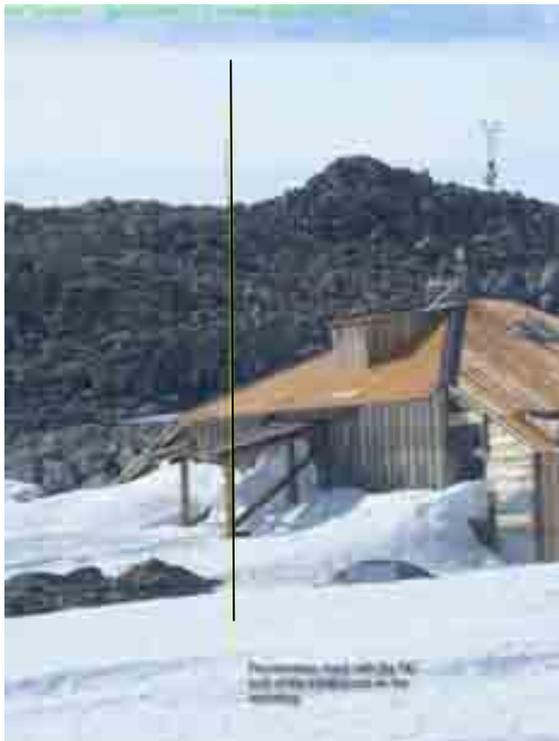
1) transit looking East

This transit is derived from the 1976 picture by Bob Reeves. It shows the frame about 500 mm out of the ice, and the transit points are the Proclamation Pole on the hill, and the NW corner post of the small porch on the workshop of Mawsons Hut.

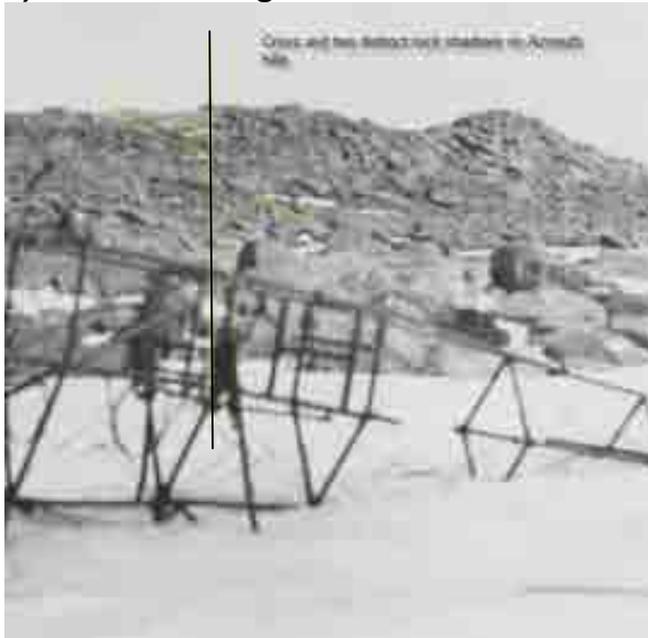
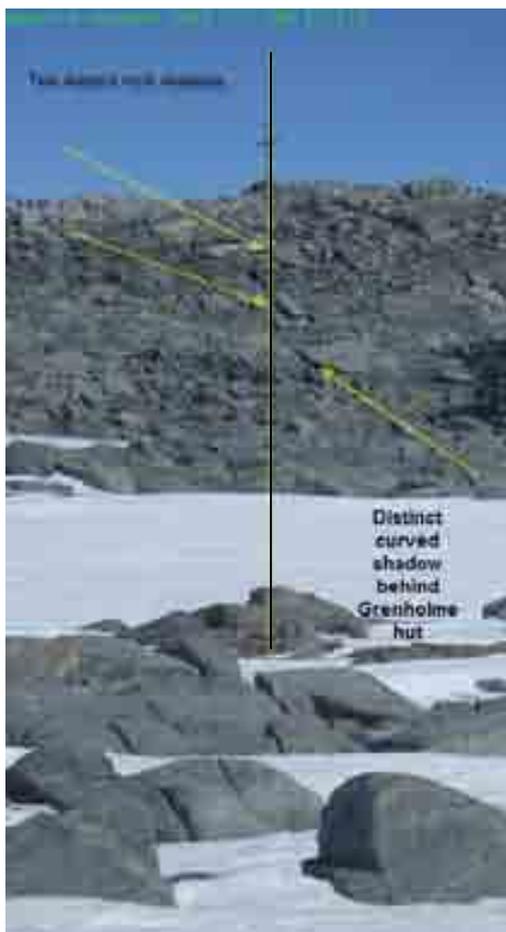
2) transit looking West

This picture is taken from the 1931 expedition by S Campbell. The rock shadows provide the transit in conjunction with the Memorial Cross – it is necessary to see the rock face in sunshine at about 1pm to match the original photo.

The transit points are the Memorial Cross, and two distinct rock shadows on the hillside. The curved shadow behind Granholm Hut provides a good orienting feature.

The triangular rock at the bottom right of the picture is an obvious feature which appears on other photographs, and proves useful to orient the view.

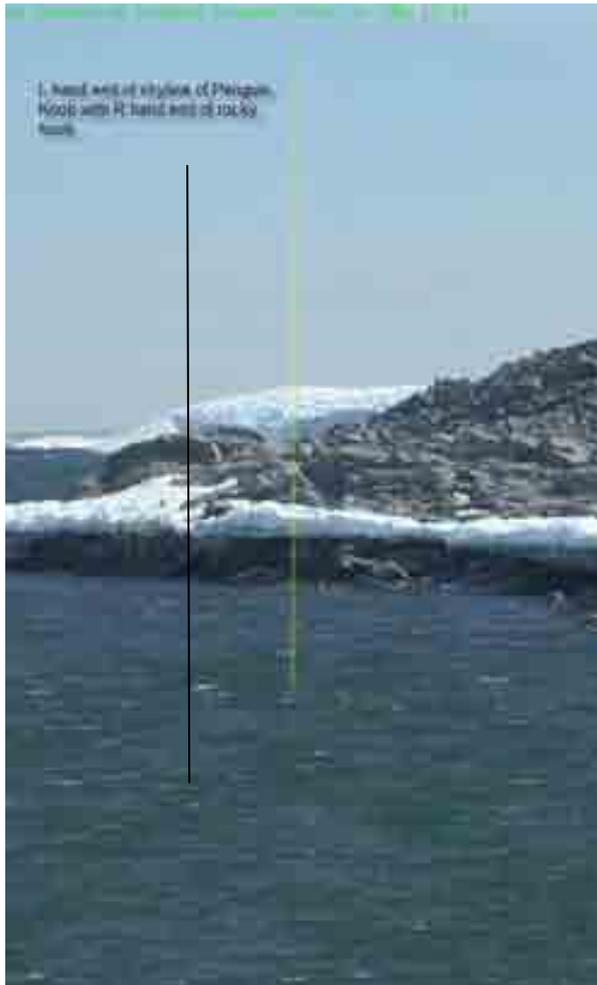
3) transit looking North

This picture is from 1931. The rocky knob is about 100m in front of Penguin knob, and the transit line is quite easy to see, though it looks hard in the picture.

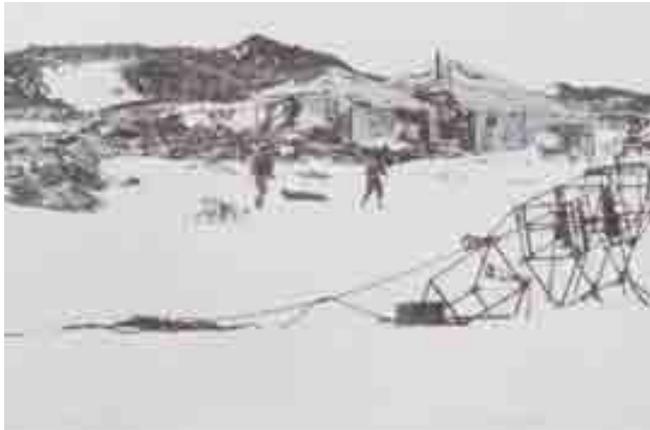
Figure 8: the airframe in 1912 This photograph is taken from a few metres north of the place in the 1976 image below. Moving the camera into the 1976 position would give exactly the same transit as the 1976 picture. The frame is already partly buried in the ice. [Note that the third seat has been cut from the frame, which establishes that its 2008 discovery on rocks across the harbour is not related to the position

of the tractor.]

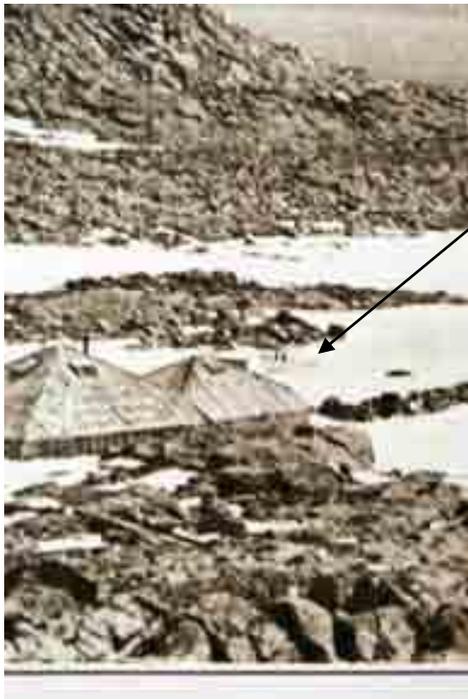
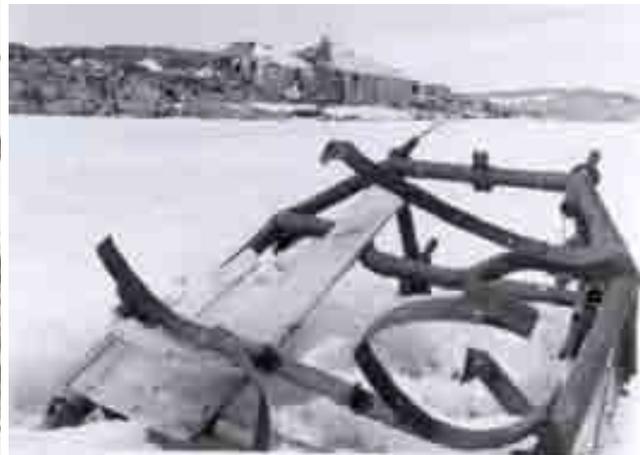
Figure 9: taken from 1931 and from 1976 – the photographs are taken from points almost exactly opposite each other (the air tractor frame in 1931 is shown by an arrow). No movement of the frame is seen in 45 years, supporting the proposition that the ice is not glacial in this area. Comparing the 1976 picture with the 1912 picture in figure 6 shows there has been no movement in 64 years.

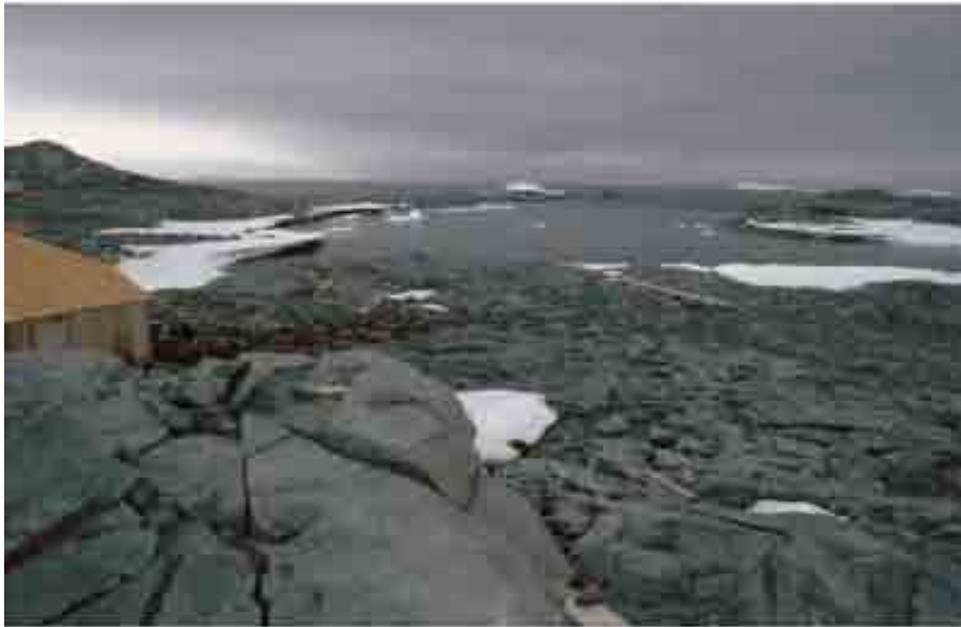
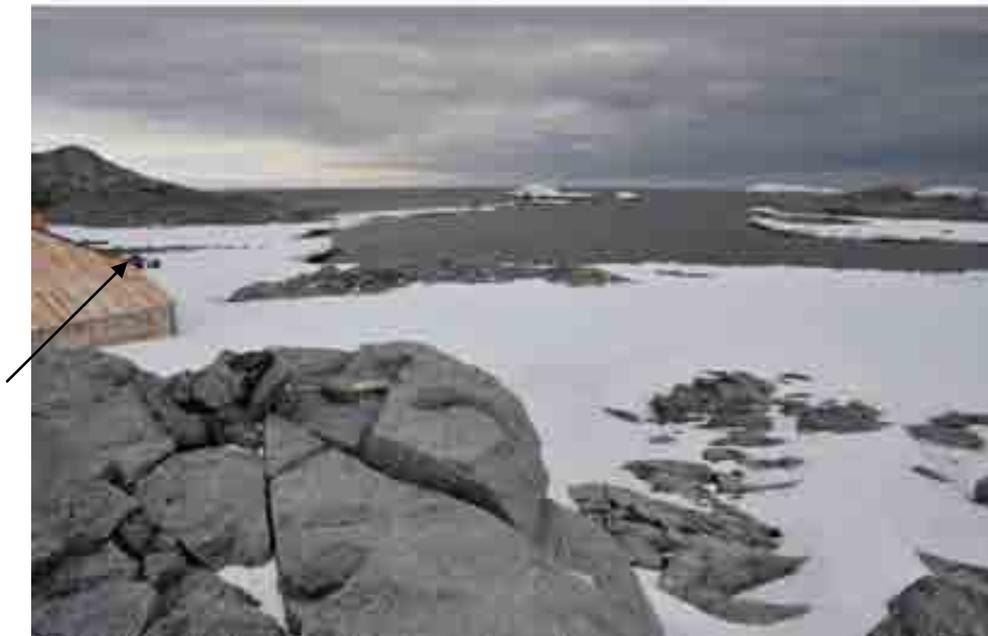
Figure 12: Extensive exposed rock is seen in 2002 (top). The air tractor frame position is represented by the quad bike and trailer seen in the lower image above the hut roof (arrowed). It can be seen that the frame would have been close to the edge of the harbour in a melt. (Photo: David London).

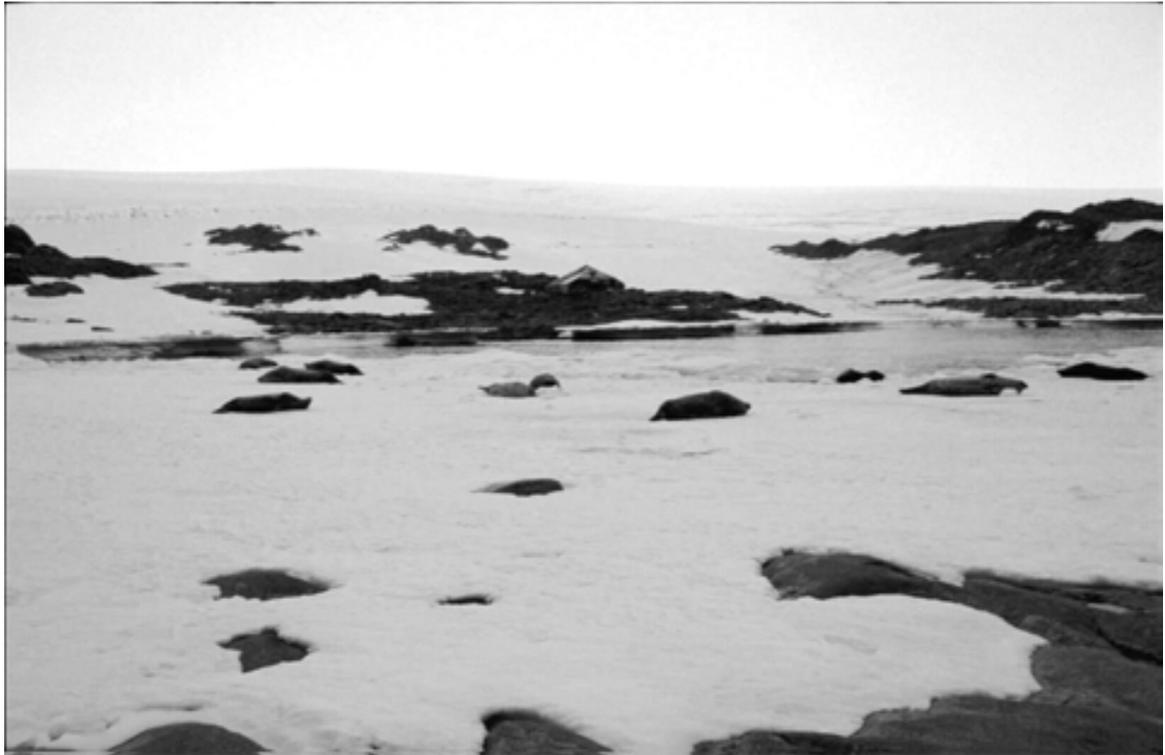
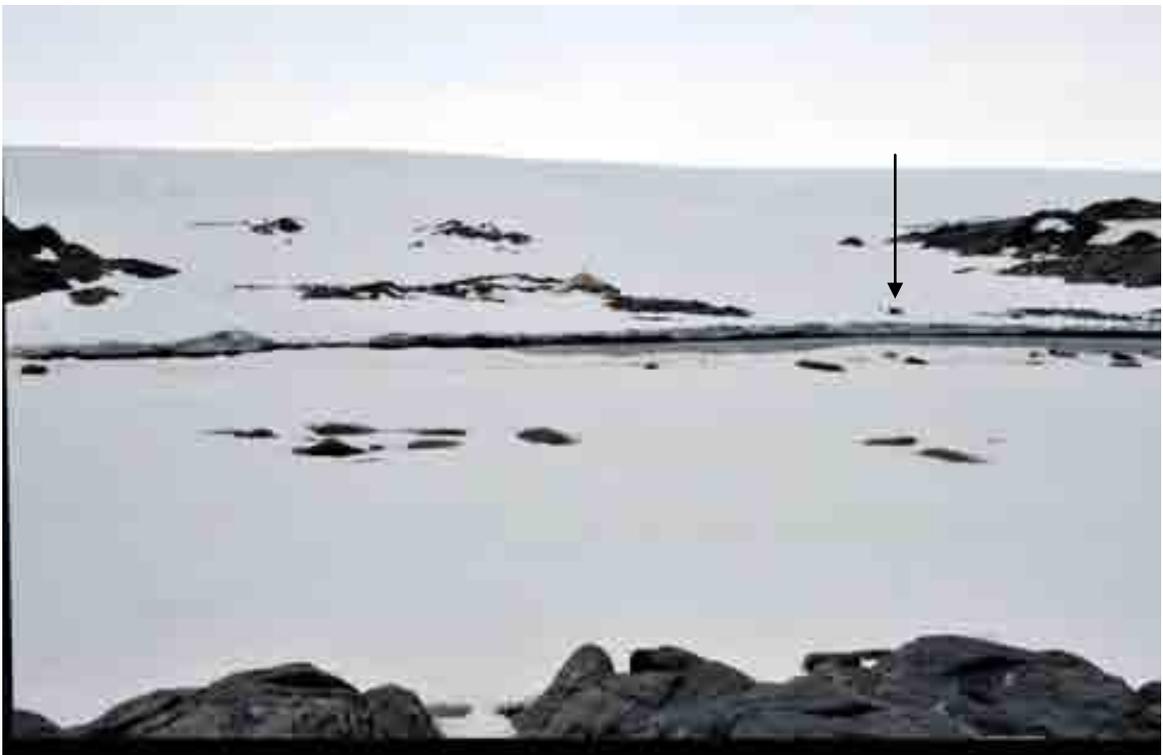
Figure 14: Facing S across Boat Harbour. The air tractor position is arrowed and can be seen to sit almost over the 2002 glacial melt stream. Note exposed rocks in upper picture (2002). Compare the level of snow 2002 with 2008 (bottom). (Photo: David London).

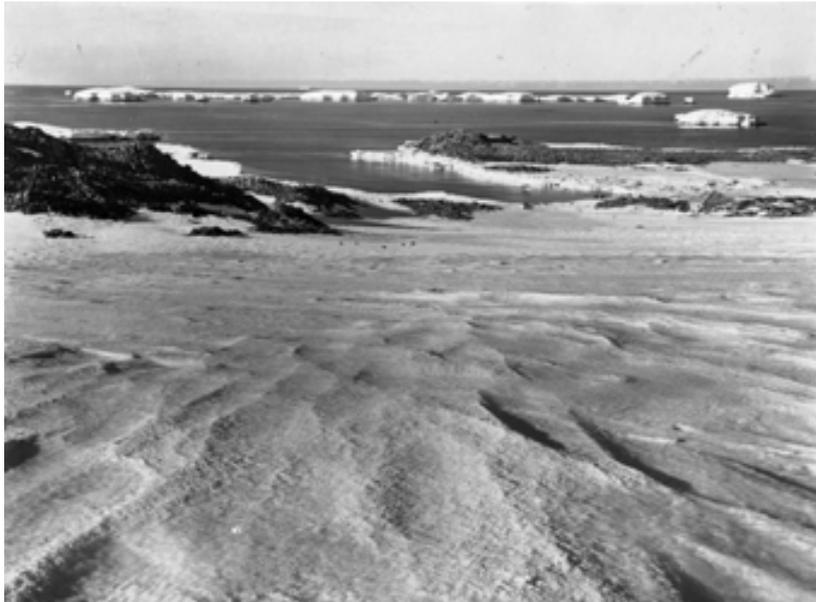
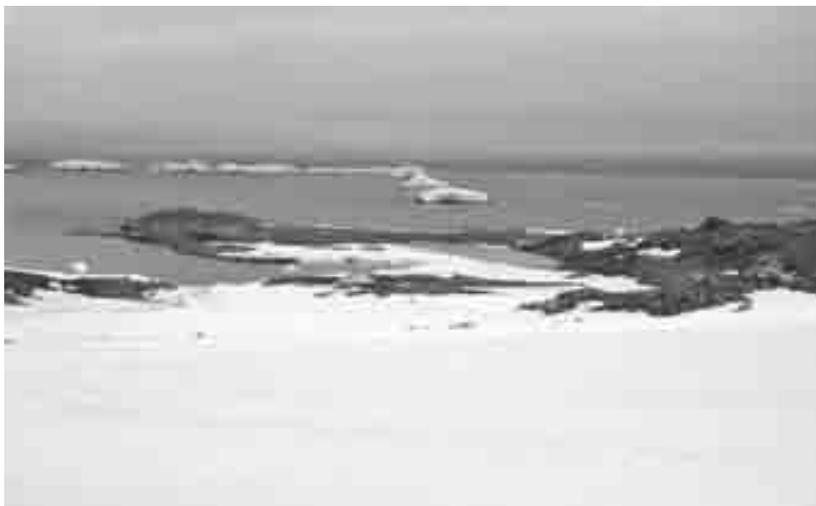
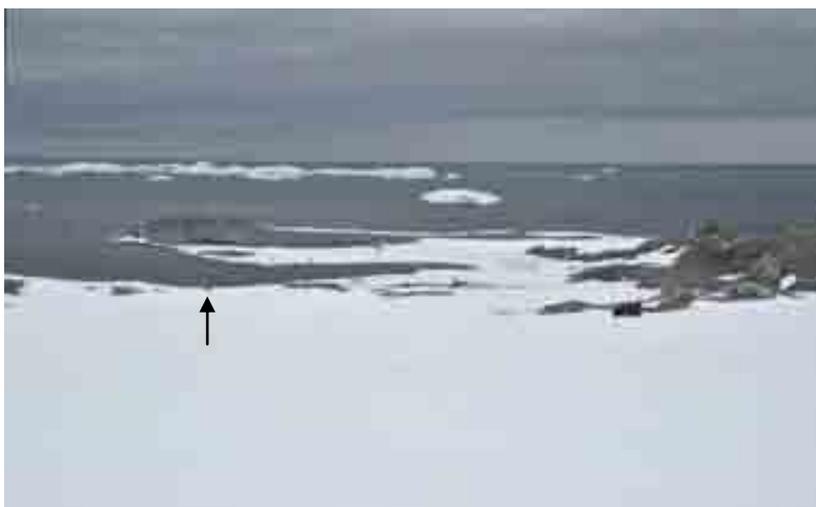
Figure 15: If the air tractor had sunk in the ice, and was still there, where would it be? This is a general view of the bay seen facing N from the hill behind the huts. The images are from 3 different years. The air tractor is seen in the upper picture (1931) and the quad bike (arrow) in the lower one (2009). The middle picture is from 2002. The ice level in 2002 is about the same as in 1931, and about 1m lower than 2009. The frame is about 2.5m high.

A magnified image of the air tractor in the top picture shows that it had already sunk about 1m down in the ice by 1931. By 2002 it was not visible. Therefore the top of the frame would be at least 1m below the 2009 surface, and the bottom about 3.5m below it.

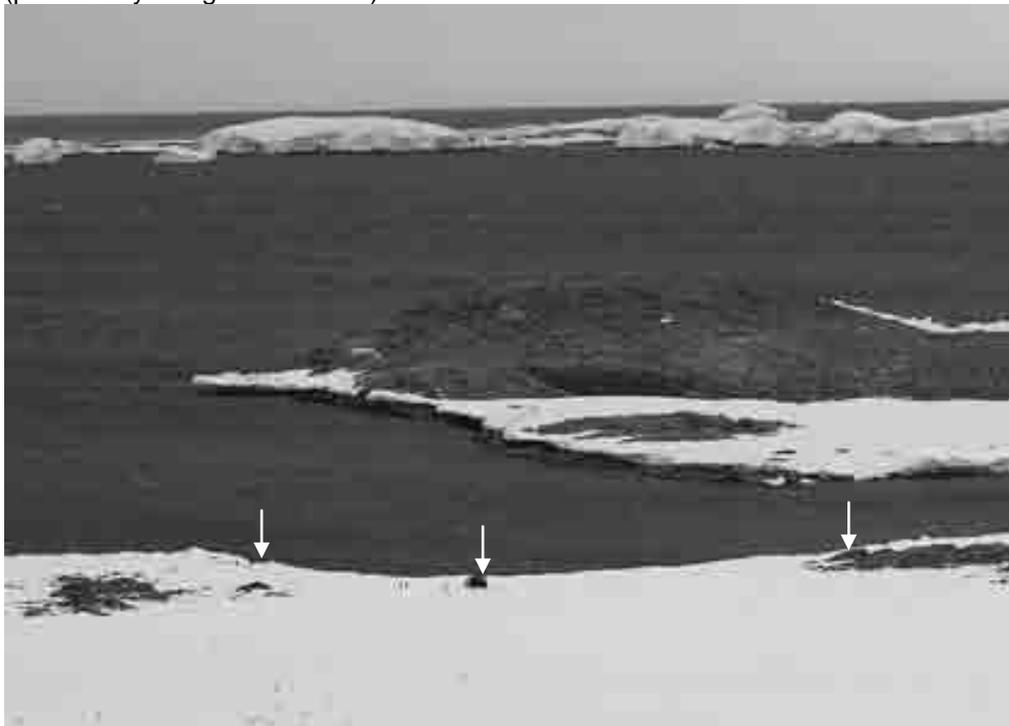
Figure 17 Picture taken this year showing level of ice, identifiable rocks in the same focal plane, and the air tractor position represented by the quad bike.

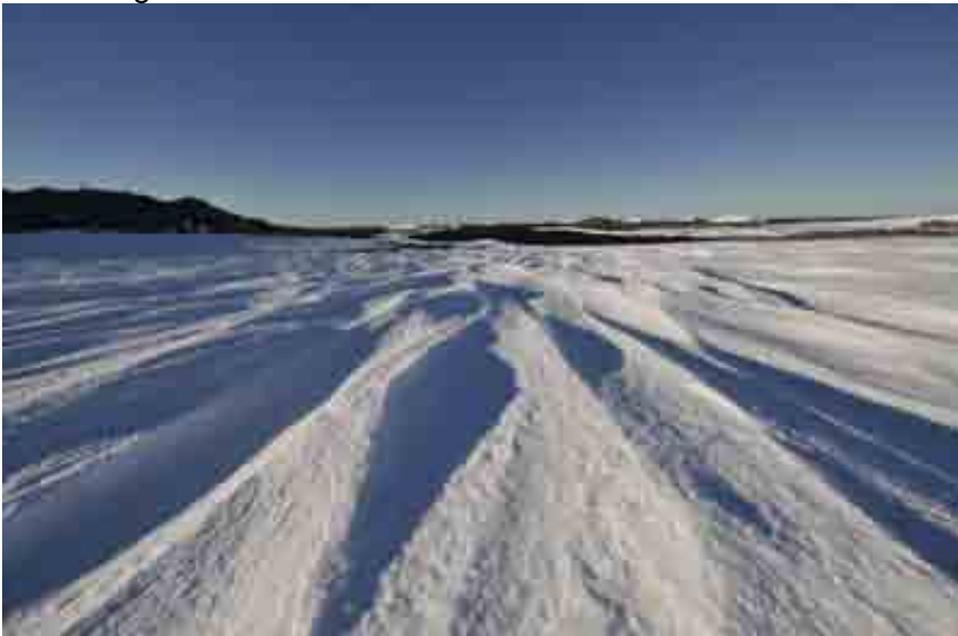
Figure 18 sastrugi disturbed the stability of the radar aerial (Photo: David London)

The area where the search was carried out was subject to extensive sastrugi (wind-blown frozen 'waves'). It was clear from the first search that the radar unit was forced to rock back and forth when traversing the sastrugi, so it was decided to flatten them out as much as possible before the second search to eliminate any possible error.

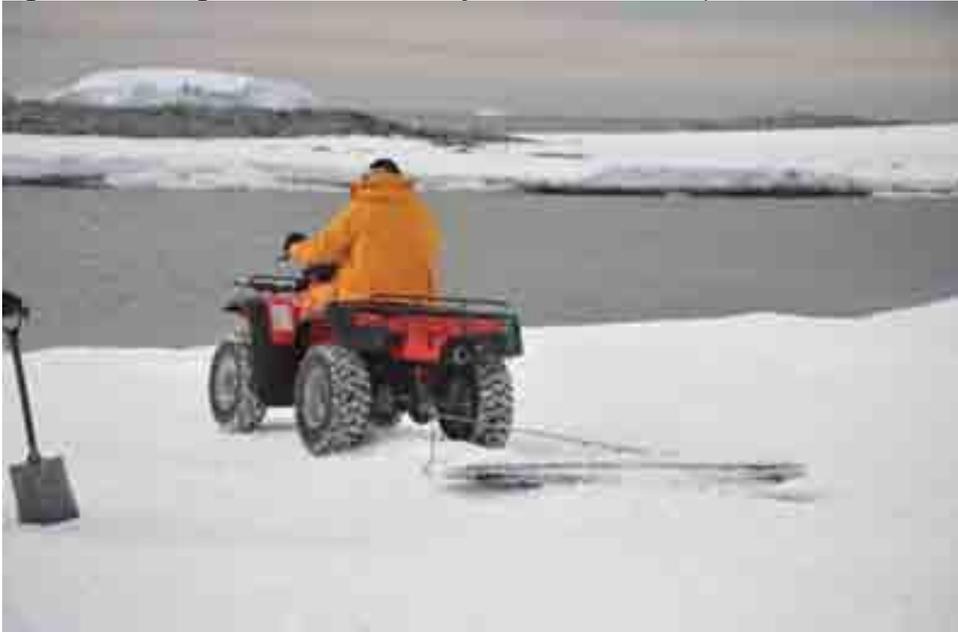
Figure 19: clearing sastrugi with a custom made cutting implement (Photo: David London)

Accordingly a large area encompassing the proposed new searches was flattened using a device built with the help of Ben Burdett, Carpenter. This was remarkably effective, and soon provided a relatively smooth, gently undulating surface.

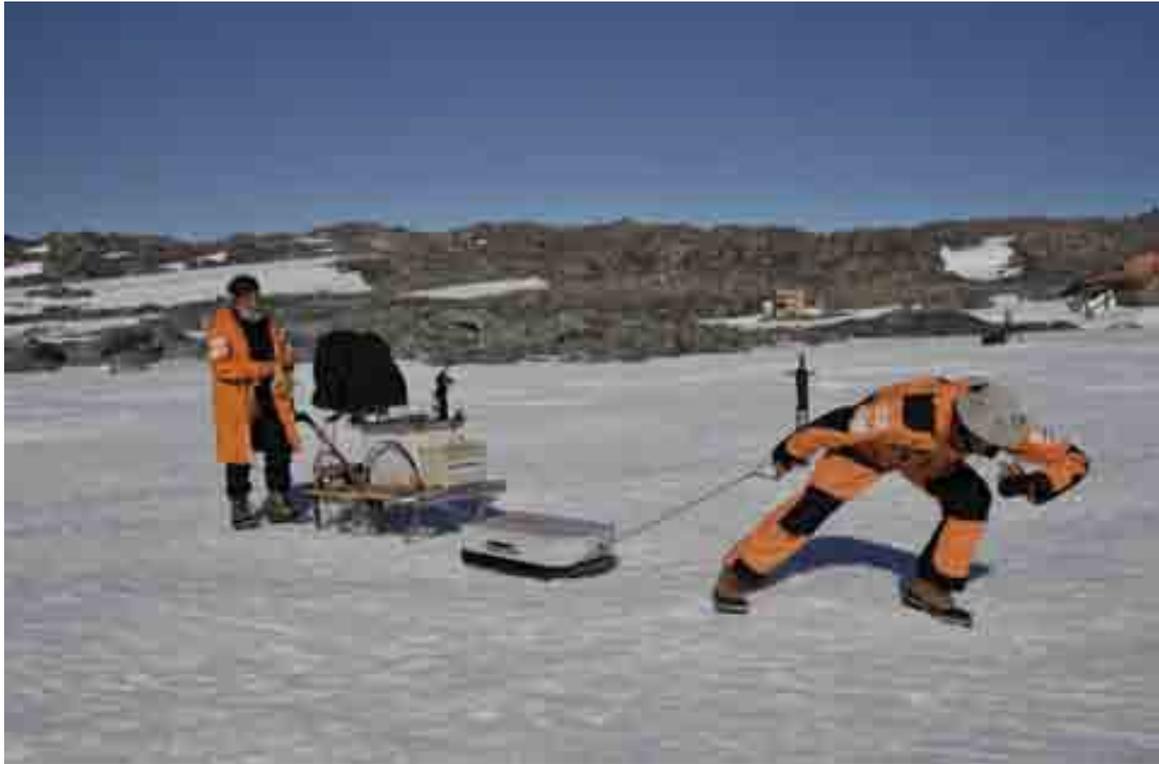
Figure 20 : smoothed sastrugi gives clear surface for second radar scan. Ben Burdett (front) and Chris Henderson (rear) demonstrate different opinions on how hard it is to pull the cart. (Photo: David London).

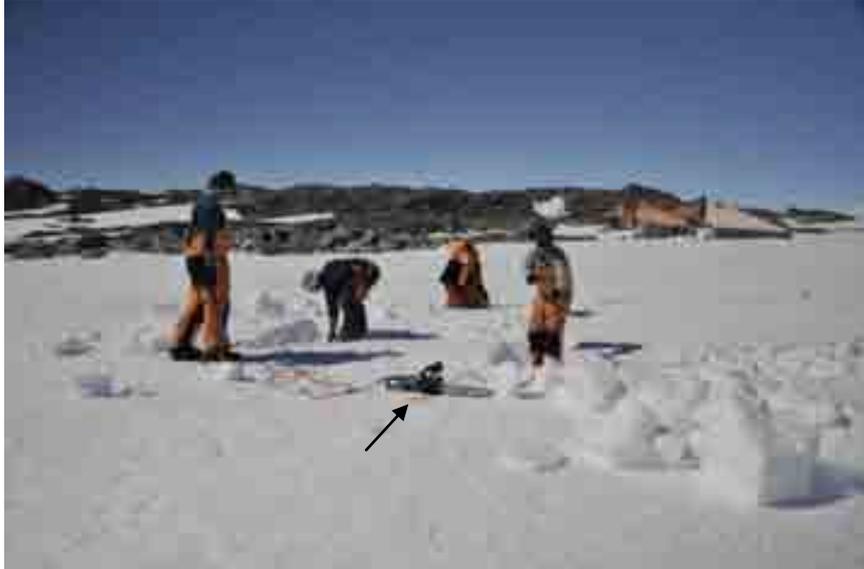
Figure 23: start of second dig. The coats hang on the post at the centre of the circular search area. The small orange tag in front of the chainsaw (arrow) is the spot where the three transit lines cross and represents the position where the air tractor frame was until its last sighting in 1976. (Photo: David London)

Having established the estimated position for the air tractor, and got what looked like a significant echo of about the right size, an exploratory trench was dug down to the level of interest.

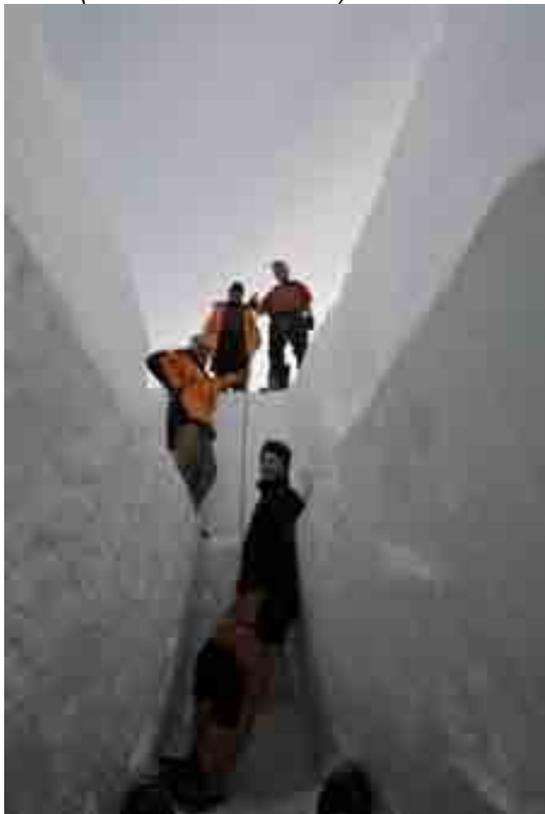
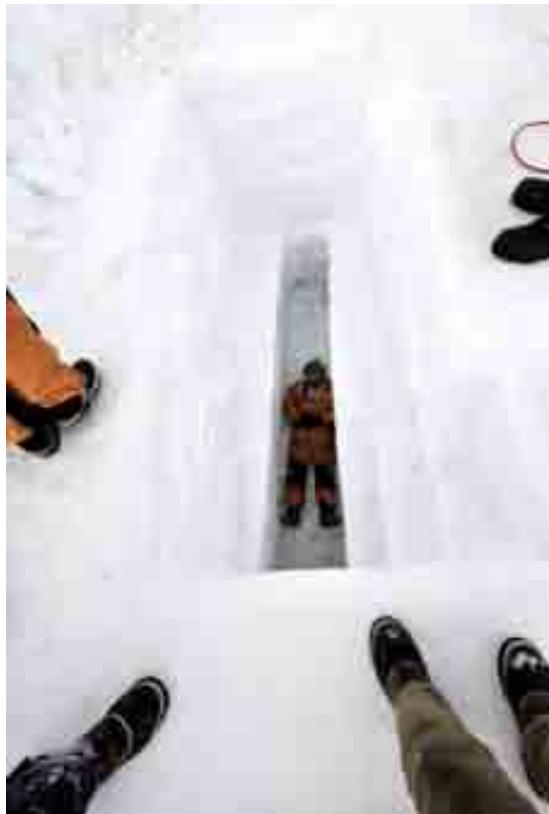
Figure 24: end of the dig. The dig was stopped below sea level. These pictures give an idea of the final size of the hole. (Photo: David London)

Digging was done using an electric chainsaw (lubricated with vegetable oil), and a shovel and crowbar to lever out blocks of ice. (Chainsaws blades can be made for faster ice digging by filing off half the kickback tangs⁶). The dig took about 8 hours spread over two days. At about 1.25 m a layer of hard ice was encountered consistent with the melt of 2002, and shown on the radar scan.

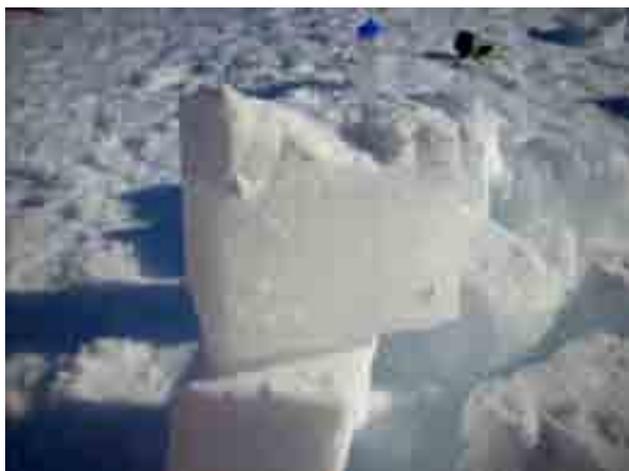
Figure 25

Layer of clear hard ice encountered at about 1.25m which is shown on the radar scan (Figure 22:) and at a depth consistent with the ice level estimated from pictures of the 2002 melt.

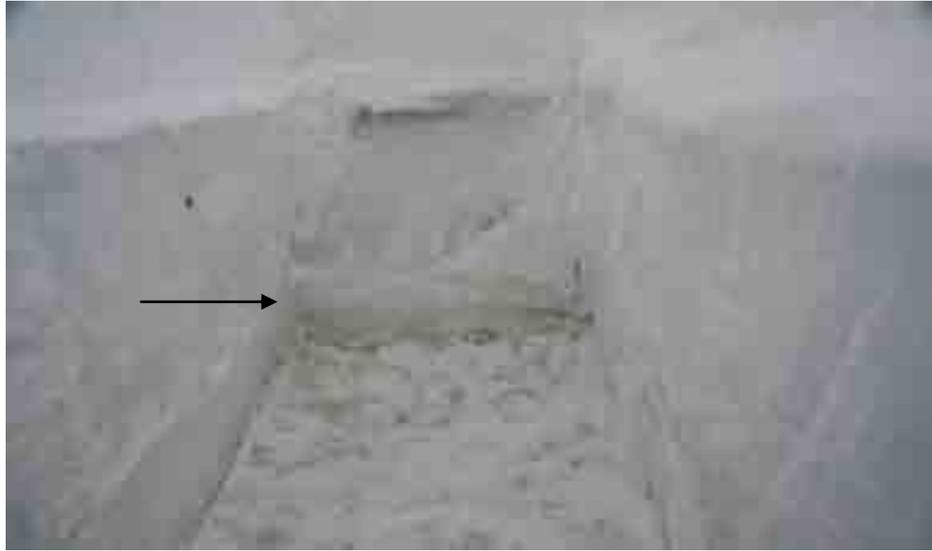
Figure 26: At the bottom of the trench a hard ice layer was encountered at about 2.5m (arrow). This layer contained seaweed and faeces and is at high tide level. The bottom of the hole shown above is at about 2.7m and consists of hard, greenish ice. The dig was stopped at this point as it was below the area of interest shown in the contour maps. (A metal detector, capable of penetrating a further 200mm showed no activity.)

A surveyor's level was available, and the bottom of the hole was surveyed with reference to the benchmark AUS2030 which is at high tide level. The bottom of the hole was found to be at high tide level.

This finding implies that, at some time in the past, a big melt had occurred, effectively removing the ice which contained the air tractor. The additional finding of a possible channel in the rocks is important, and is discussed next.

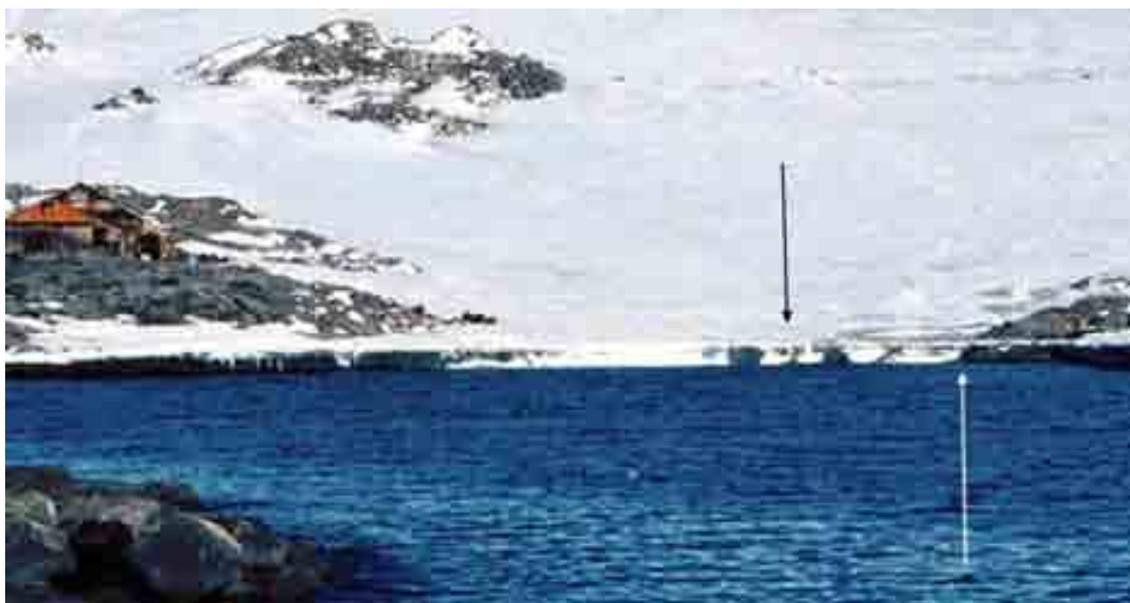
Figure 27

The area of the search from the north looking across Boat Harbour. The white arrow shows the steep sides of the rock band which is consistent with the contour map in Figure 17, and suggests that the harbour dips down into a channel at this point. (Photo: Ian Godfrey)

The left hand edge of the contour map is hard up against the band of rock at the edge of the search area. If the area on the contour map represents the sea surface, then it suggests that the rocks go steeply down into the sea at this point. A photograph of these rocks taken during the melt in 2001 confirms this is the case.

This is consistent with the shape of the rocks and ice seen in Figure 27.

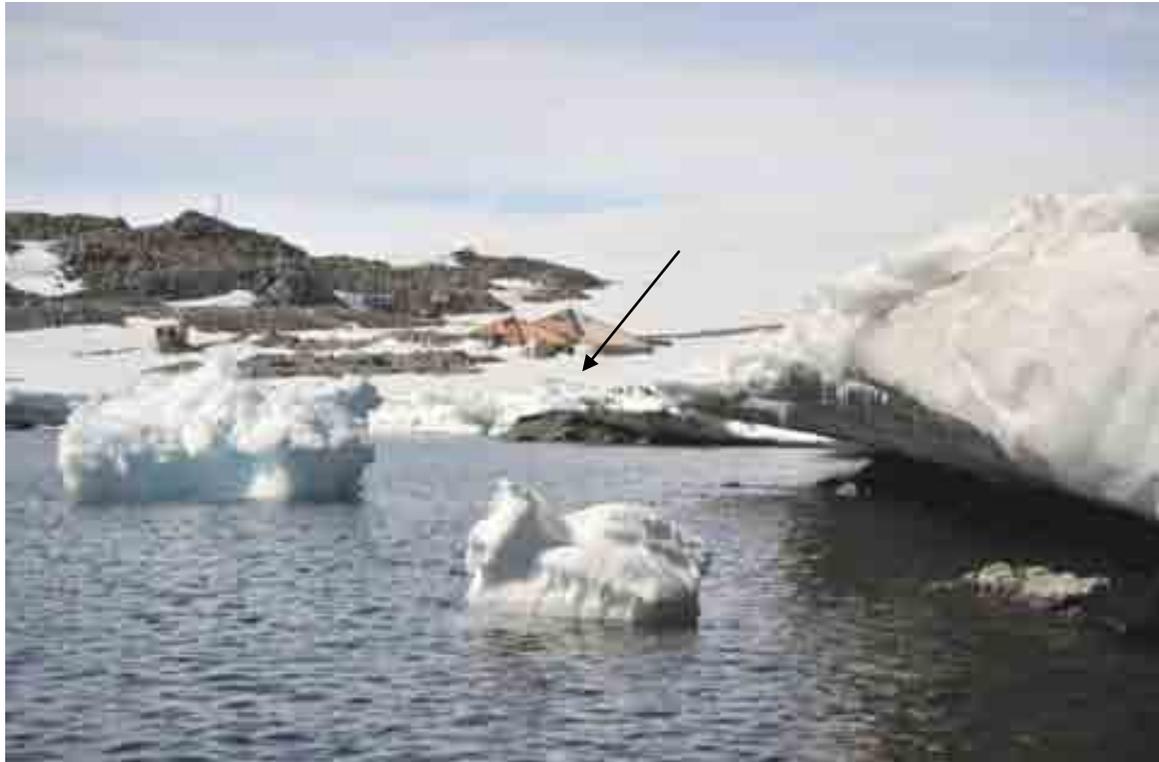
Figure 36: While the body of ice in Boat Harbour disappears quickly, scouring the bottom, the ice round the edges behaves differently. It erodes from beneath forming large overhangs which break away during summer. This picture was taken on 2nd Jan 2009. The air tractor search was behind the rocks, arrowed. If the frame had melted down to the harbour bottom in this location it would not have been taken out to sea in the early ice breakup. (Photo David London)

seawater from the bottom up, leaving large overhanging shelves that eventually break off. If the frame is resting on the bottom, perhaps in a channel or on the rocks it is likely to still be there, protected from the scouring effect by the surrounding rock.

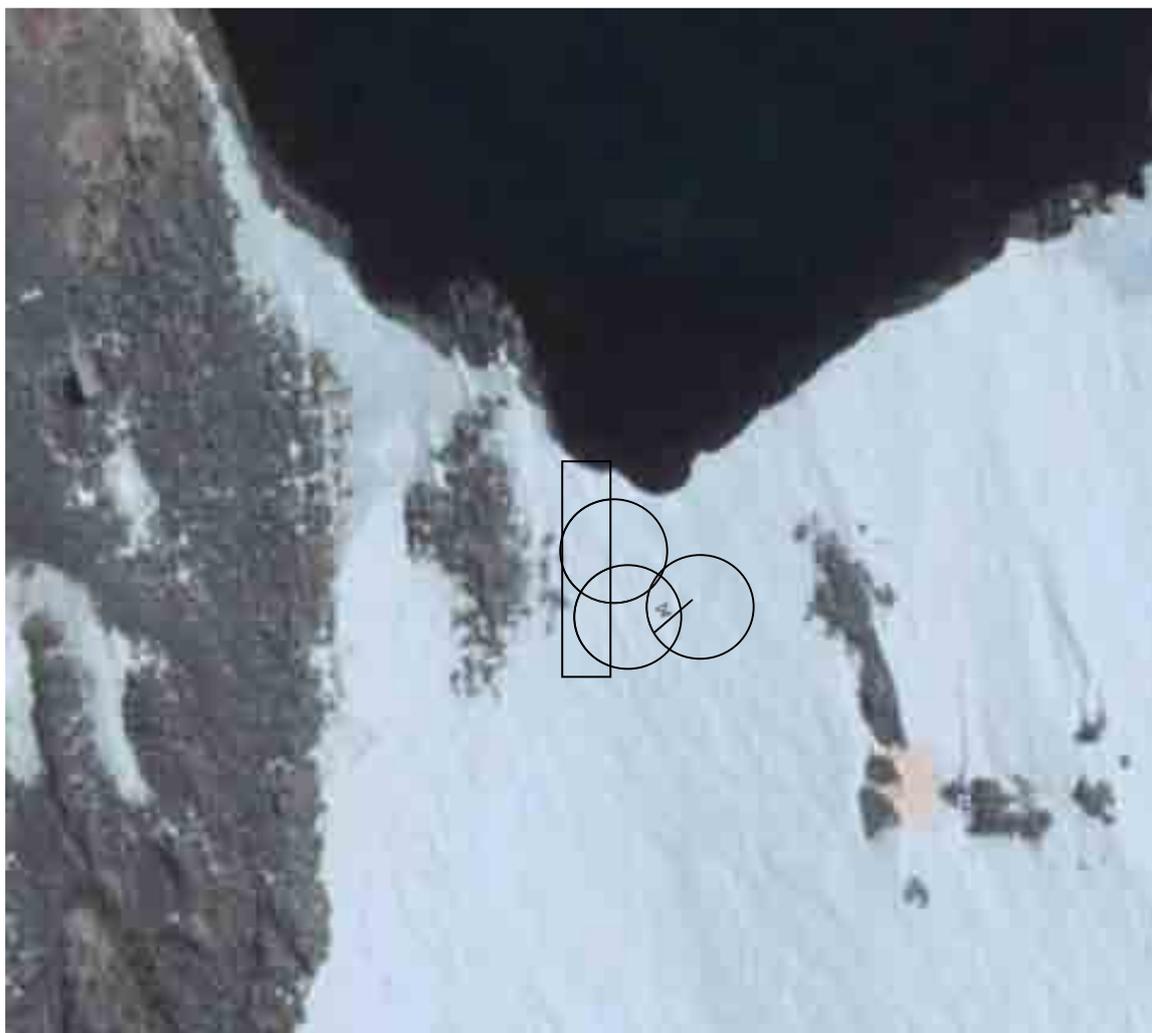
Figure 38: This shows the location of the search areas superimposed on a Google Earth picture from 295m. The total area searched amply covered the possible position of the air tractor. The circle closest the harbour was the first search, the two lower ones the second search. The cross at the intersection of the two lower circles is the estimated position of the air tractor frame. The exploratory trench we dug was approximately where the diagonal line is.

The channel found on the radar scans and discussed in the text runs approximately in the area of the long rectangle.

The Oceanic Research Foundation under Dr David Lewis visited Cape Denison in summer 1981. The engineer, Dr Don Richards, and the cameraman Mal Hamilton, are certain there was no air tractor visible, and the photo at the end of this report supports their statements (figure 38).

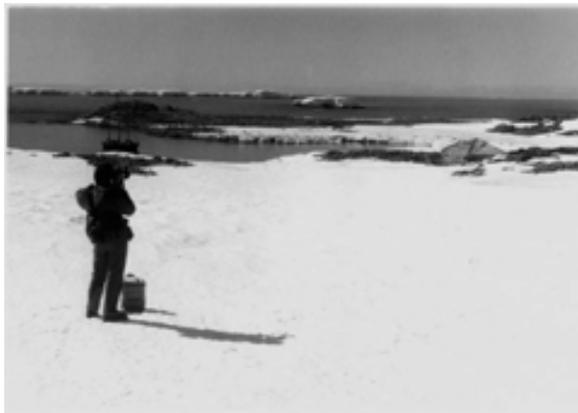
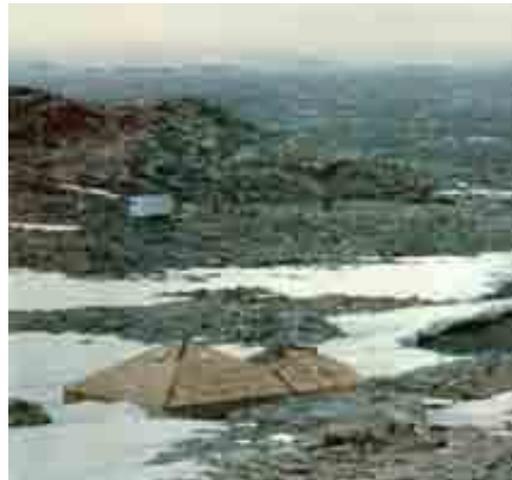
Figure 39: Dick Smith Explorer in Boat Harbour in summer 1981/2. Note the level of the ice in 1981. It is roughly the same as in 1976, and the frame should have been visible in 1981. Dr Don Richards, the First Mate and Radio Operator on the Explorer, and Mal Hamilton, cameraman, both report that there was no frame visible in 1981/2. (Photos Oceanic Research Foundation 1981, R image from National Geographic April 1983 p554)

The cameraman on that expedition, Mal Hamilton¹⁶, conferred with Don Richards, and between them they were certain there was no trace of the air tractor when they visited. A picture taken by Mal of the area where the air tractor was in 1976 clearly shows unbroken ice (below).

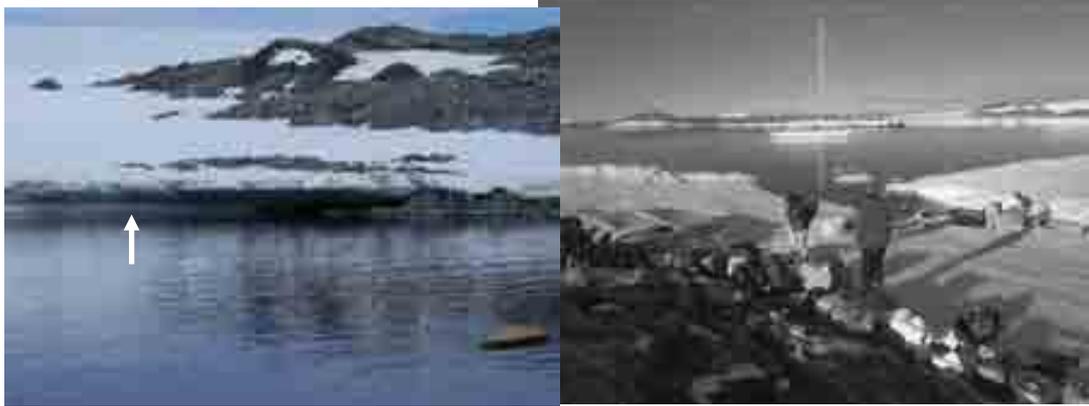
Figure 40 If the reasoning in this report is correct, then the Air Tractor is still in the ice, probably in a channel in the rock, at the edge of Boat Harbour in the area shown by the arrow on the left and similar to the one illustrated on the right, which is at the base of the rocks near Granholm Hut (photo Don McIntyre 'Two below zero').

The most likely outcome however, is that there was a big melt in 1977, which freed the frame from its enclosing ice; the frame then fell into the sea and remains at the edge of Boat Harbour, deeper than the GPR can penetrate.

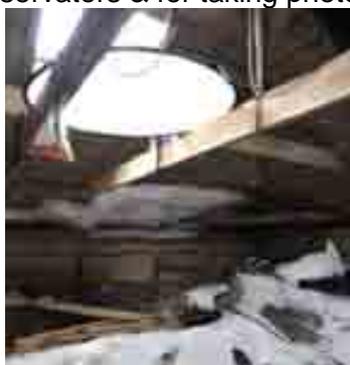
Photo flex diffuser in place in workshop

Part of my equipment included two Photo flex Multidisc 5 in 1 light reflector which double as a light diffuser. By simply placing this on top of the rafters in the ceiling in the path of the sunlight, it diffusers & disperses the sunlight through the hut, breaking down the sunlight into a soft even glow, similar to the effect of a modern skylight. With the Photo flex diffuser in place, I took light measurements in Hyde Park Corner & Murphy's bunk & the exposure 'f' stop increased by one f stop. This made more light available throughout most of the interior plus areas that were normally quite dark & was more even for the conservators & for taking photos.

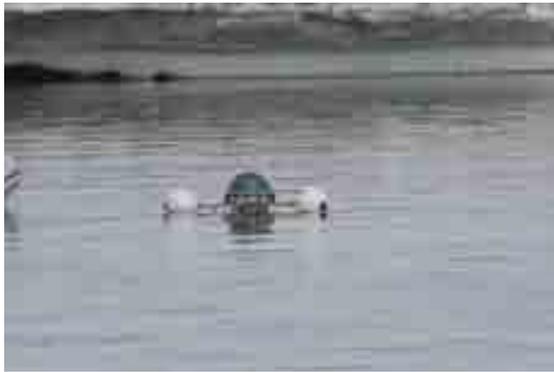
Our first attempt, note two knots attached to frame – these knots were cut by sharp edges of the frame, and the frame blew away

GPS float line: We had a problem with the line securing the GPS float, which illustrates the way equipment needs to be secured properly. The float was deployed on a calm day, but the wind blew hard that night and the anchor rope was cut by a sharp corner of the frame in two places. The unit blew out to sea, and only landed on some rocks near the entrance to the harbour by good luck.

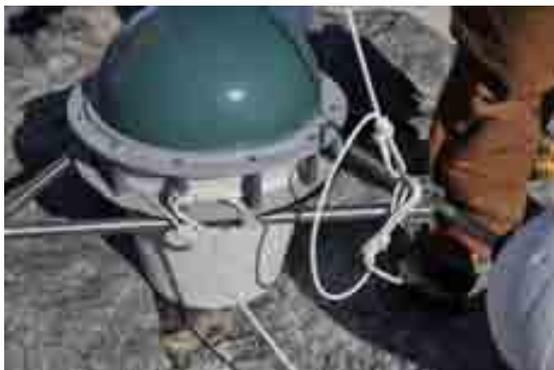
Second attempt – stronger rope, chain and shackle. This worked.

A second attempt was successful, using stronger rope and a chain and shackle. The French, using similar equipment, probably did it better.

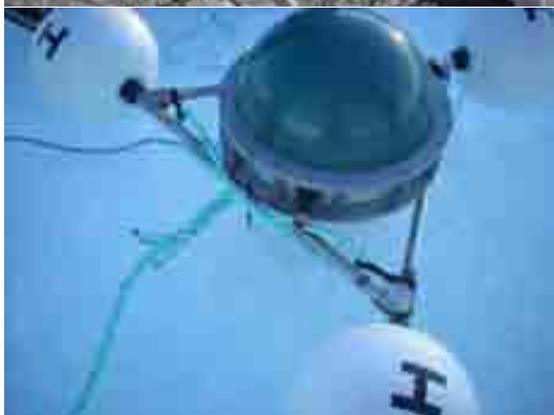
The French solution, which seems much better using a bigger spliced loop centred using lashings.

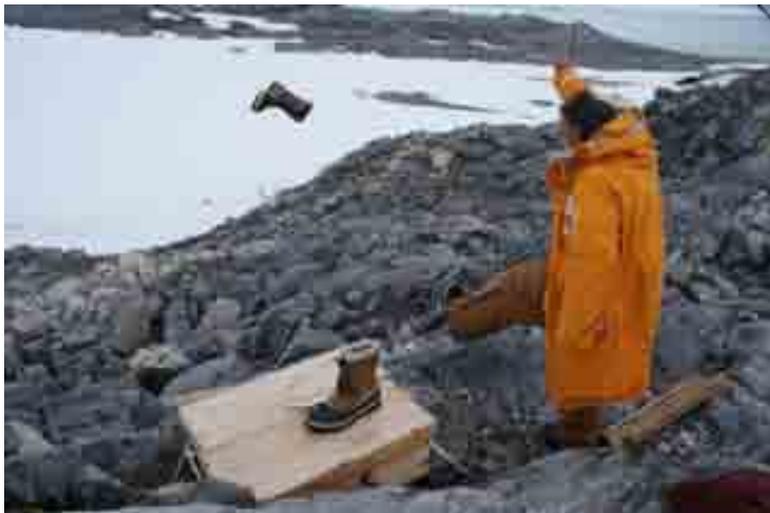
Re-booting the weather station.

The AWS is owned by the University of Wisconsin, and MHF does occasional maintenance. Each year the weather station needs rebooting by taking out and replacing the battery plugs. This year the anemometer head was replaced.

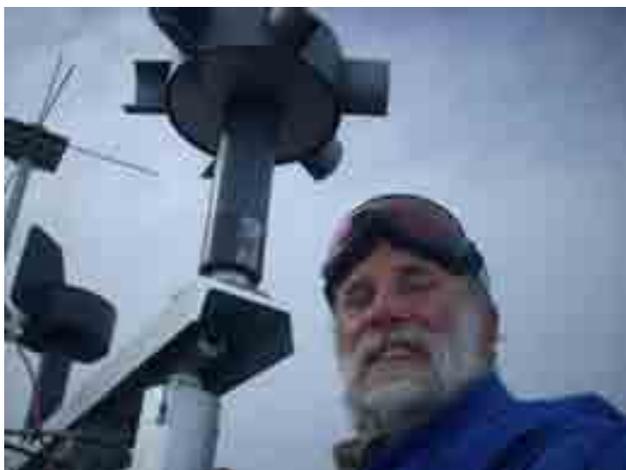
Replacing anemometer head at top of weather tower.
