Mawson's Huts Foundation

2008–09 Expedition Report

MAWSON'S HUTS CONSERVATION EXPEDITION 2008/09

EXPEDITION REPORT

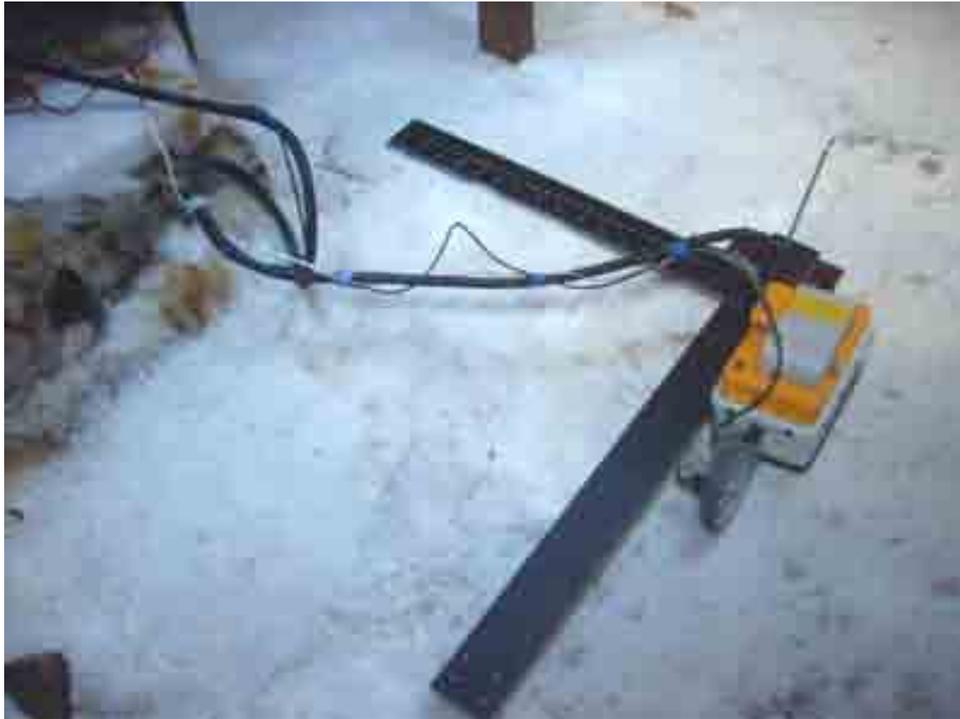
Figure 42: The equipment ready to scan an area of about 0.8m square near the table. The 800Mhz aerial and trigger wheel is run along the guide bar. The guide bar is moved along the fixed bar which is screwed to the ice (the bar is shown top left with registration holes). The guide bar (T piece) is held in place by the tent peg.

As the aerial was moved along the T piece, the distance wheel triggered a recording. The frequency of recording was every 1cm. Each line of the grid was done in the same direction, and each line formed a separate file.

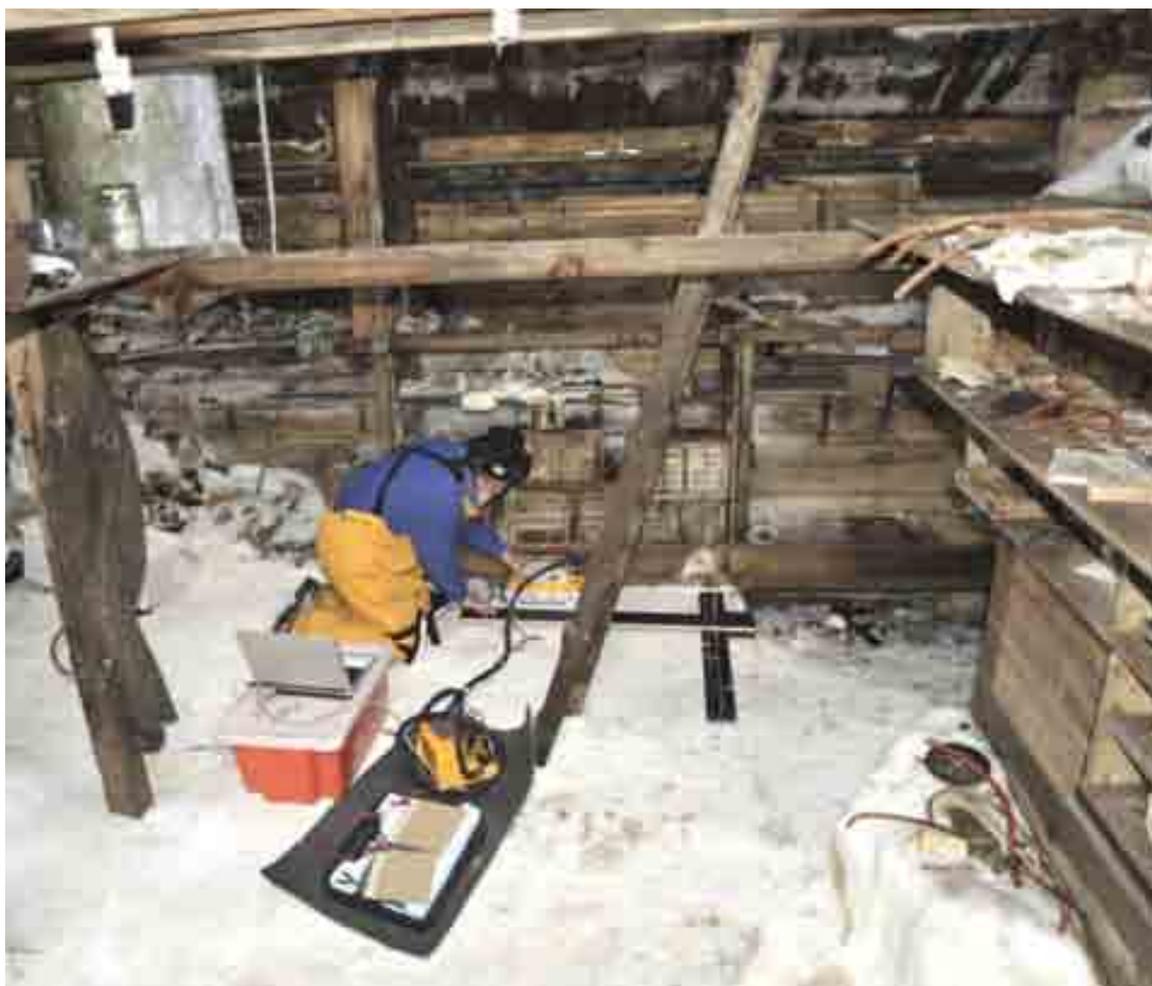
Figure 43: Scanning next to the bunk of J. H. Close. The floor was undulating but relatively smooth. Four areas were chosen where the guide bars allowed easy movement of the aerial. (Photo David London)

The hut floor is packed ice crystals to a depth of about 500 – 600 mm. It is relatively smooth, but undulating. Four areas were chosen where the surface was flat enough to fix the guide bars to the ice, and to run the aerial freely in the grid lines.

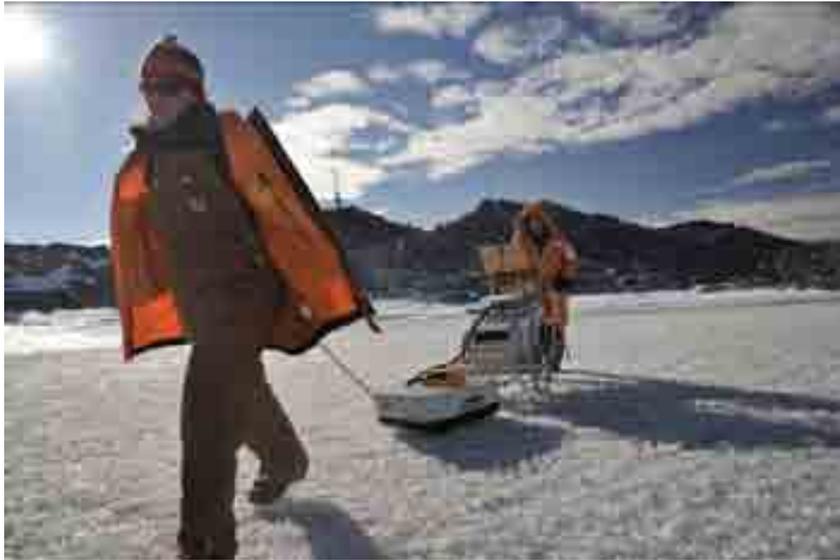
Figure 51: Surveying Round Lake. Note very rough ice surface. The process was much improved by using the ski attachments to the cart. (Photo David London)

The frozen lake surface was thick enough to walk on (300mm of ice), but the top surface was very rough, being serrated like an egg carton with serrations up to 75mm high (figures 1 and 5). This not only made the cart hard to pull, but the vibrations unscrewed its nuts and bolts. It was found that attaching skis solved this problem and made for a smooth ride and easy pulling.

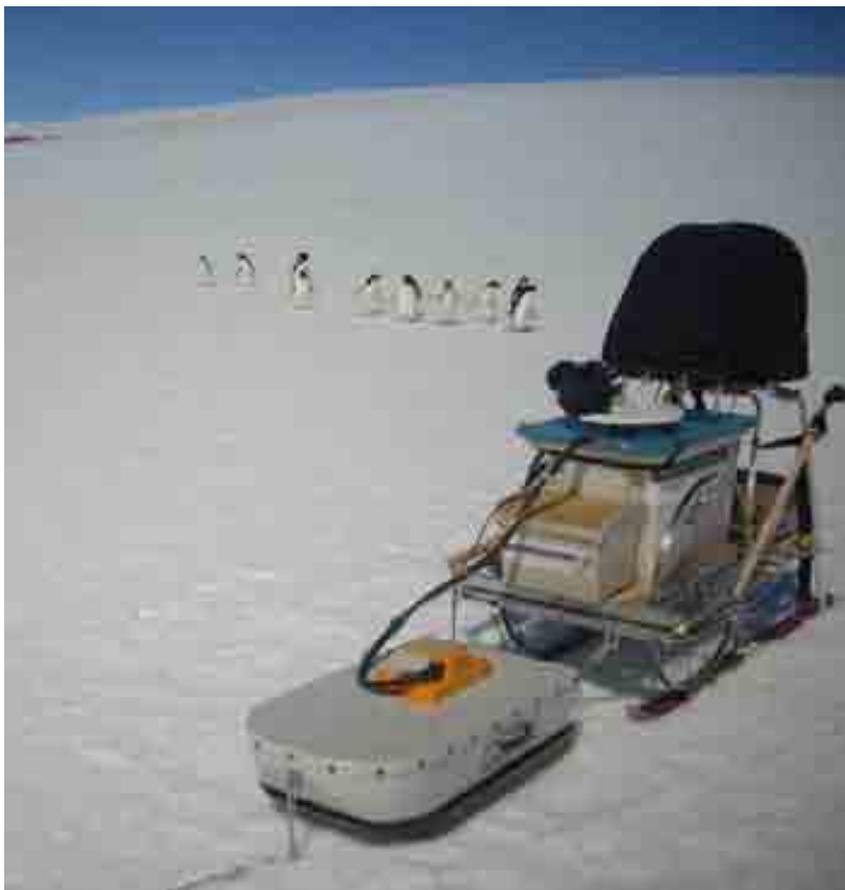
Figure 52: Ski attachments make the cart much easier to push on a rough surface. Penguins found the whole exercise fascinating.

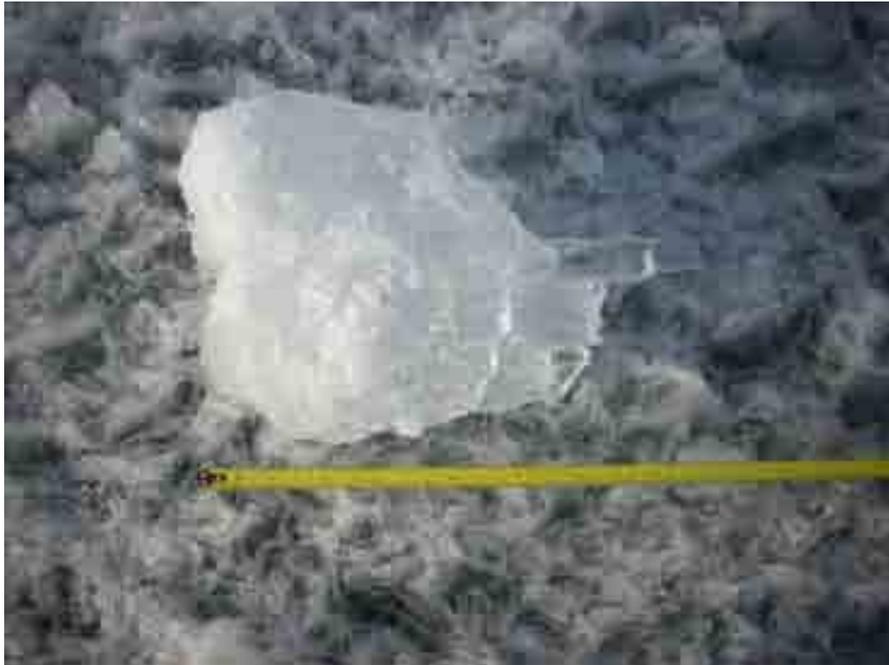
Figure 56: Ice surface and thickness Round Lake. The rough surface of the lake is well shown here. The surface ice was 300mm thick.

This lake is just below the weather station, and is about 50m across. The ice surface was about 300mm thick.

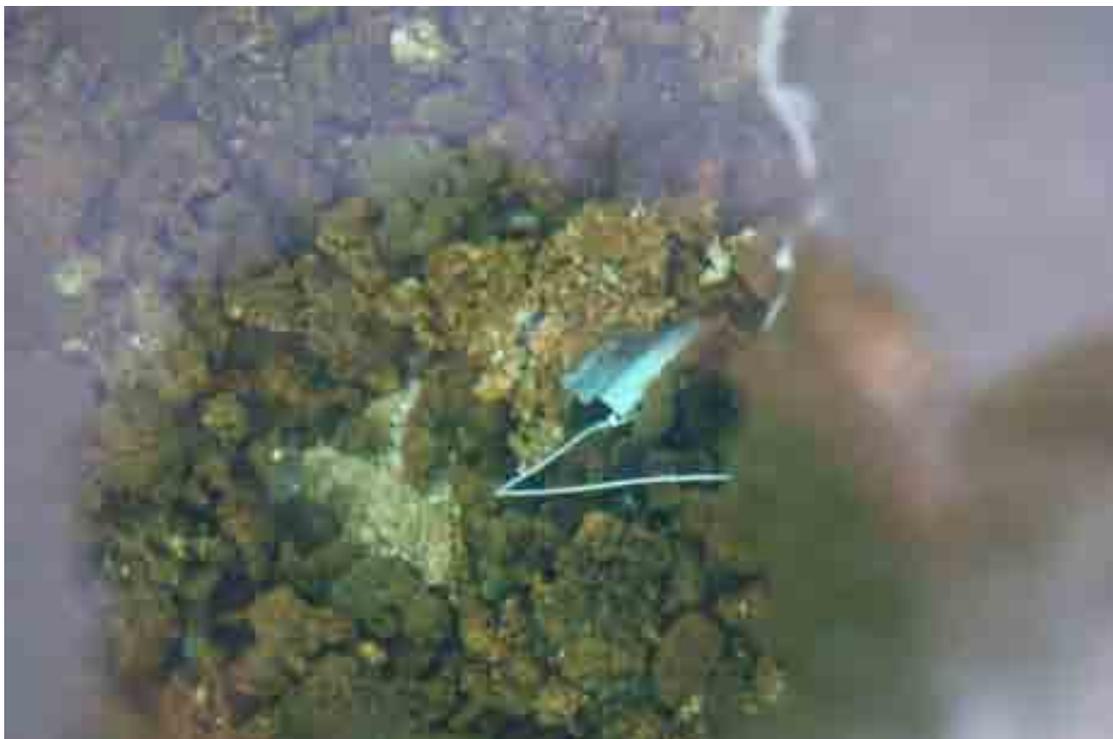
Figure 57: Picture of sediment in Round Lake. The sediment is 1m thick and consists of fluffy green/brown masses. The water is clear – this picture was taken through the ice hole and 2.5m of water. The 150mm metal C channel is seen on the sediment surface.

In Round Lake, where the water was crystal clear photographs were taken of the sediment. It consisted of buoyant 'blobs' of greenish material.

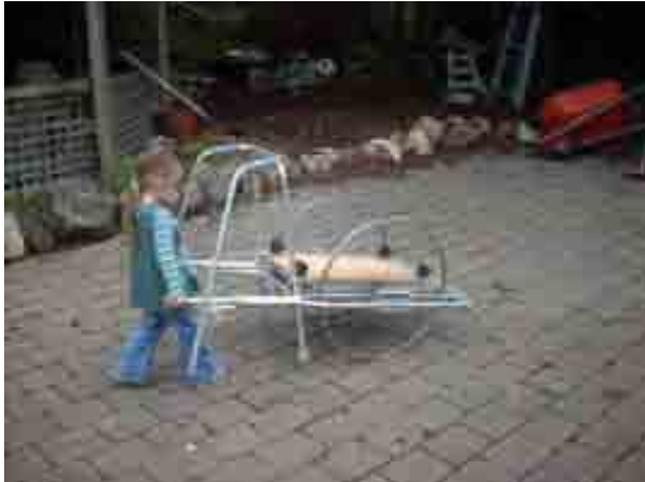
Figure 67: the basic frame.

The cart needed to be strong and light, and the aircraft-grade aluminium in a Zimmer frame and crutches provided this capacity, as did bicycle wheels and ice-hockey sticks.

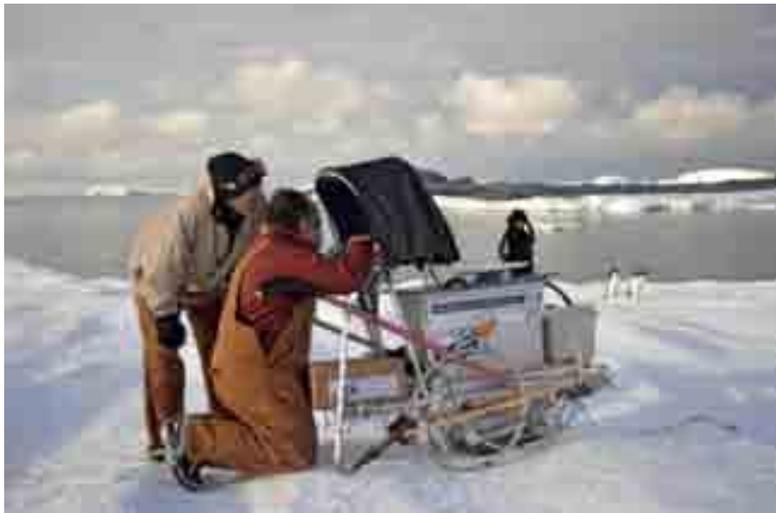
Figure 68: the cart in operation at the first search site. Pete Boyer towed it, and Chris Henderson pushed it. Here Chris looks at the radar trace, while Pete and the penguins wonder what is going on. (Photo: David London).

The radar unit was triggered by a trailing wheel, which sent out regular pulses (Figure 5, the smaller side wheel). A position was recorded from a GPS unit (Trimble 5700) every time a radar wave was transmitted. The rope traced out a circle 17 metres in diameter, with a total of about 1400 positions being surveyed within that area.

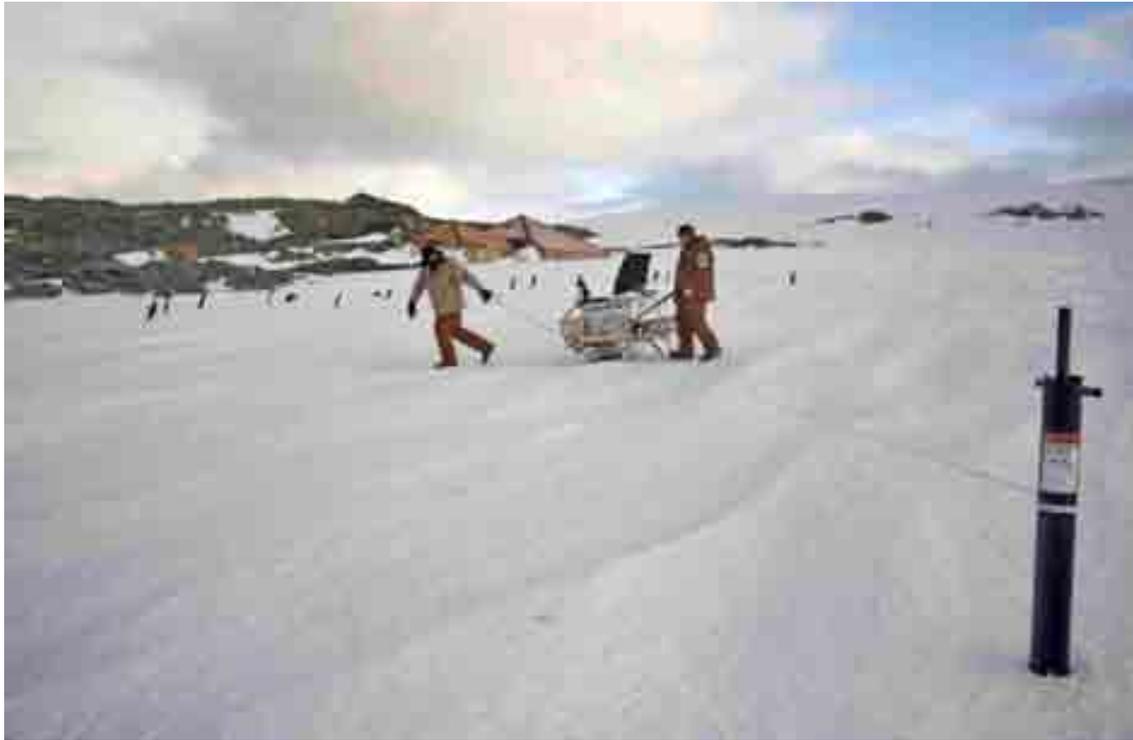
Figure 69: The search technique provided exactly the right spacing between scans while letting the operators concentrate on moving the cart. (Photo: David London).

GPR needs a close search pattern to work. Classically this is done by laying out a grid of closely spaced markers and recording individual computer files of each 'run'. This turned out to be so cumbersome that a better way was developed. The cart was tied to a central pole by a rope, and pushed around in a spiral, being wound closer each revolution by exactly the right 'grid' distance for an effective search density.

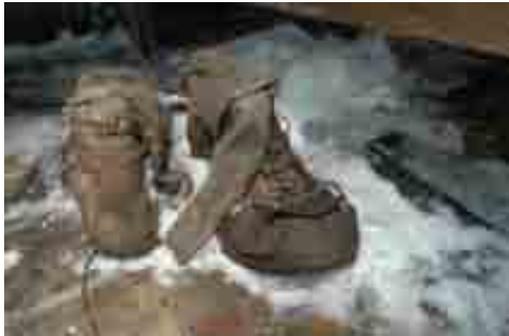
Pair of boots

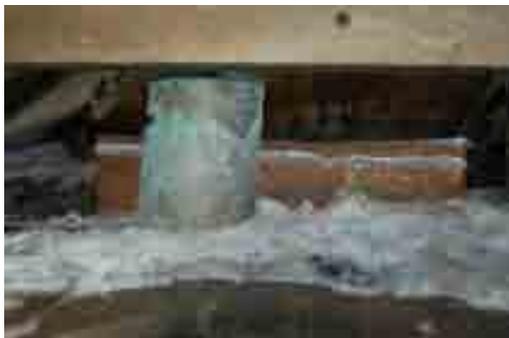
Copper alloy can and iron box

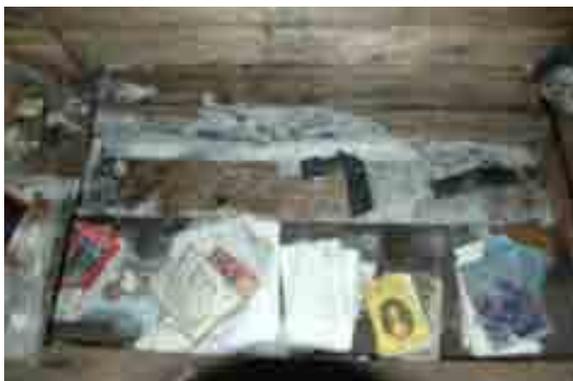
Books and papers

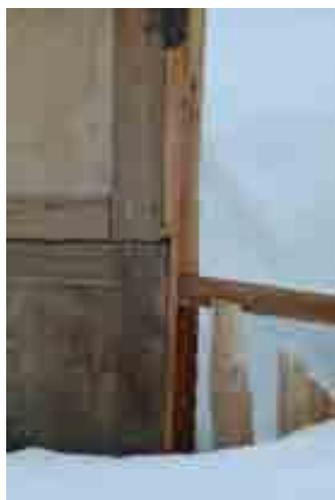
1. Absolute Magnetic Hut

Position from lowest point of timber	2000/01 thickness (mm)	2008/09 thickness (mm)
5	17.72	17.37
10	18.22	18.19
15	17.25	17.67
20	18.16	18.11
25	18.22	18.21
30	17.51	17.36
35	18.15	18.37
40	18.78	18.76
45	18.49	18.58
50	17.92	17.94
55	34.38	34.13
60	34.93	3.71
65	34.63	34.69
70	35.04	34.51
75	35.47	34.96
80	35.16	34.74
85	35.12	34.84
90	35.08	34.73

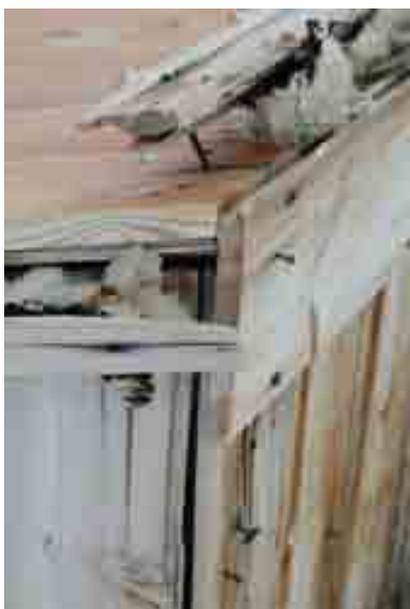
Timber thicknesses were measured on the end grain of a small fascia board on the NE corner of the building (northern face), with measurements taken from the bottom of the board to the top at 1 cm intervals. Note that from the 5 to the 10 cm mark, the timber was shielded from the prevailing wind by other wood and wool. Measurements taken during the 2008/09 fieldtrip are compared with those taken from the same position in 2000/01.

Position from lowest point of timber	2000/01 thickness (mm)	2008/09 thickness (mm)
1	13.99	14.21
2	14.61	14.54
3	14.69	14.94
4	15.33	15.41
5	15.79	15.54
6	15.52	15.81
7	15.87	15.70
8	15.88	15.89
9	15.50	15.99
10	15.68	16.07
11		15.66
12		15.78

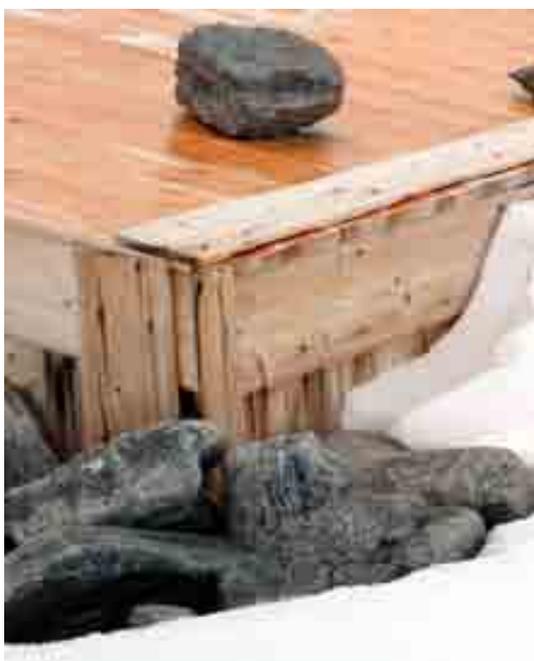
SW corner of the magnetograph house

Timber thicknesses were also measured on a small piece of timber (approximately 30 cm long) on the southwest corner (western face). The lower portions of this piece were protected by the rock wall. Readings were taken, where possible at 3 cm intervals. Readings should also have been taken of another small piece of timber on the SW corner (southern face) as this piece had been measured previously in 2000/01 (see image below).

Position from lowest point of timber	2008/09 thickness (mm)
3	12.11
6	11.89
9	10.89
12	11.05
15	10.30
18	9.56
21	9.63
24	8.49
27	9.20
30	7.98

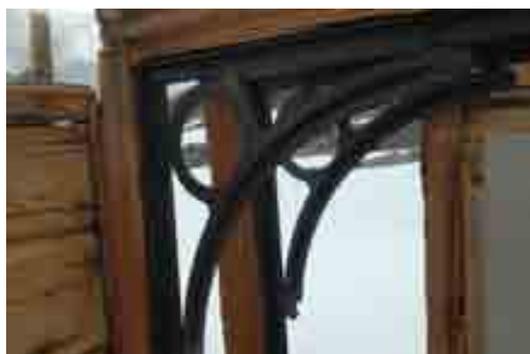
No comparative timber measurements were possible for the transit hut as the timber that had been documented in 2000/01 has been lost from the building in the intervening years. Measurements were taken however, of one of the shelving brackets to see if corrosion and wind abrasion losses of corrosion products could be determined via measurements of the metal thicknesses. Measurements were taken in triplicate and averaged. Sampling positions are shown below, as is comparative data for the NE bracket (2000/01 and 2008/09 seasons).

Transit hut brackets, classified as NW (foreground) and NE (background)

Position	2000/01 average thickness (mm)	2008/09 average thickness (mm)
1	3.86	3.83
2	5.68	5.72
3	3.83	3.65
4	3.53	3.58
5	3.78	3.65
6	3.83	3.68
