**REPORT OF THE AAP MAWSON'S HUTS FOUNDATION
EXPEDITION 2000-01**

March 2001

REPORT OF THE AAP MAWSON'S HUTS FOUNDATION EXPEDITION 2000-01

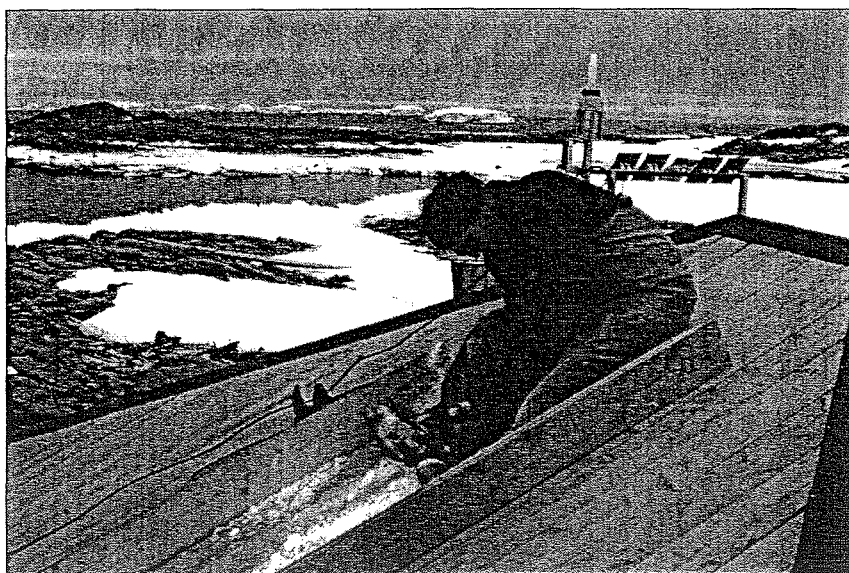
Carpenter Ted Bugg excavates ice from the workshop to examine the internal collar ties and rafters.

The excavation, to the level where the collar ties were joined to the rafters exposed 5 out of the 8 rafters had been split and or broken at the bolted joint .In the process, the pine lining had also pulled away from the rafter.

- 1 *It is considered if the collar ties are to be repaired and the split rafters replaced, the new external cladding be removed in the vicinity of the rafters and original fabric carefully taken up. New fabric can then be inserted through the slot created. It will be less intrusive on the lining with this method. The decision to repair this will be only cosmetic if the main mass of ice is to remain in place.*
- 2 *A permanent boardwalk be installed to the main entrance from the normal summer ice edge of approx'15 metres in length, with a spur track leading through the artifact scatter. Lazer supports this concept*

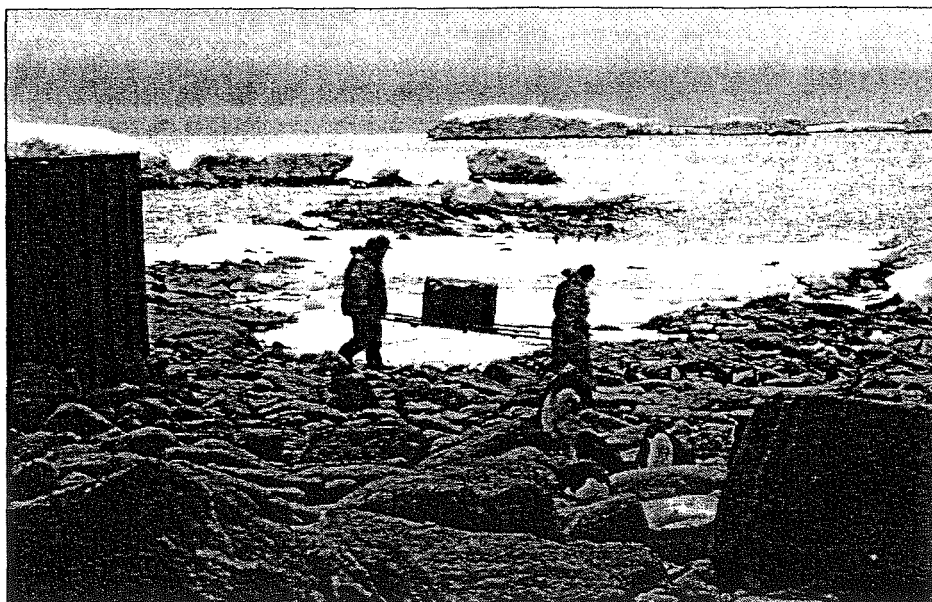
Members of the expedition ferry rusted waste from in front of Granholm Hut to the head of Boat Harbour for transport to the ship.

Rusty fuel drums, gas cylinders, old ration packs dating back to the 1960's, camping gear and two cargo containers and their contents were transferred to the relief ship 'Sir Hubert Wilkins' and transported to Australia for disposal. Most of the waste was from the 1978 AAD expedition with some from the Magnetograph House left by an American expedition in 1965 and Project Blizzard, 1984-5.

The clean-up program was challenging for members of the Expedition and for the ship's Crew as the whole operation was conducted using the rubber boats. It was a physically demanding task. For Expedition members, the business of cutting the steel containers into manageable pieces then handling them on a litter carried by four people over rocky terrain, was a potentially dangerous activity. That any back, knee and muscle injury was avoided is gratifying, especially as the Medical Officer was a key member of the clean-up group!

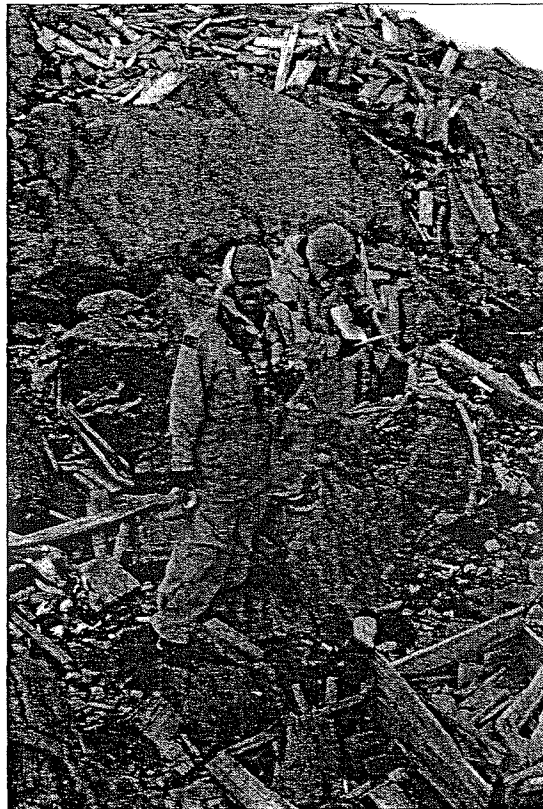
Alasdair and Estelle record amidst the artefact scatter downwind of the Winter Quarters.

Estelle has now documented artefacts at the Historic Site over three field seasons and has amassed a considerable amount of information in note books and on film; most recently, on digital record. There is a need to make this information available for research and general interest purposes to the wider community. But it will require considerable effort to achieve its conversion to **a systematic and comprehensive data base**. Consideration needs to be given to how this might be achieved, perhaps through a grant or temporary employment of a suitable person. Otherwise, the benefits of much hard work in freezing conditions will realise only a small fraction of its true worth to the Australian public and heritage community.

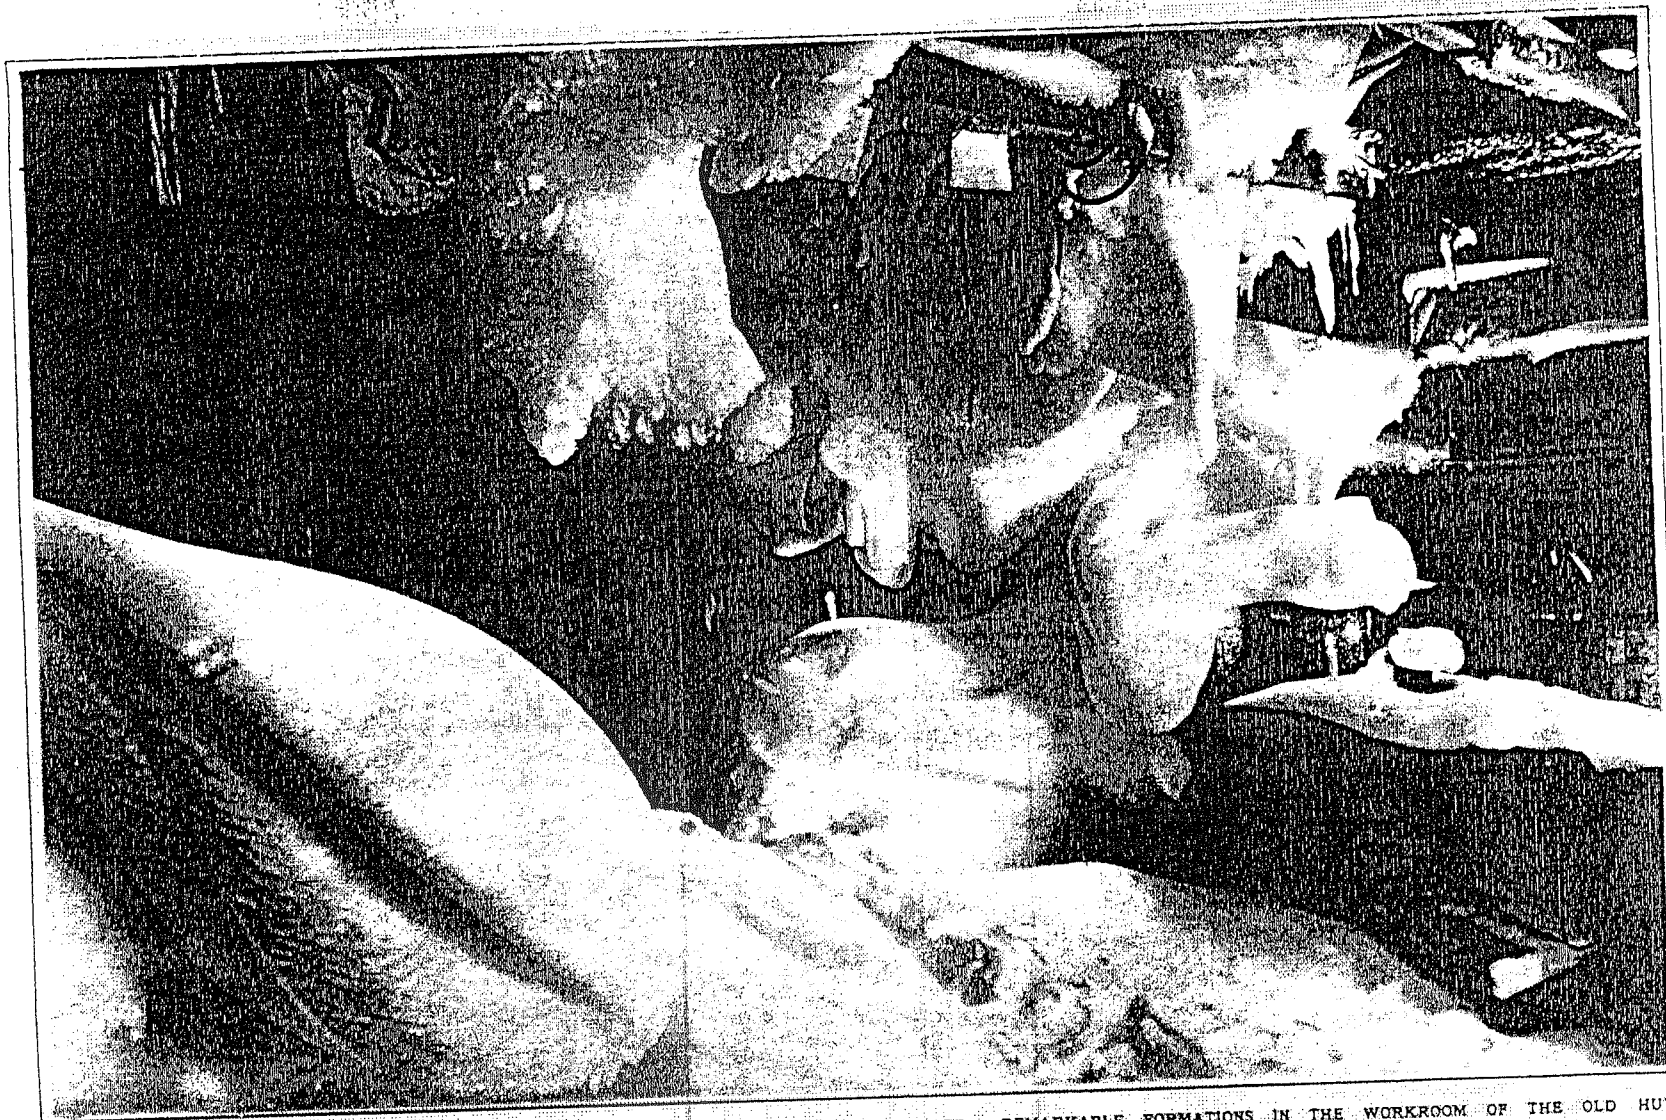
SNOW SCULPTURES REMINISCENT OF THE PREHISTORIC OR THE ULTRA-MODERN MANNER: REMARKABLE FORMATIONS IN THE WORKROOM OF THE OLD HUT, AS THEY APPEARED WHEN IT WAS REVISITED AFTER HAVING BEEN LEFT EVER SINCE TO THE UNDISTURBED OPERATIONS OF JACK FROST.
