# Mawson's Huts Conservation Expedition 2006

## Expedition Report

Compiled and edited by Dr Ian Godfrey  
Western Australian Museum

Mawson's Huts Foundation  
&  
Australian Antarctic Division

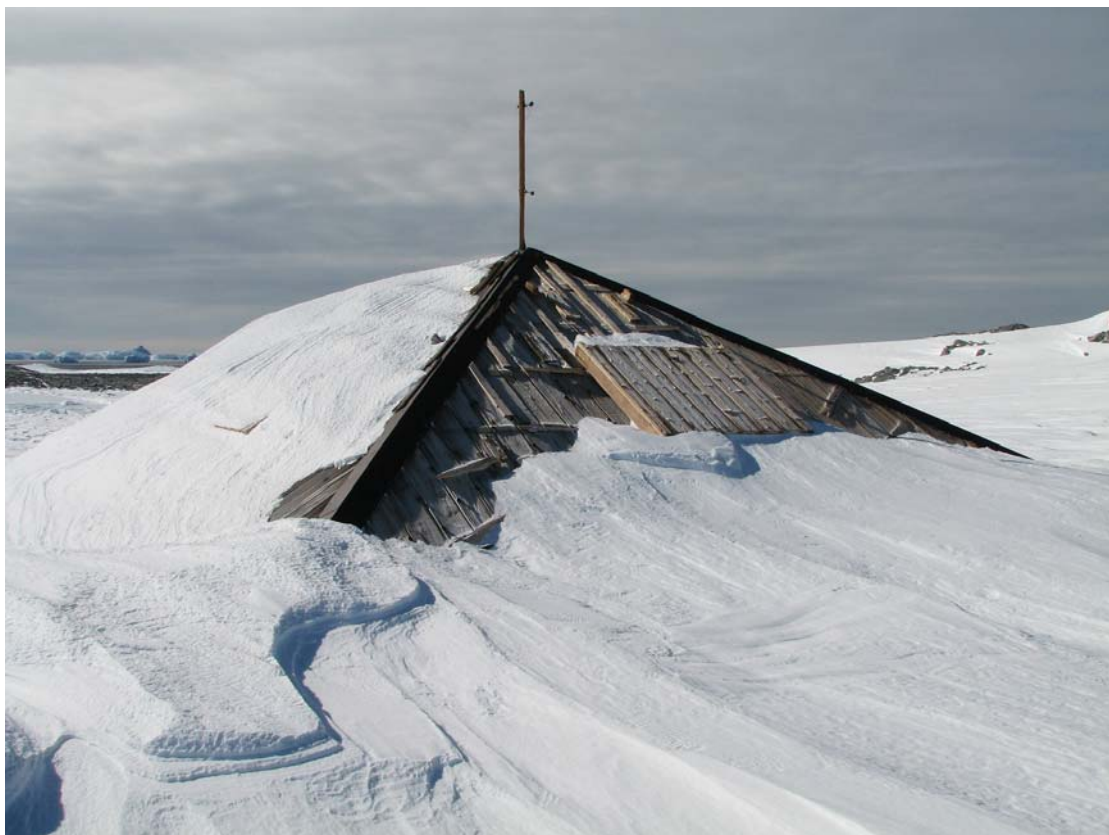
*The roof of the Living Quarters as first observed by the team on their arrival at Cape Denison, October 2006*

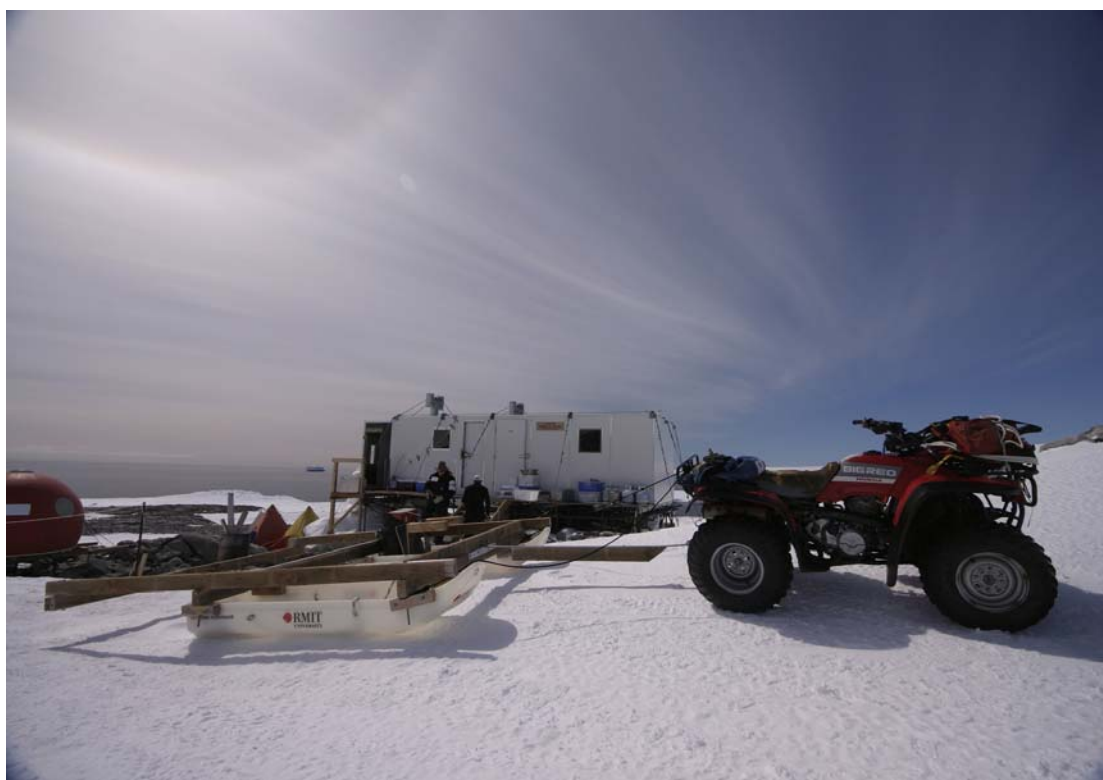
*'Spirit of Denison' sled (version 1.1) with Sorensen Camp in the background showing the new stairs and extended platform (photograph by Simon Mossman)*

Ted, Marty and Chris used the RMIT sleds as the basis for constructing a large sled ('The Spirit of Denison'). This proved invaluable in transporting the timber from the Granholm to its new location just south of the Sorensen Hut and for moving large quantities of cargo during RTA operations. It is recommended that this sled be kept in its current configuration and that additional RMIT (or similar) sleds be taken to the site for the next expedition.

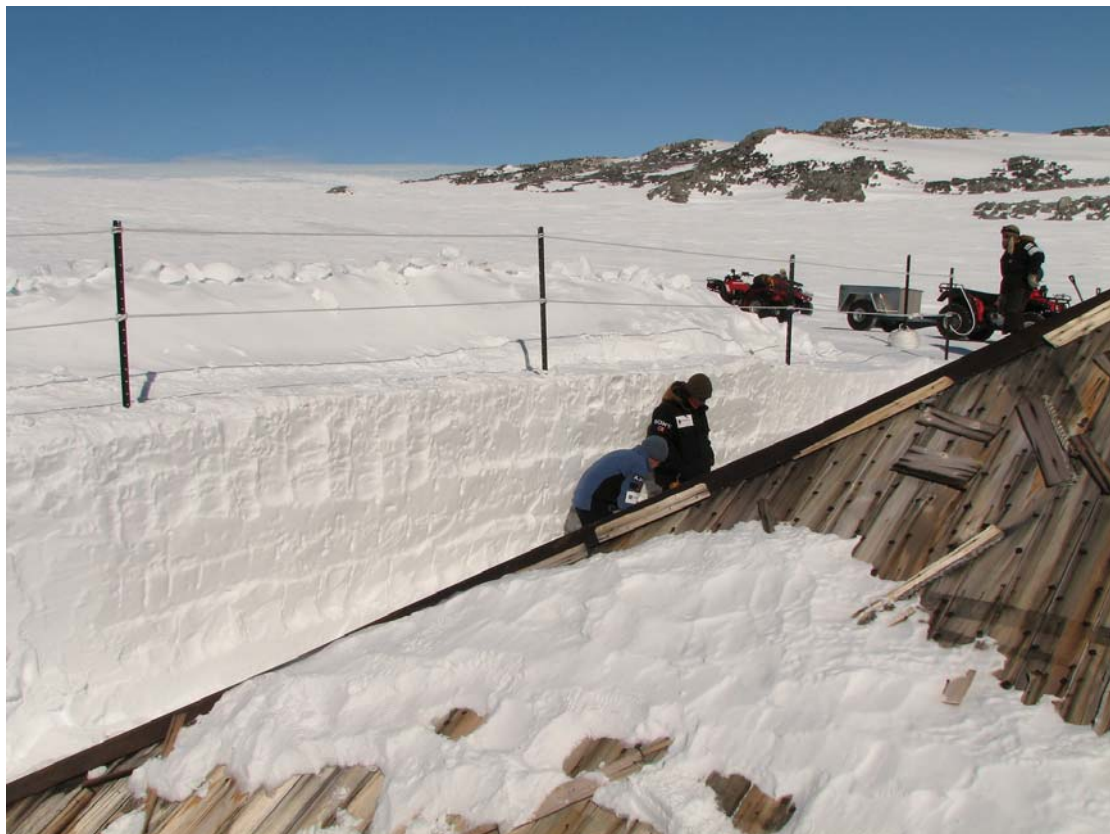
*Safety fence on the southern side of the Main Hut*

During over-cladding activities a trench approximately 1.9 m deep had to be dug to expose the southern roof plane, with shallower trenches on the eastern and western planes. A safety fence was constructed on the deeper eastern and southern sides.

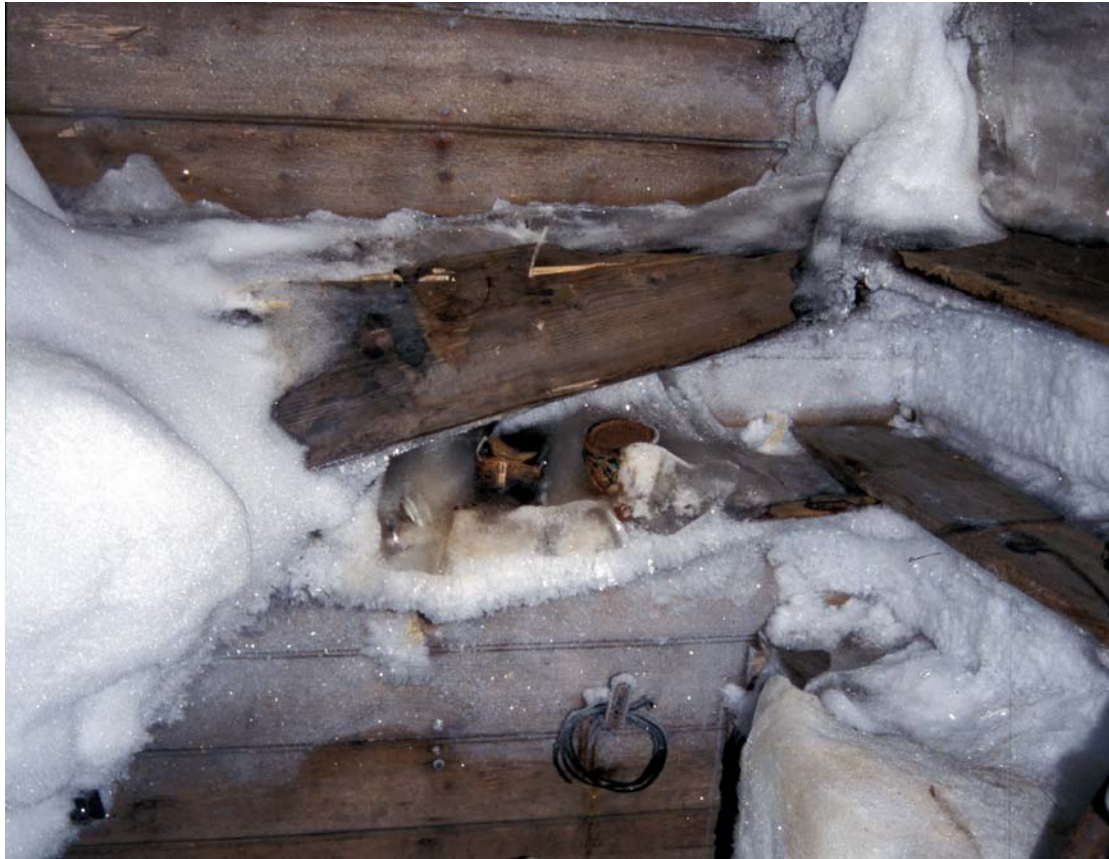
*Damaged and sloping shelving in the south east corner of the Workshop*

This recommendation applies particularly to shelves, many of which have been damaged by accumulated snow and ice buildups. Care is needed with this work as many damaged shelves still hold artefacts embedded in ice and snow (eg above Mertz's bunk, in the workshop etc).

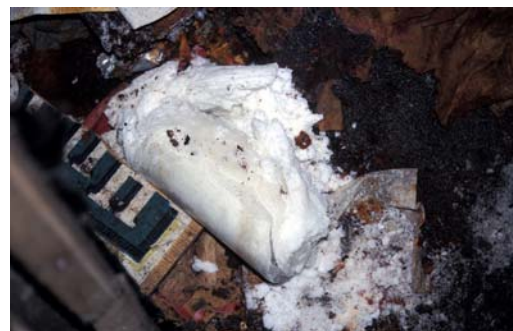
*Broken chemical jar, darkroom floor*

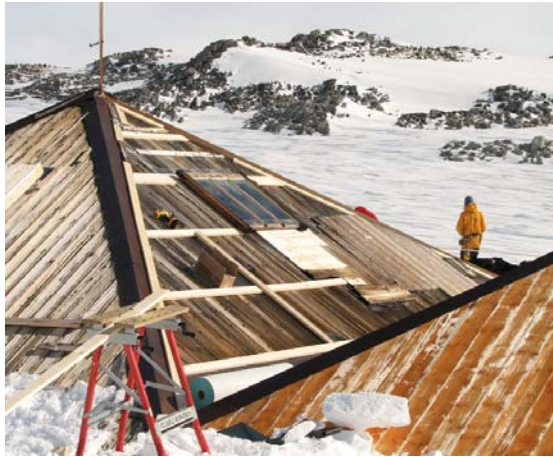
*Under battens – north roof plane*

The northern plane, being the smallest and most protected, was chosen as the starting point. The over cladding was carried out as per works plan which started with a layer of 20mm battens, then the membrane fitted with an appropriate lap, followed by the second layer of battens and finally the tongue and groove boards. The battens were fitted with a 100 mm 10 gauge screw which penetrated both battens through the original fabric and into the structural member of the hut roof. The cladding was fitted to the battens with a 50 mm class 3 coated Robertson type screw. Every fourth cladding board was fitted with a 100 mm class 3 coated Robertson type screw for extra bonding to the original plane. The quality of the Baltic pine tongue and groove appears to be expectable, as no major movement or shrinkage was observed after installation.

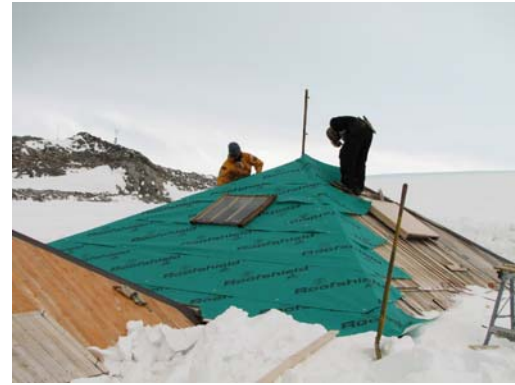
*Roofshield® applied to under battens*

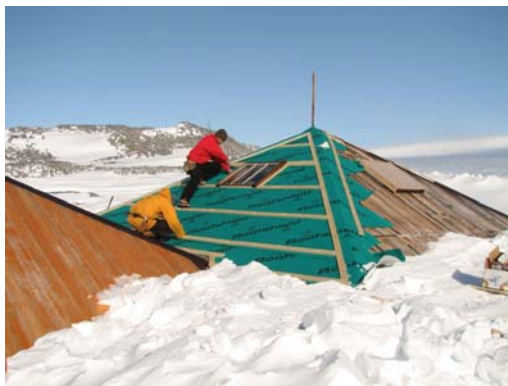
*Battens attached to Roofshield® membrane*

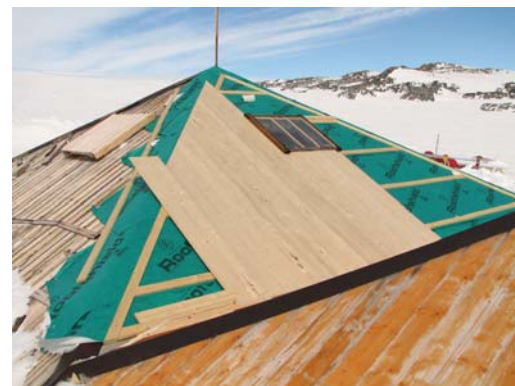
*Over cladding with Baltic pine tongue and groove timbers*

The three other planes were over clad in the same manner, followed by re-fitting of the skylights and hatches. A weather-proof membrane was fitted between the skylight and the new roof plane to minimize snow ingress. This was backed up by a Sikaflex bead.

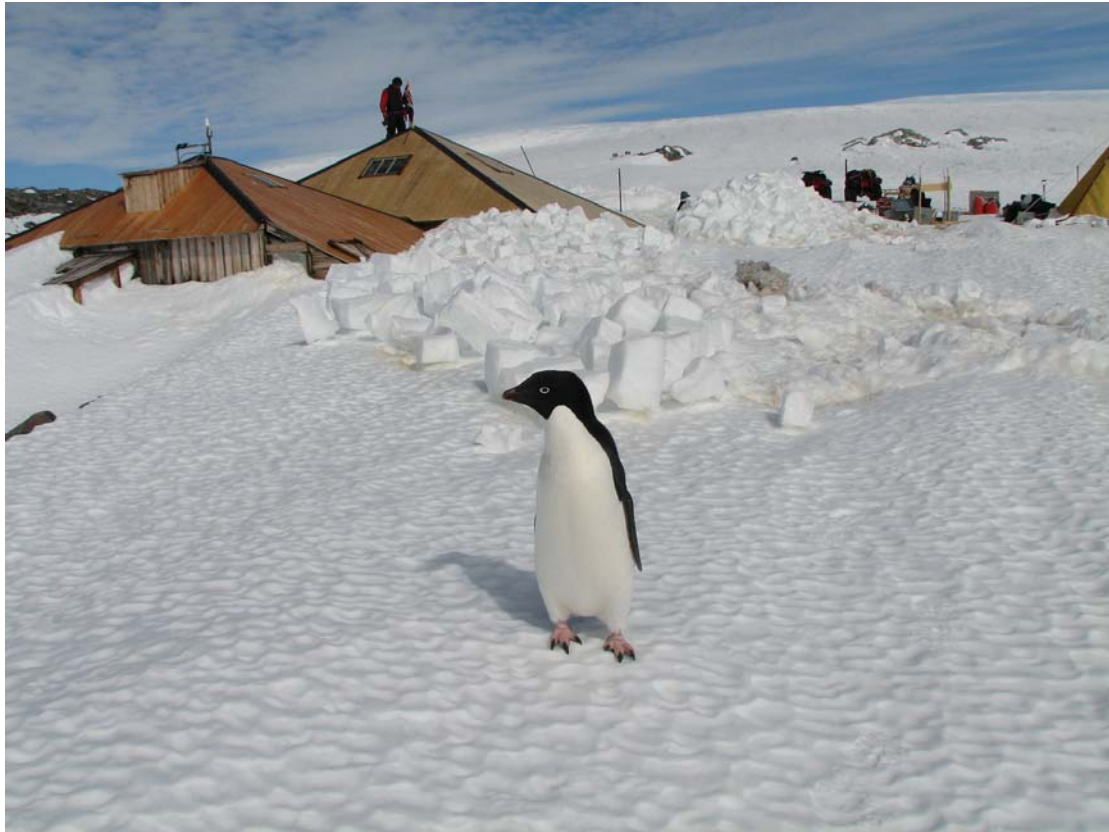
*Completion of over cladding and installation of replica flagpole at the apex of the Living Quarters*

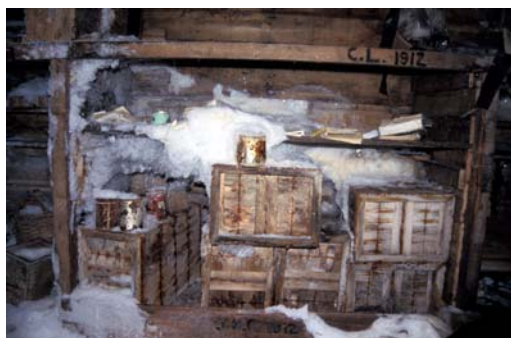
*Exposed artefacts under Laserson's 1912 bunk*

Old ice was removed from the eastern side of the main hut, exposing more bunks and artefacts upon these bunks. Approximately 4 cubic metres of old ice was removed from this section which uncovered artefacts not seen since work began in the 1970s. A small amount was also removed from the shelves in the kitchen (northern wall, living quarters). This removal exposed many bottles and other fragile artefacts. Special methods were used for extraction and more discussion must be undertaken before commencing future excavation.

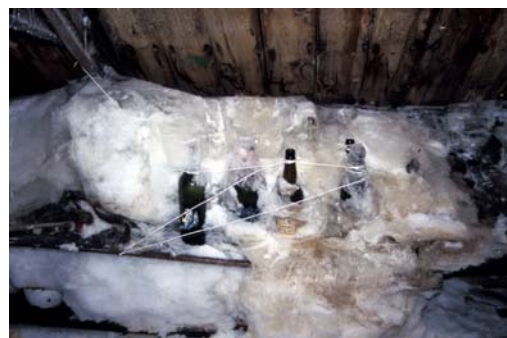
*Bottles exposed on upper kitchen shelf*

Clearly the two main issues with ice inside the huts can be defined as old ice, and its method of removal, and new ice, which needs monitoring and also prevention of further ingress. The artefacts and fixtures inside the hut are clearly suffering due to ice ingress. The forces created by this ever moving formation of ice are contorting shelves and the artefacts found on them.

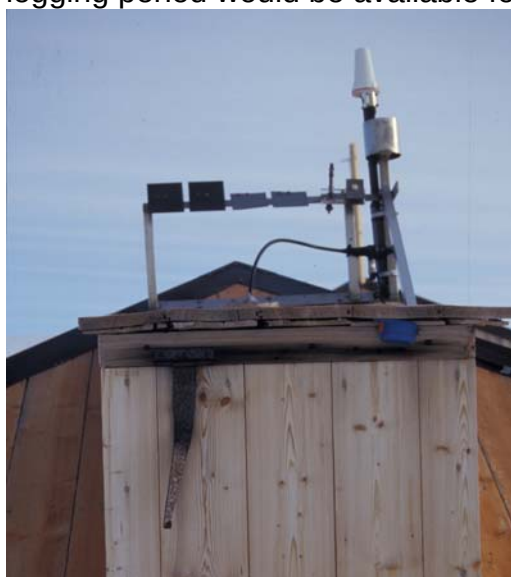
*Tinyview logger under ventilator eave*

The Australian and Western Australian Museums supplied Tiny Tag Ultra and Tinyview data loggers to monitor the external climate at Cape Denison and the internal environment in the Main Hut located at that site. Loggers supplied by the Australian Museum collected data for the duration of the current field trip while those of the Western Australian Museum were left on site to continue to collect data for either 422 or 368 days. All loggers were programmed to commence logging at 19.00, 23 November 2006 and were in place by that time and date. The WAM loggers 35, 36 and 38 were subsequently removed from their original positions and used to check the calibration of *in-situ* Vaisala loggers under ambient conditions and when in a low relative humidity environment created using silica gel. They were subsequently reprogrammed to collect temperature and relative humidity (RH) data for the coming year. Logger information and logging positions are given in Table 1 below. Data was downloaded from all loggers immediately prior to the end of the expedition and the loggers reprogrammed so that the maximum logging period would be available for all loggers left *in-situ*.

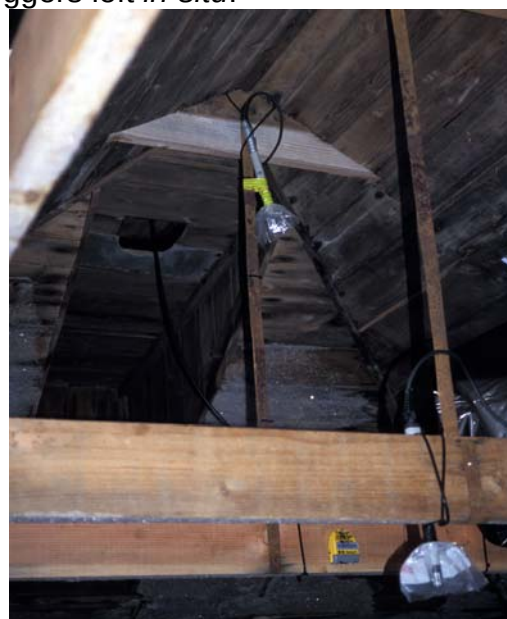
*Vaisala and Tiny Tag loggers in Workshop*

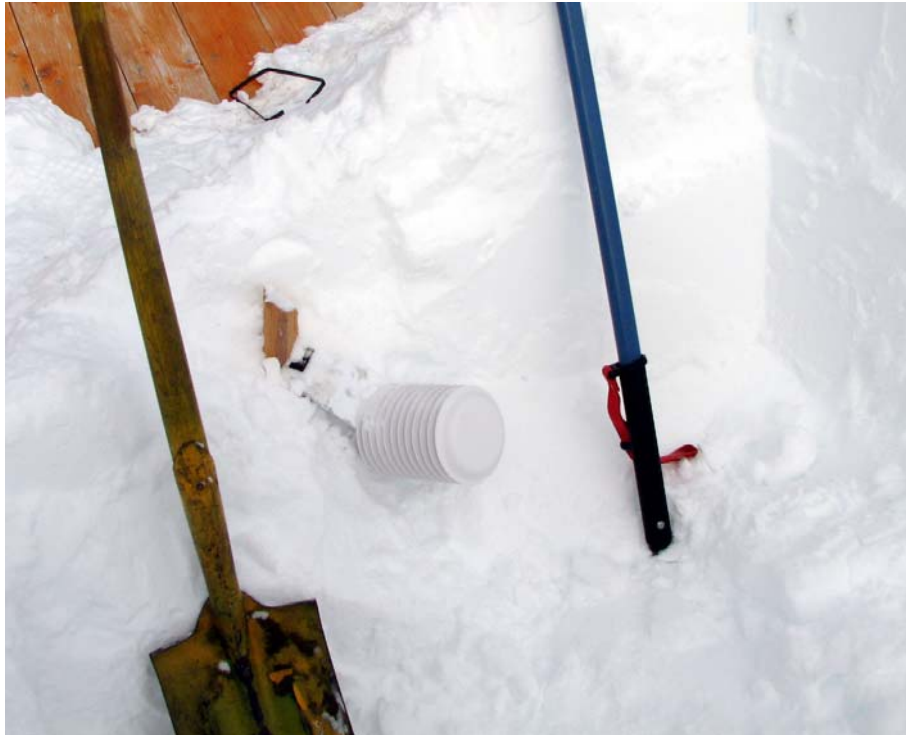
*Damaged sensor housing located above the Workshop door*

Eight Vaisala temperature/RH sensors were installed in a variety of locations during the 2002 expedition. Of these, two (#5, #7) were severed during the 2005 expedition when ice was removed to gain entry to the Main Hut via the workshop door. These sensors had been located at the NW corner of the workshop in order to monitor external climatic conditions. As a result of the damage to these sensors, T/RH sensor #2, formerly located on the west wall workbench in the workshop was relocated to an external position (December 2005)<sup>6</sup>, mounted on a timber pole to the left of the entrance door to the workshop, with the sensor tip protected in a radiation shield about 400 mm above the edge of the roof. Unfortunately, despite its newly elevated position, this sensor was embedded in snow and ice during 2006. When excavated it was found to have been severely damaged, presumably by the pressure of the covering snow and ice. The radiation shield and sensor were bent, almost at right angles to the post, movement that broke the sensor in half, irreparably damaging the sensor. The cable and sensor were removed from this location.

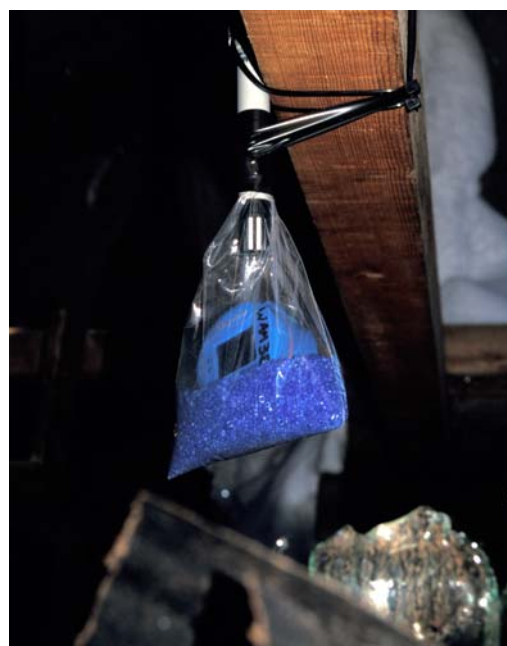
*Drying and calibration check of Vaisala sensor*

After approximately 3 days of drying in the low relative humidity environment created by the silica gel filled, sealed plastic bags, all sensors appeared to be functioning well, with this prolonged drying being particularly beneficial for sensors #1, 4 and 6.

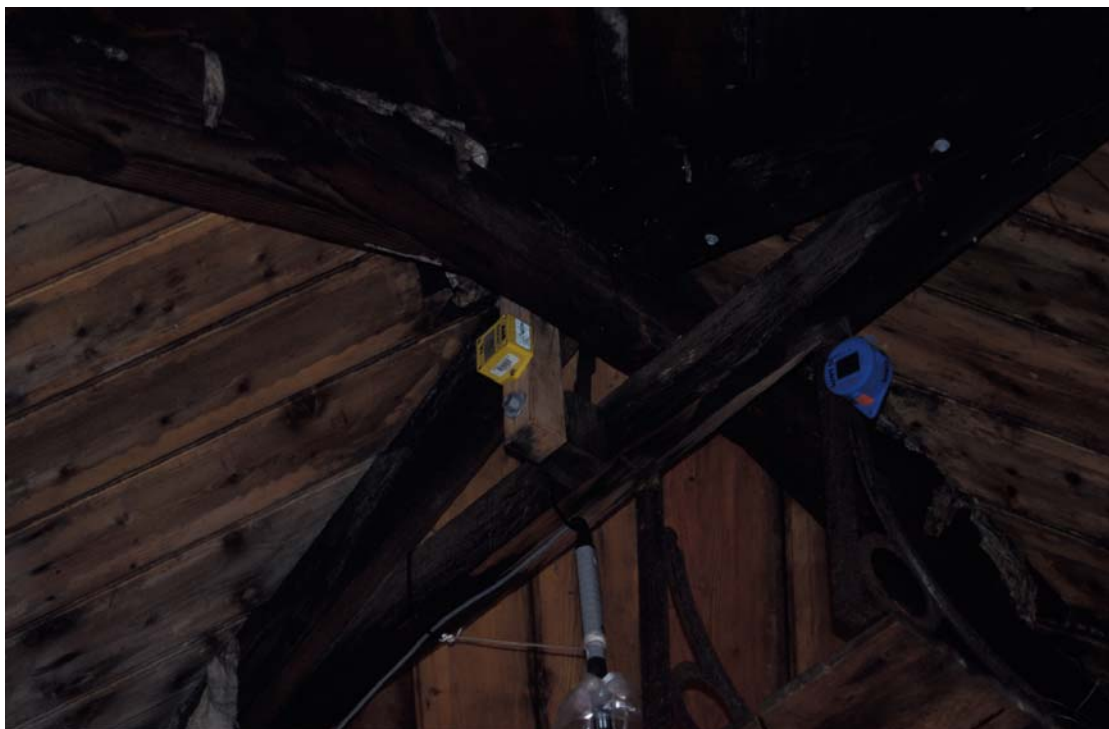
*Vibration, Vaisala and Tinyview data loggers at the apex of the living quarters*

Tape and cable ties were used to attach loggers to original building fabric while screws were used to attach loggers to non-original building materials.

Some of the vibration data collected during the expedition period is likely to have been compromised by over cladding and flagpole removal activities. Dates on which hammering may have affected data have been recorded as have been the ambient wind speeds for the duration of the expedition. These will be correlated when analyses are made of all the vibration data. An initial examination of this data indicated that the only significant vibrations were recorded when the replica flagpole was being installed, indicating that the vibrations were therefore due to hammering and not a reaction to strong winds. It is anticipated that the vibration loggers located near the electroscope housing will be the only ones affected by work-related activities.

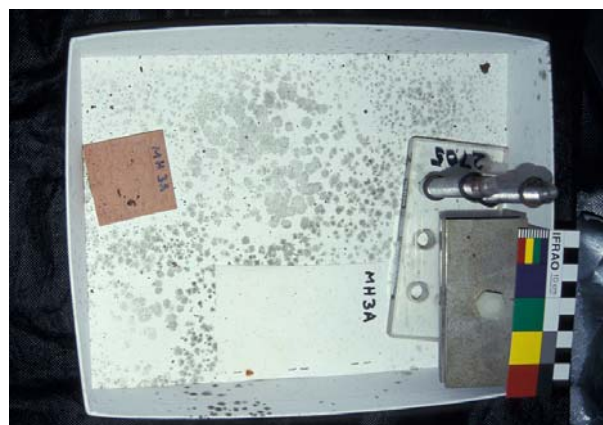
*Artefact tray showing mould growth*

Samples were taken using a sterile swab (Transwab® for aerobes and anaerobes) supplied by Professor Tom Riley of the University of Western Australia. Sample descriptions and locations are given below (Table 5).

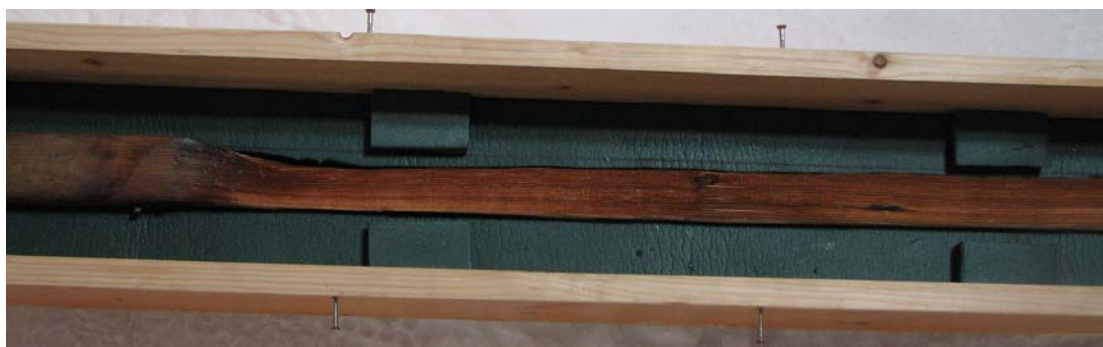
*Flagpole packed for RTA, showing abrasion at the roof line junction point*

- A pine box was constructed to hold the pole.
- The base of the box was lined with foam cut from a standard 'roll mat'.
- Two pieces of roll mat were cut to fit the box, with the central part of each of the mats cut to match the profile of the pole. This allowed the pole to be supported while restricting any lateral movement. These mats were glued in the box using silicone (acetic acid cure).
- Small roll mat blocks were cut and glued in the base of the box and to its lid. These were designed and cut to thicknesses such that they fitted snugly, just above the surface of the pole, to prevent its movement should the box be tipped upside down.
- The lid was screwed closed, using Robinson screws, with a driver bit secured in the lid of the box.

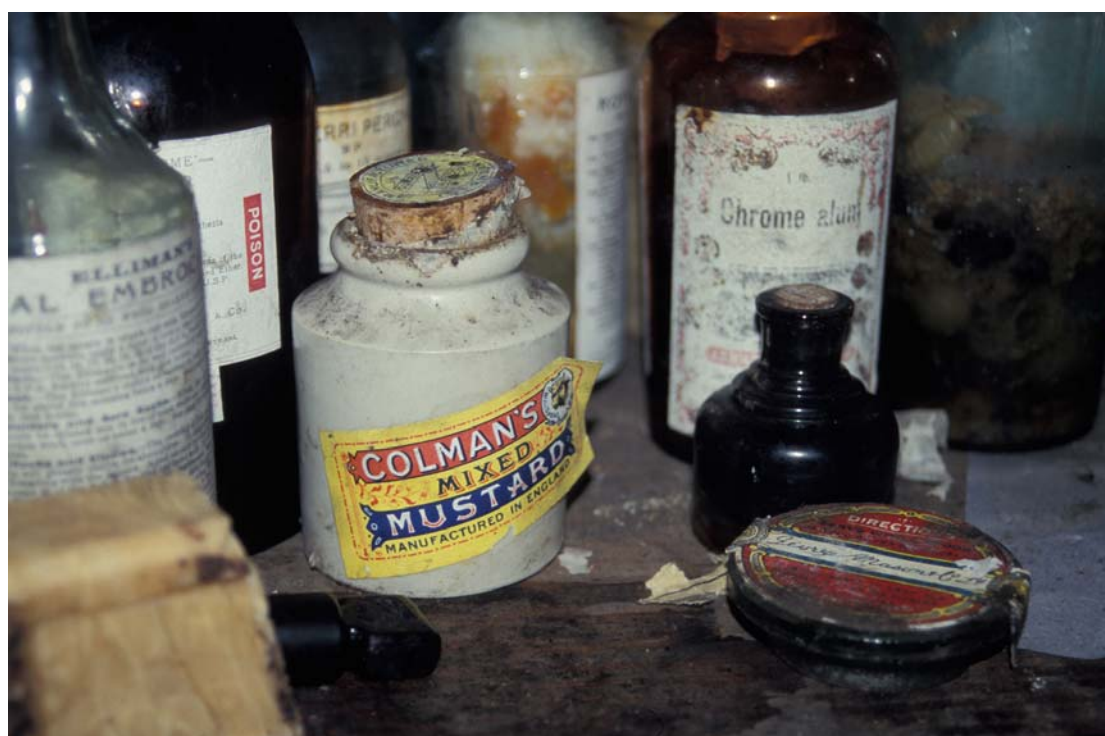
*Chemicals and condiments on McLean's 1912 bunk*

The presence of snow and ice and lack of time inhibited a more thorough examination. As a result, while many containers were observed, it was not always possible to determine if they were empty or still contained residues of their original contents. Bearing this in mind, materials that were noted during this survey include the following:

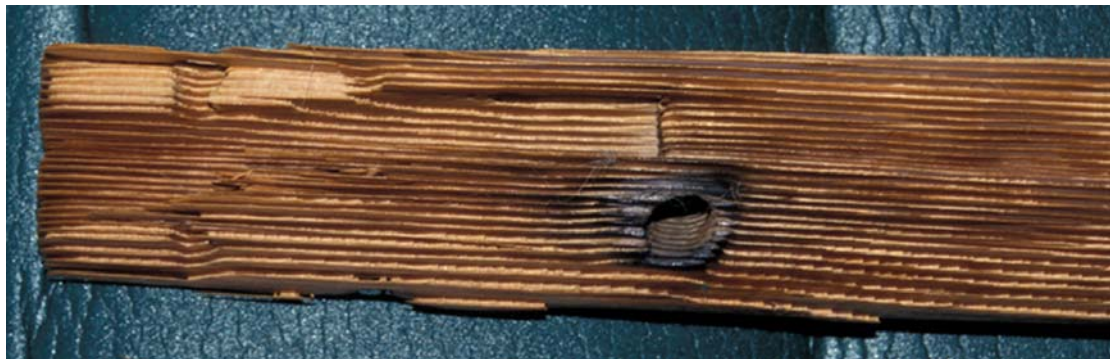
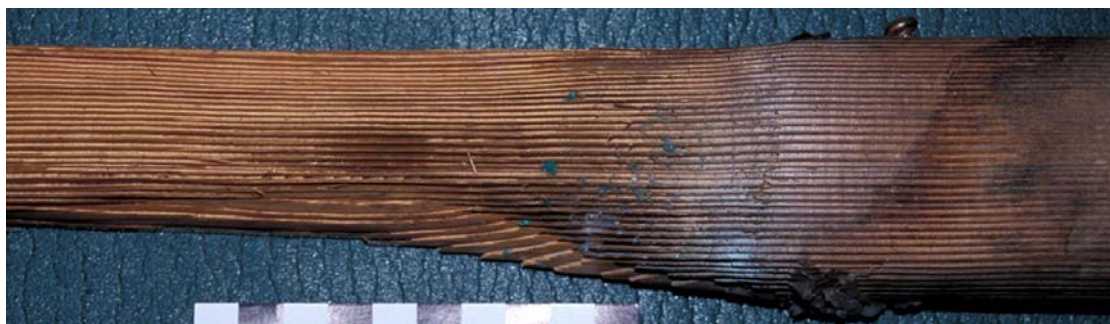
### Southeast face:

Flagpole showing areas of recent loss and abrasion from SE face

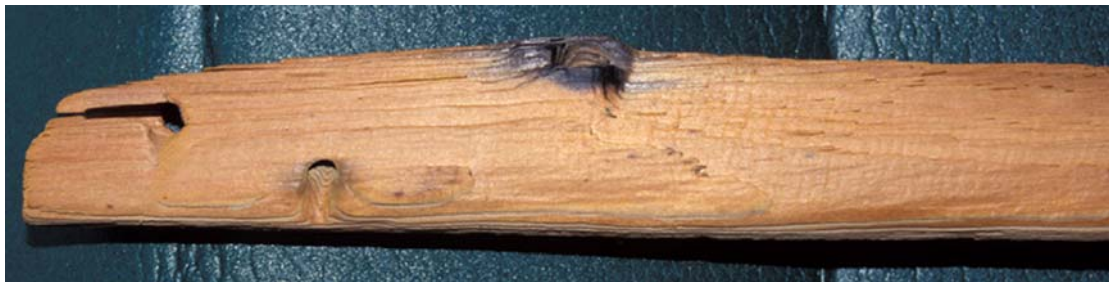
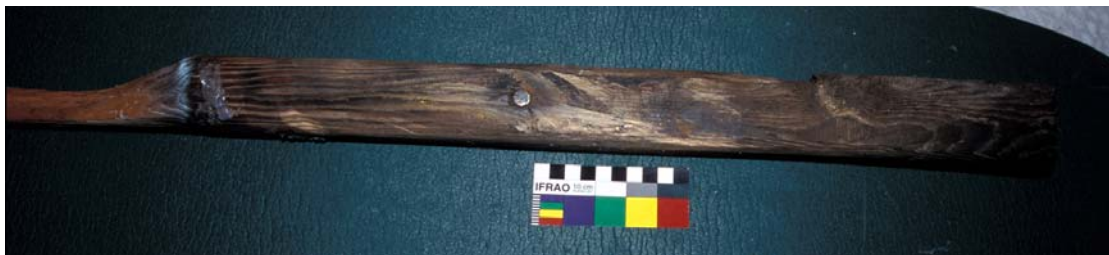
## Southwest face:

SW face of the flagpole showing the extent of wood loss at the roof line junction and the physical protection afforded by the former metal fitting at the upper part of the pole

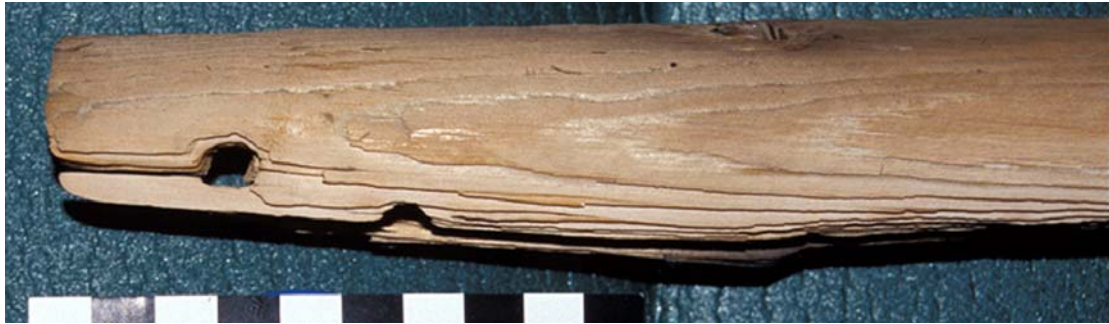
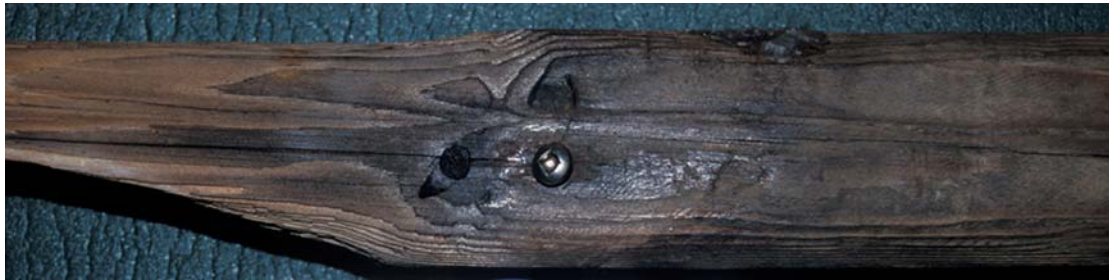
## Northeast face:

NE face of the flagpole showing historic and modern fastenings (tack and screw respectively) used to attach flashing at the apex

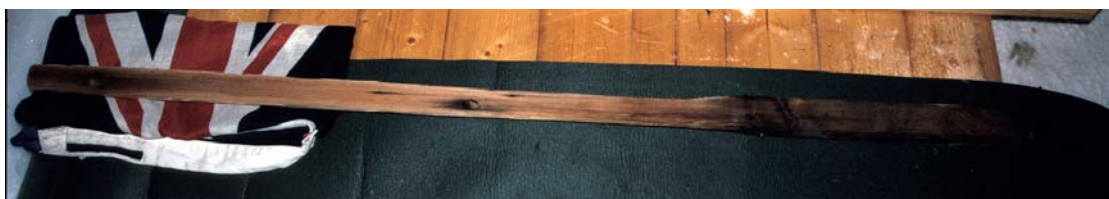
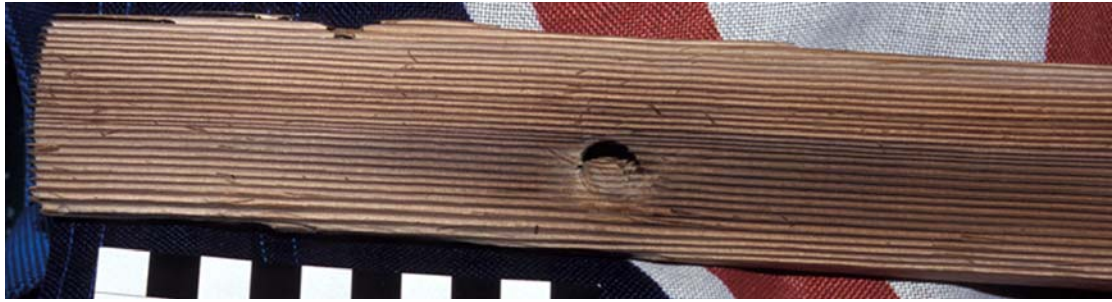
### Northwest face

*NW face of the flagpole showing abrasion and upper bolt hole*
