MAWSON'S HUTS CONSERVATION EXPEDITION 2002

EXPEDITION REPORTS

CONSERVATION ARCHITECT'S REPORT

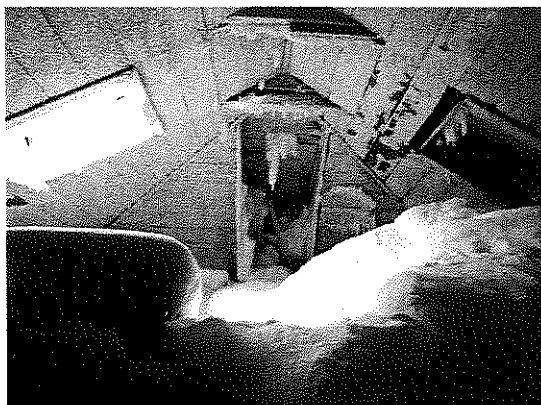
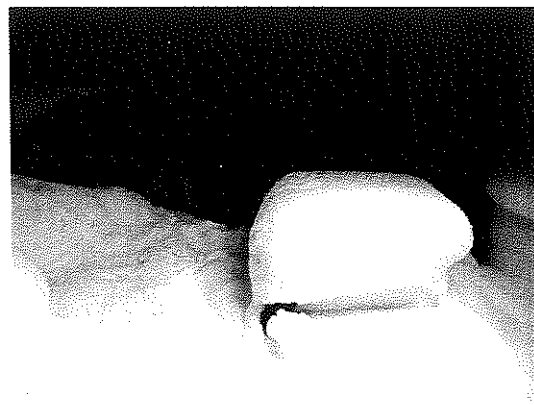
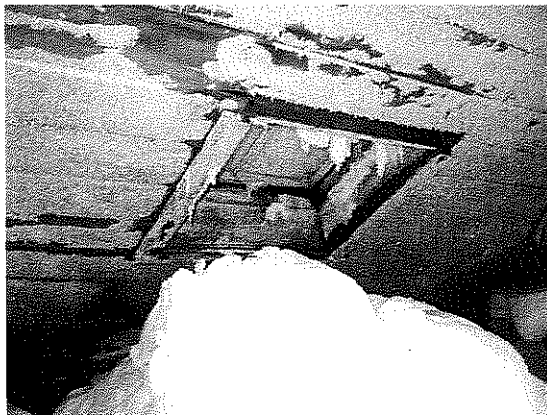
3. The largest deposit within the Workshop was along the eastern wall. Evidence suggested that the snow had entered the roof space (between the ceiling and roof cladding) along the northern wall roof junction and entered the interior via the collapsed section of ceiling lining to the east and north wall.

4. Only a small amount of material was deposited on the wet wall. The same mode of ingress as 3 was apparent.
5. Large sections of solid melt ice were experienced in the roof space to the southern roof plane, these deposits possibly dating back to pre over-cladding of the roof. The remainder of the roof contained only recent deposits of soft snow /ice. It is assumed that the solar gain to these planes ensures that the snow / ice melts and ice does not accumulate.

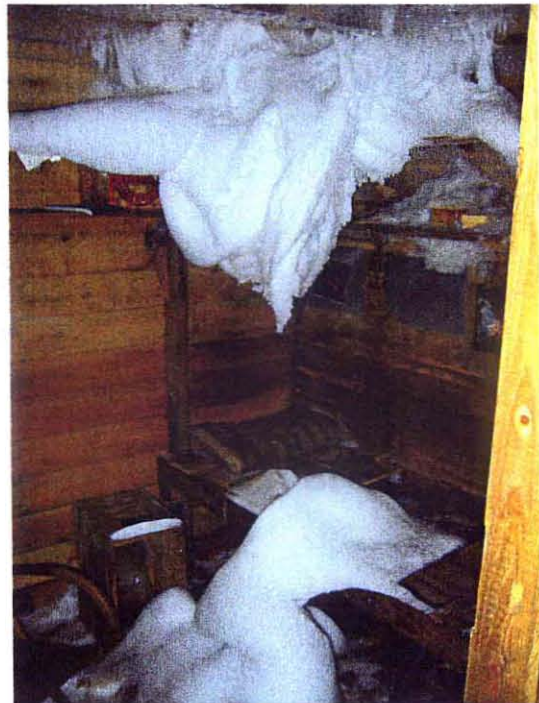
SOUTH – EAST CORNER MAWSON'S ROOM

5. An accumulation continues here similar to the southwest corner although in greater volumes.
6. A significant accumulation of snow / ice forms and suspended by the shelf in the southeast top corner of Mawson's Room. Recent expeditions have also removed this deposit. It is apparent that this snow comes via the verandah space through the wall roof junction.

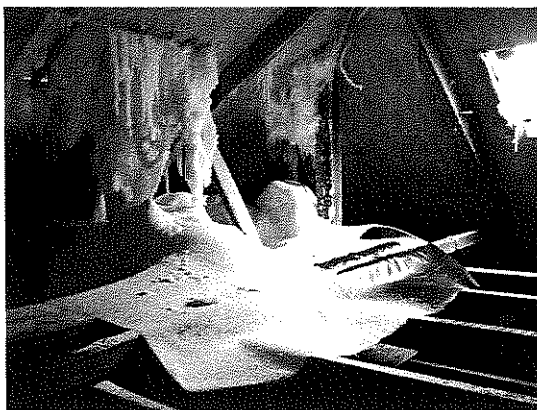
SNOW / ICE ON TOP OF MAWSON'S ROOM

7. An accumulation of soft snow / ice was recorded on top of the dark room. Failure of some of the new cover battens was identified as the most likely source.

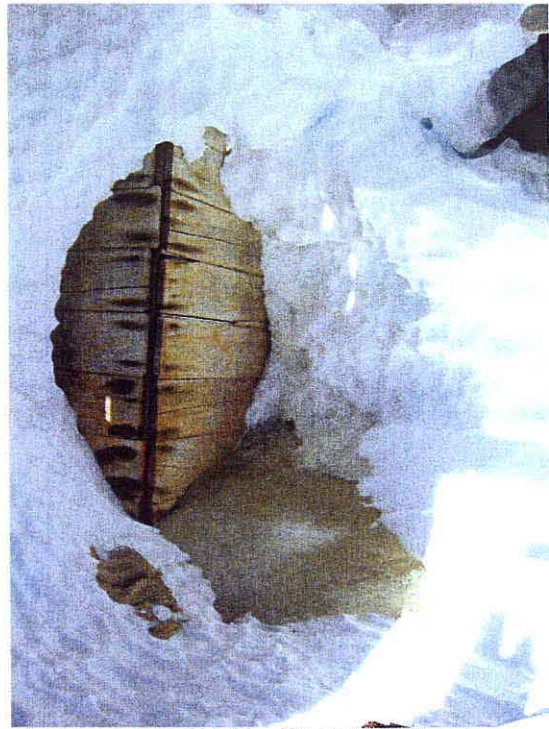
VERANDAH SOUTH – WEST CORNER

1. Ice excavated to gain access to the interior of the Main Hut
2. Area ablated due to wind action through the south wall.

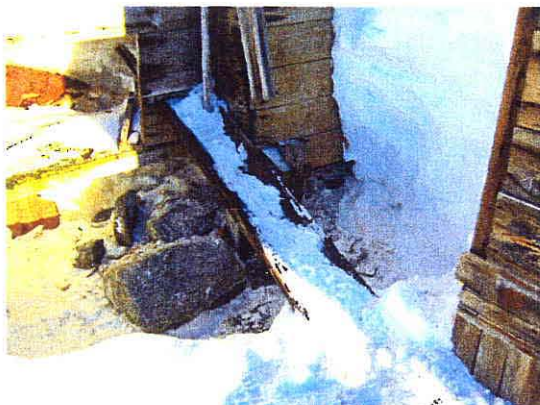
EXCAVATION – N-W CORNER LIVING
QUARTERS

The snow and ice has been excavated to expose the top of the footing and corner post, fixing stumps for the building and floor framing.

Excavation did however only achieve the removal of 1x 'footing' rock. All remaining rocks (varying in size from medium to large) were firmly embedded in ice and despite considerable force (short of causing fracture and/or significant damage to the rock itself) would not budge. All further attempts to dislodge these rocks were abandoned subject to further melt of the surrounding ice. No significant change in this was experienced for the duration of this expedition.

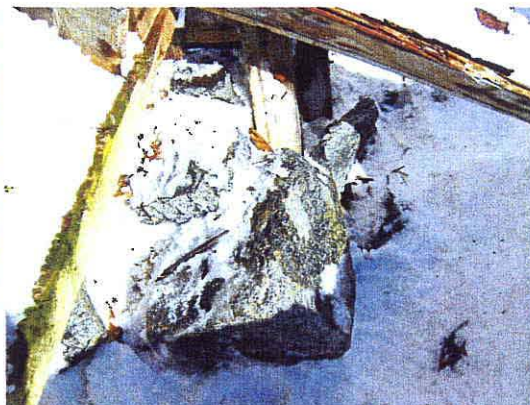
ROCKS EMBEDDED IN ICE AT BASE OF
FOOTING

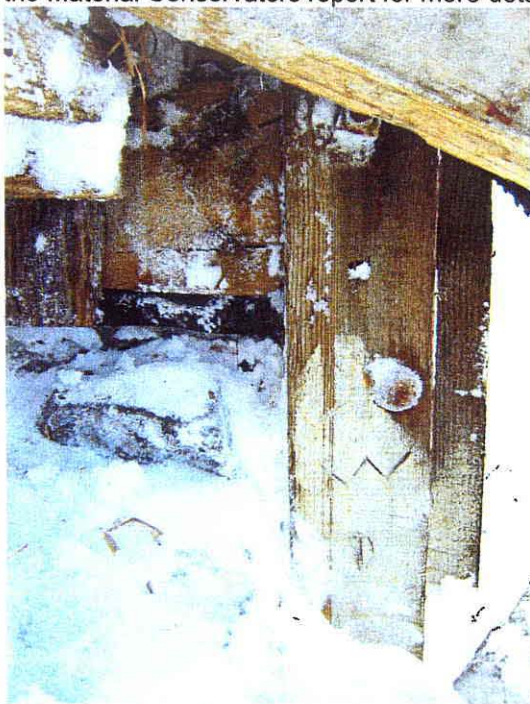
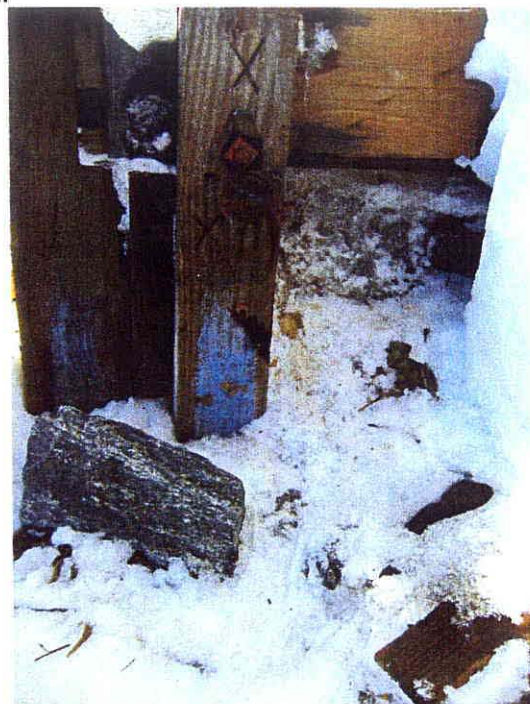
The construction / framing system employed for the Main Hut is clearly evident and was documented. The system revealed is consistent with previous descriptions and photographic evidence. The photographic evidence clearly supports the use of the same system along each wall line.

The condition of all exposed timbers (including stumps into the footing ice) and fixings appear in good condition and are consistent with conditions in the remainder of the Huts. Refer also the Material Conservators report for more detail.

Solid ice was been encountered under the floor structure of the Main Hut at this corner. This ice is above the level (approx 300mm) of the surrounding melt ice level encountered. This profile could suggest that the ice under the floor structure has not experienced any significant melt in recent time (eg during the Ian Godfrey visit). This could however only be tested by taking ice samples for further analysis.

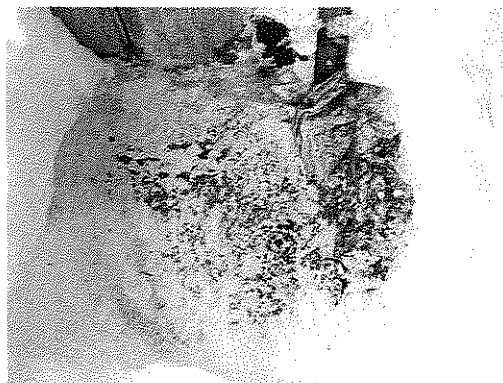
ARTEFACT DETAIL

A deposit of organic material and bagging has been encountered at or about ground level. Following an inspection by Archaeologist it was agreed that any further excavation at this location be abandoned subject to conditions at the remaining 2x locations. Given the problems experienced during excavation at first location no further work was undertaken here.

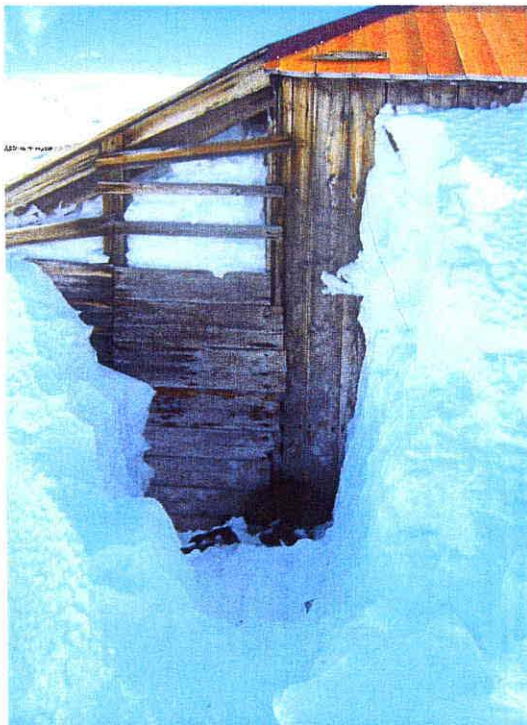
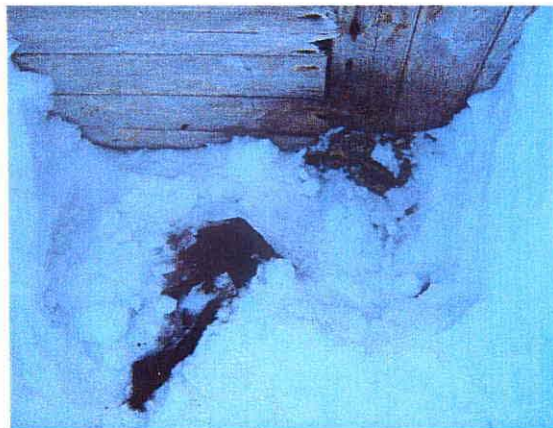
**EXCAVATION – N/E CORNER
WORKSHOP**

Excavation was commenced but only taken as far as the melt ice level. A wooden box and metal container were encountered in the vicinity of the footing requiring excavation. A deposit of organic material also lay at the base of the post.

Given the unlikelihood of being able to undertake any significant excavation as per Excavation 1 a decision was made not to proceed and all artefacts were left in place.

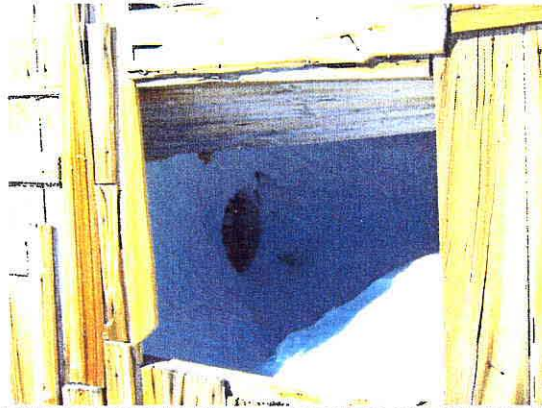
VIEW TO SOUTH WEST CORNER OF LIVING HUT

This corner is in the inside of the verandah surrounding the Living Quarters and remained full of snow and ice for the duration of the expedition. A decision was made to leave this excavation until more of the existing snow/ice had ablated but little change was experienced. It is also clear from photos that this corner of the building contains many artefacts and excavation will be a delicate proposition.

No further attempts were made to excavate at this location.

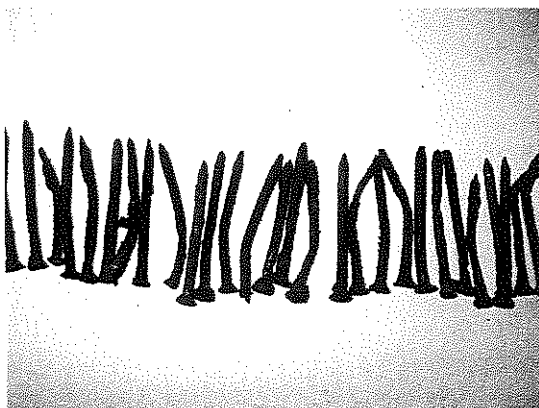
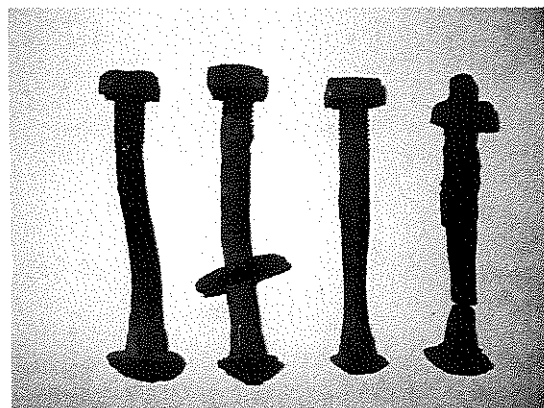
All materials and connections inspected were in good condition and performing their function adequately. Bolts retrieved from the collar ties indicate nominal corrosion but not sufficient to effect their performance. The level of corrosion is consistent with bolts removed during the replacement of beams etc in the Living Quarters (some stored on the platform of the Hut and others under the Granholm). Nails retrieved during ceiling removal also indicated a level of corrosion but not sufficient to effect their performance in securing the ceiling lining as a shear plane.

Samples of both bolts and nails were collected for further analysis.

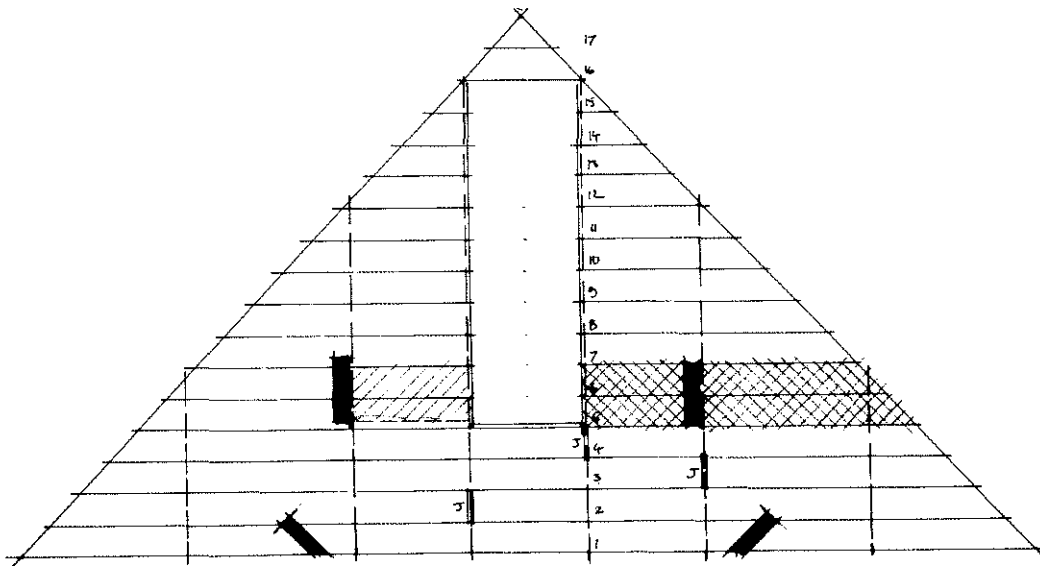
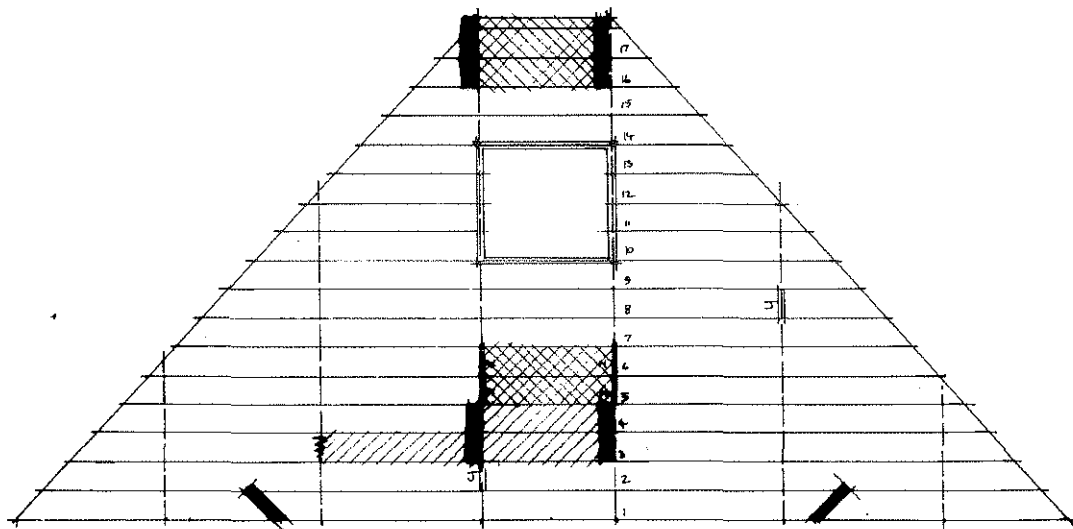
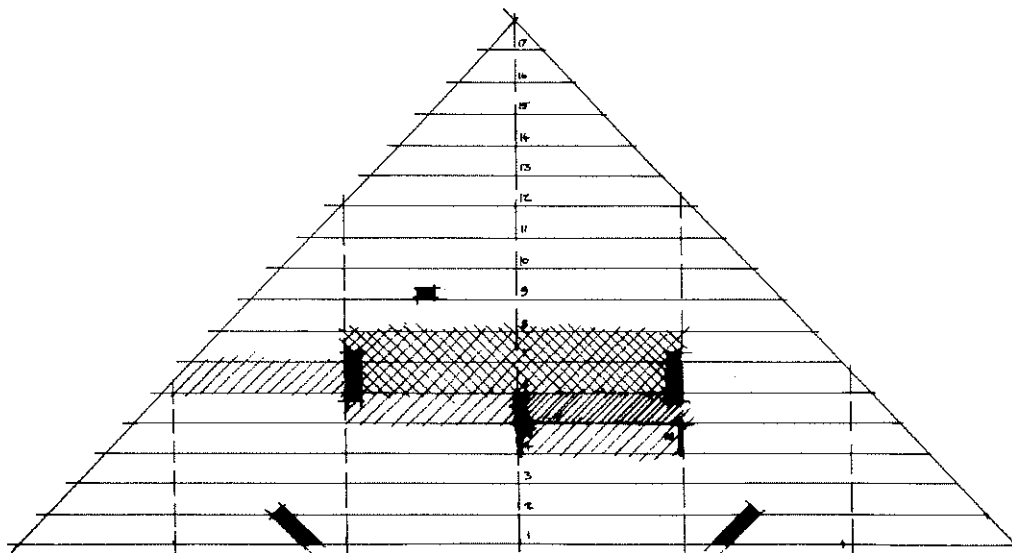
Where possible advantage was taken of existing jointing in the boards to restrict the amount of material to be disturbed. A number of new cuts were however required as shown on the following plans.

During this stage it was noted that a number of boards had clearly been refixed at some stage. Different fixing nails and evidence of the tongues of a number of boards suggested that these boards were the boards refixed in 1978. A full investigation of the extent of this work was not undertaken.

NEW CUT MADE TO FACILITATE STRUCTURAL PROGRAM.

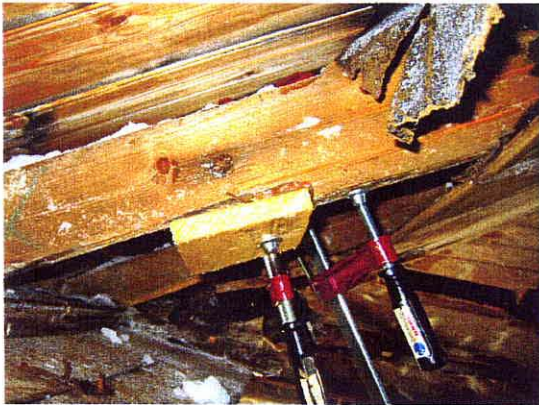
SECTIONS OF RAFTER RECOVERED AND ORIGINAL LOCATIONS DETERMINED

- Broken sections of the rafters were located and their original location determined
- Sections and splits in timber were glued and clamped until set
- Tek screws were installed to strengthen the glued joints
- A new section of rafter was glued and stitched with tek screws to the side of the repaired rafter.

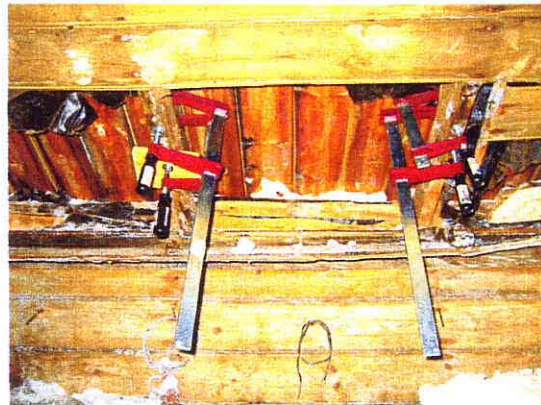
SECTIONS AND SPLITS IN TIMBERS GLUED AND CLAMPED

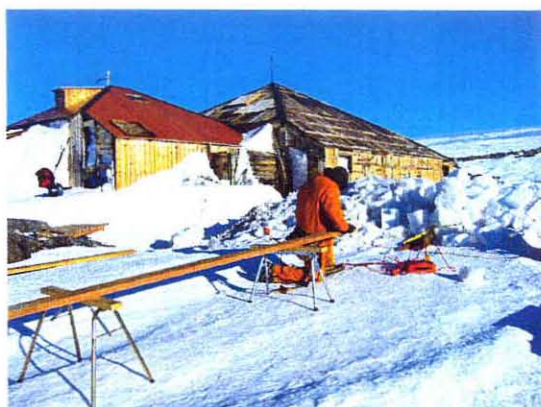
CUTTING NEW TIES OUTSIDE

4X new collar ties were installed using timber and section to match the original. No removal of the external roof cladding to either access the rafters and/or the delivery of the lengths of timber was required as suggested in the Works Plan. Timbers were cut to length outside and delivered successfully through the western skylight on the roof.

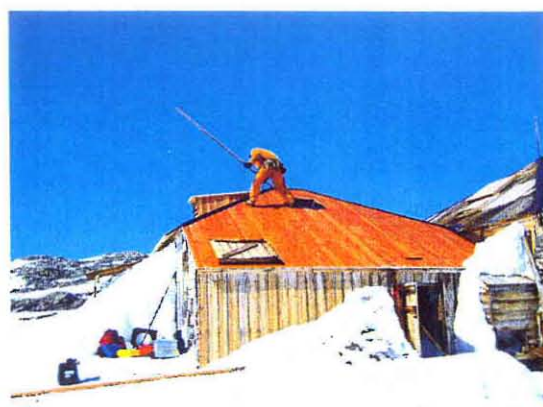
DELIVERING NEW TIES THROUGH SYKLIGHT

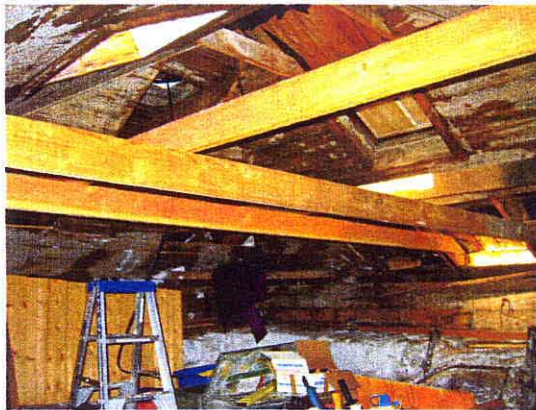
NEW LOWER COLLAR TIES IN PLACE

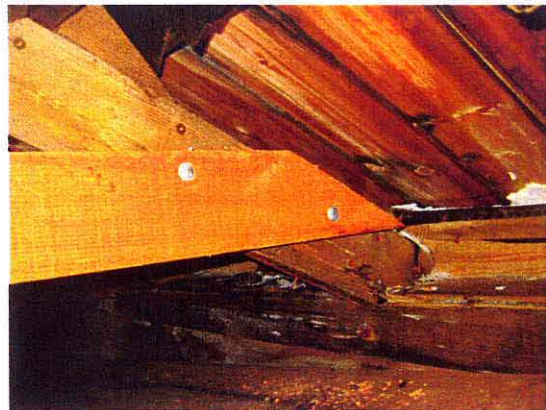
FIXING OF NEW TIE TO RAFTER

The collar ties were fixed to the rafters with 2X 12mm new galvanised bolts to match the original. Bolts were installed each side of existing bolt hole to improve the strength of the connection.

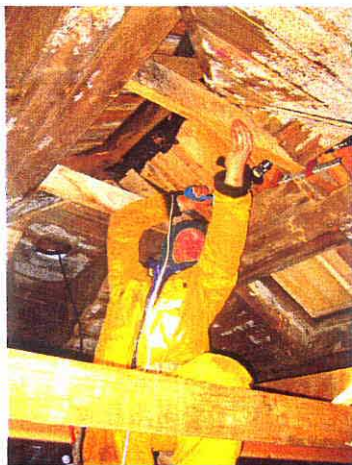
INSTALLING NEW APEX COLLAR TIES

The existing apex collars ties were removed and ties installed to match the existing timber and section. The ties were bolted to the rafters using 2X 12Mmm new galvanised bolts to improve the strength of the connection.

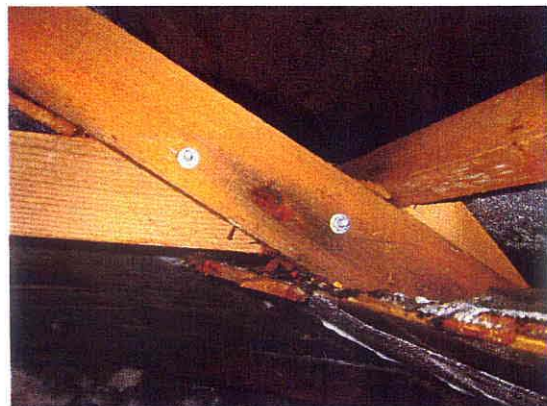
FIXING OF NEW TIE TO RAFTER

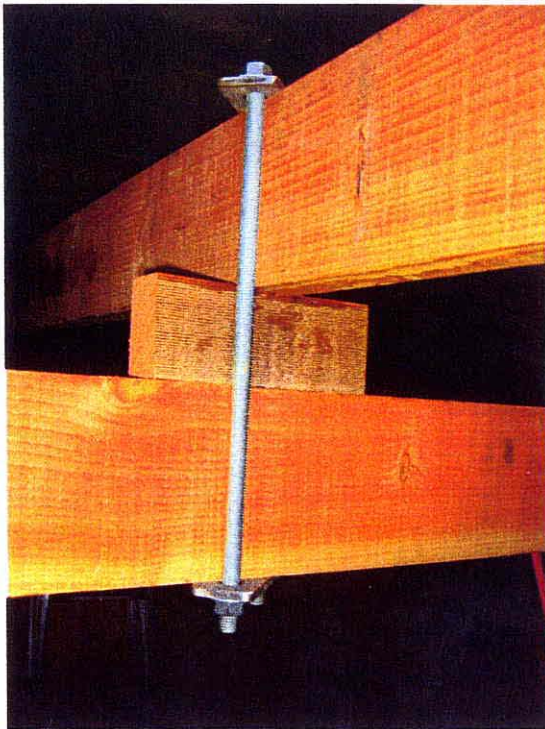
INITIAL BLOCK AND 'U' BOLT INSTALLED

New spacer blocks and 'U' bolts fabricated from stainless steel rod (to accommodate the additional length required to span the spacer) were initially installed to complete the structure. When the original material was recovered during the second stage of ice removal these elements were reconditioned and installed.

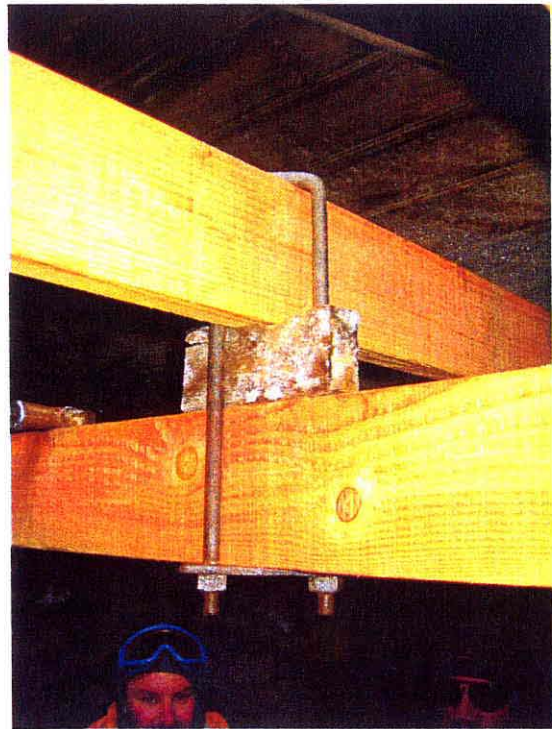
ORIGINAL BLOCK AND 'U' BOLT
RECOVERED AND REINSTATED

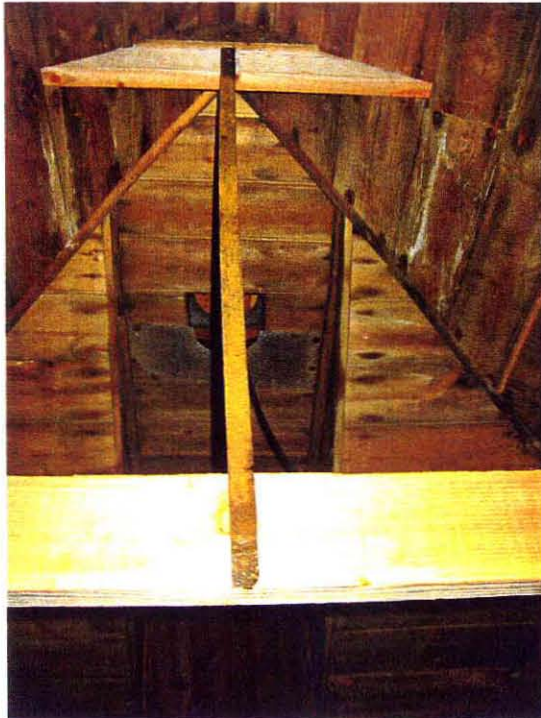
ORIGINAL STRAP REINSTATED

Straps were refixed using stainless steel tek screws.

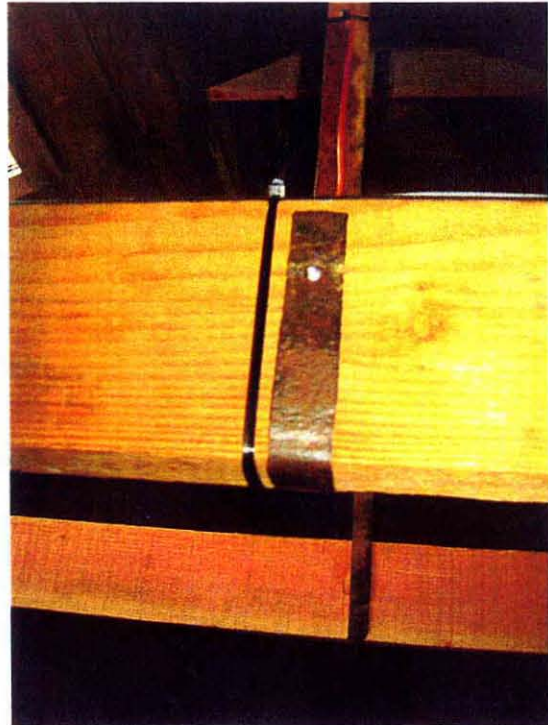
DETAIL OF STRAP FIXING WRAPPED UNDER COLLAR TIE

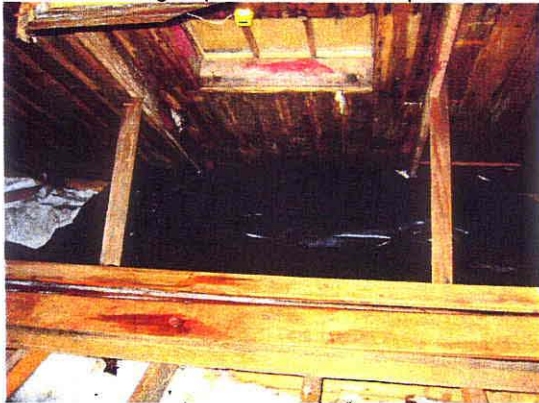
SHEET ON TOP OF MAWSONS' ROOM

Black plastic sheeting was installed in both the Workshop and the Living Quarters where snow ingress was most likely to occur to be able to more accurately determine the source, measure the volumes being experienced and to protect vulnerable artefacts inside the hut.

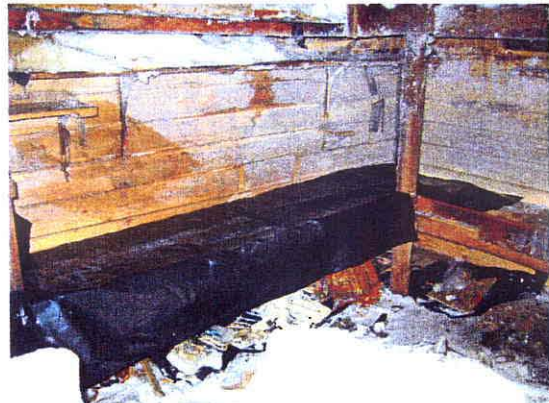
SHEET ON BUNK IN S-E CORNER

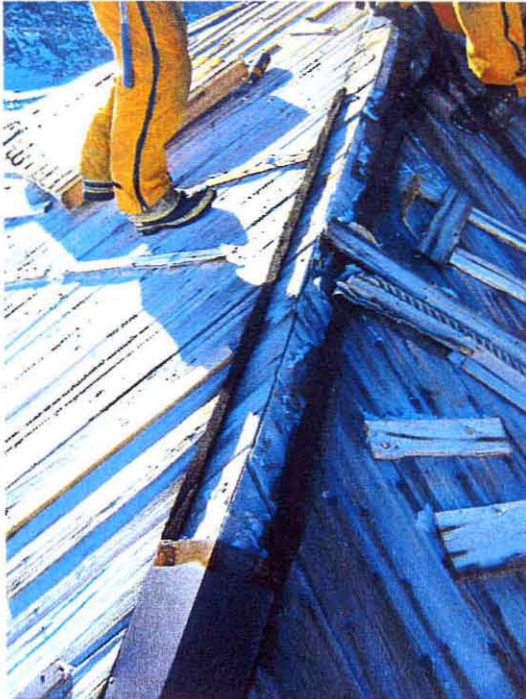
In most instances the foam did press tight into the gaps in the roof boards but it is noted that in some instances the gaps were sufficiently wide and long enough that the foam will only be partially successfully in preventing any further ingress. Refer also above for general comments on the roof repairs.

FOAM STRIPS IN PLACE FOR CAPPING TO BE FIXED OVER

Ridge capping to the Living Quarters was removed and a strip of bituminous impregnated foam was carefully secured along the line of the edge of the capping to ensure none was exposed after refixing the cap. The cap was resecured with the same stainless steel screws.

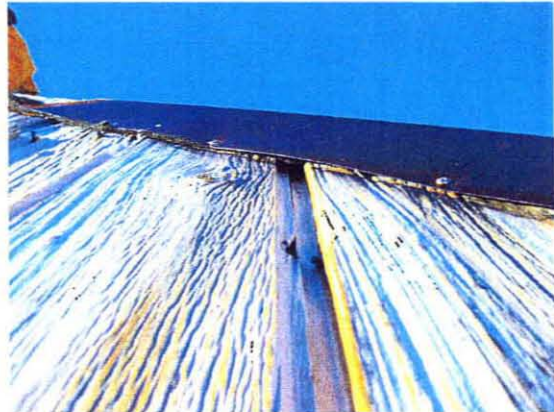
DETAIL OF FOAM PRESSING INTO GAPS

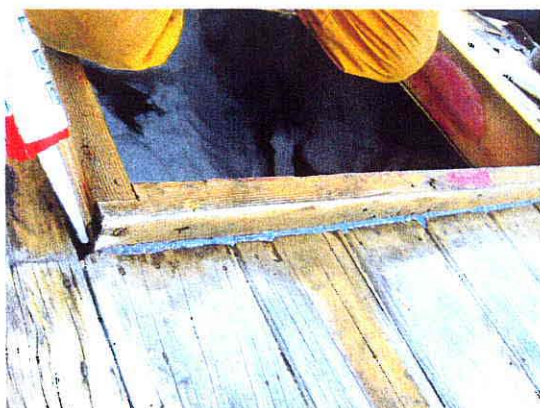
Observations made during the 2000-01 Expedition identified melt water dripping from the skylights to the Living Hut and resulting stalagmites forming below these points inside the Hut. The Works Plan adopted the recommendation from this expedition to install flashings to apex side of all of the skylights.

LEAD FLASHING TO APEX SIDE OF EAST SKYLIGHT

A sheet of 300 X 3mm lead sheet was installed to the apex side of all four skylights. The lead was formed around the corners of the skylight to run water away from the side junction of the skylight. The lead flashing was secured with stainless steel screws and over battens as shown below.

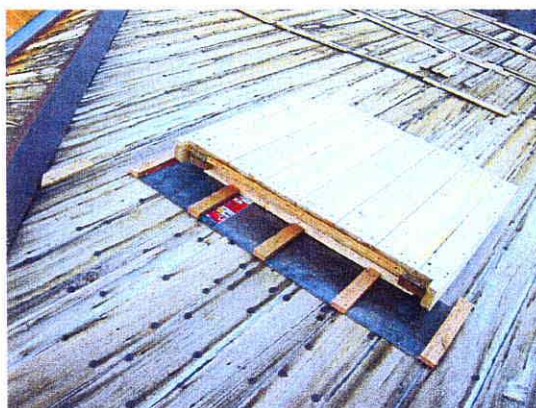
OVER BATTENS AND REMNANT CANVAS REPLACED AND REFIXED TO SOUTH SKYLIGHT

All side and edge battens were removed to facilitate the installation and to allow sealing of the junction with silicone. Battens (and any associated fabric) was then refixed to its original location.

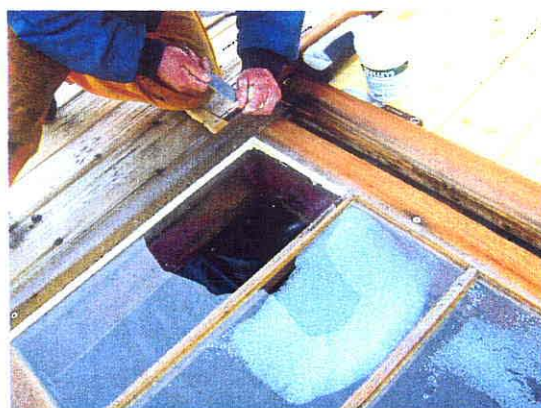
The puttying of the glazing to the skylights of the Living Quarters had commenced during the 2000-01 Expedition but not completed.

PUTTYING TO EAST SKYLIGHT

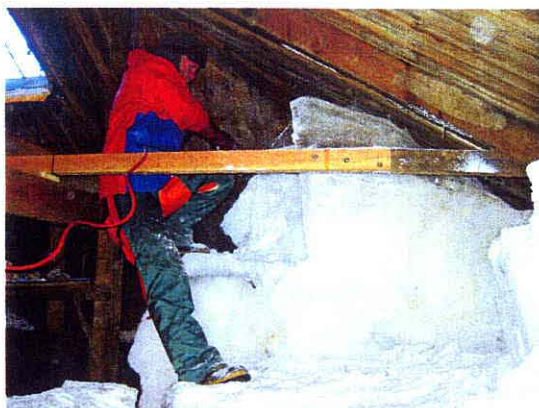
REMOVAL IN PROGRESS WITH FINISHED LEVEL AT THE BOTTOM OF IMAGE

1. Above Kitchen Area. Approx 2 cubic meters of ice was been removed from on top of this area to provide access to a section of the ceiling adjacent to stove flue that has been dislodged. Excavation was taken to approx 600mm below the collars ties. It was noted on removal of this ice that sections of the ceiling boards have been dislodged. It is recommended that these boards be refixed to assist in the sealing of the roof.

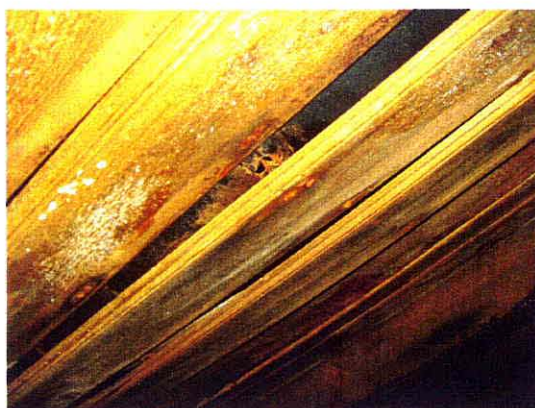
DISLODGED CEILING BOARDS

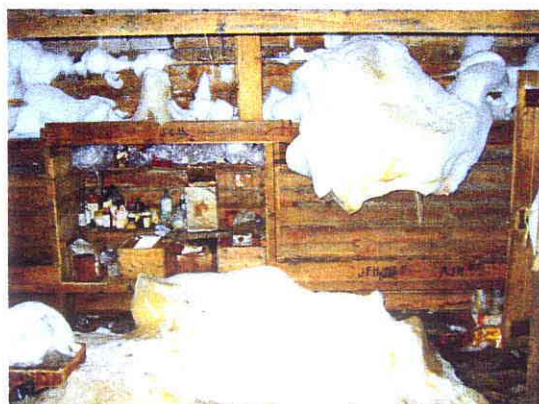
BEFORE

Approx. 1 cubic meter of ice was removed that was entirely suspended from the centre of the upper bunk.

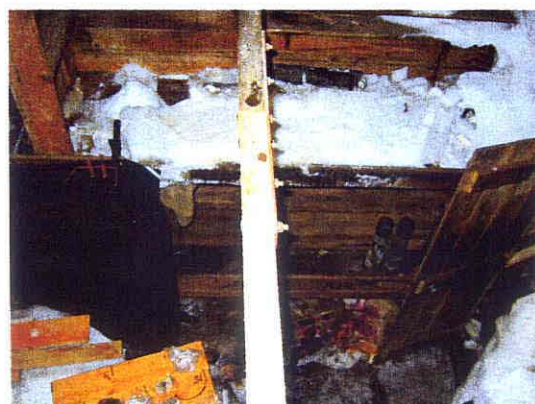
AFTER – NOTE LAYER OF ARTEFACT RICH LEFT REMAINING ON HURLEY'S BUNK

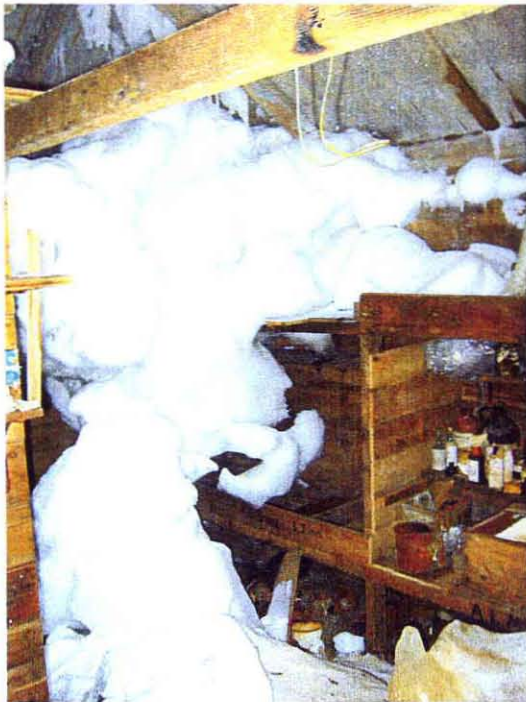
BEFORE

3. Upper Bunks in the south west corner. Approx. 1.5 cubic meters was removed for the same reasons as above. Removal of ice from this area also allowed access to inspect the southern wall / roof junction for possible leaks. Refer Section 11.5.

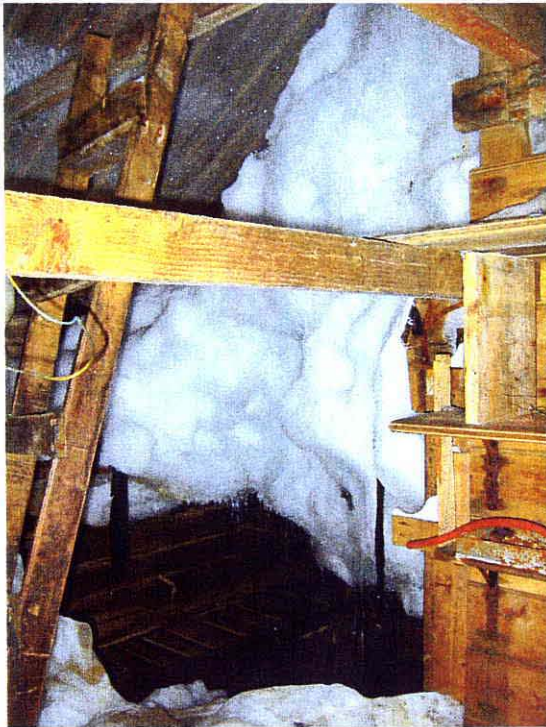
This ice mass was suspended between the bunks in the corner and the top of Mawson's room and had already caused visible damage to this area. Access to the top southeast corner also assisted in the determination of snow ingress into this part of the room.

BEFORE – NOTE CAVAIITY UNDER ICE MASS

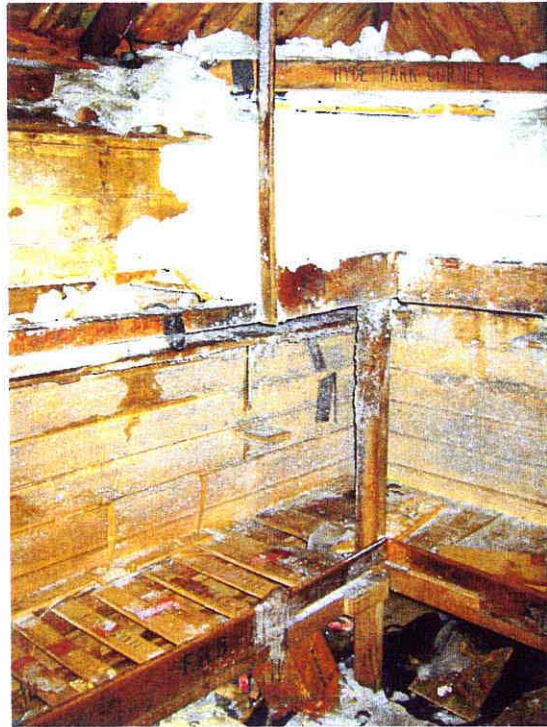
A layer of ice was retained on the top bunk as it was likely this area contained artefacts. It is also not known if further snow / ice will accumulate in this area and recover an artefacts retrieved.

AFTER – NOTE ICE RETAINED ON TOP BUNK

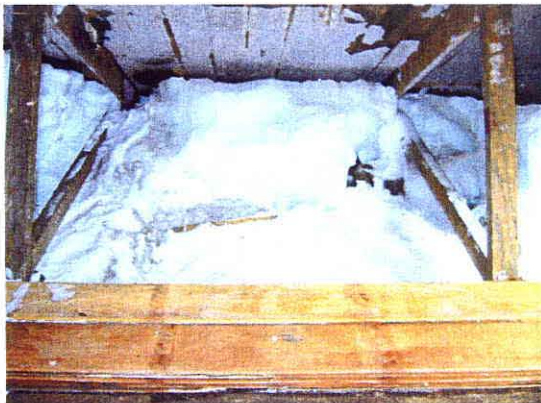
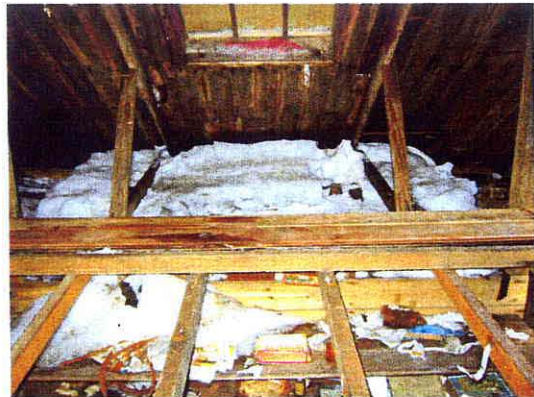
The accumulation of soft snow/ice was removed.

Additionally, small sections of solid ice remaining (after collar tie repair work in 1998) were removed to a level created in the first stage removal. No further excavation work was undertaken due to the presence of artefacts in the ice.

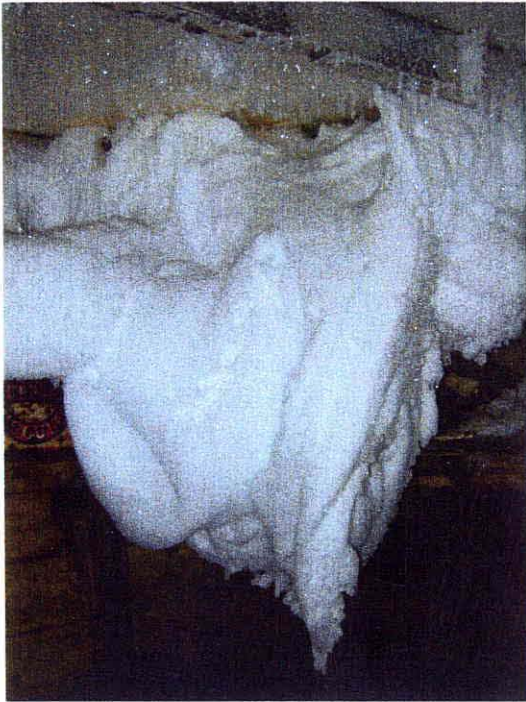
ACCUMULATION BEFORE REMOVAL

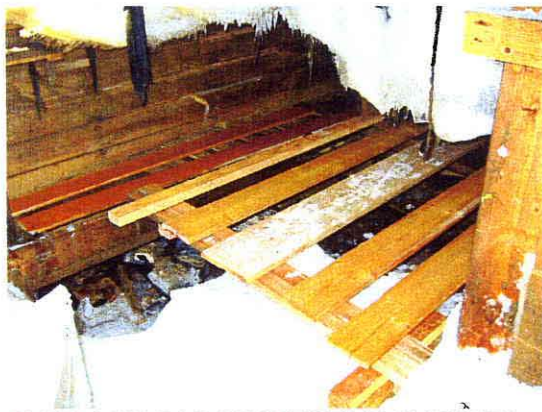
PLATFORM FOR PROTECTIVE SHEET TO BE LAID OVER READY FOR ICE EXCAVATION

All sections of ice were removed taking care not to either damage and / or bury artefacts with ice fragments and shavings. Temporary platforms of timber and plastic sheeting were used to protect vulnerable areas.

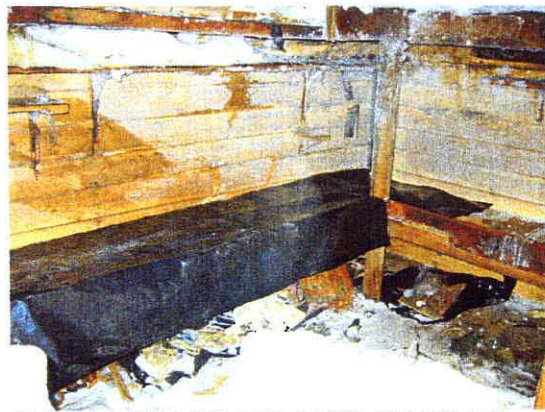
PLASTIC SHEET LEFT OVER BUNKS TO PROTECT COLLECTION OF ARTEFACTS UNDER

When completed, plastic sheeting was placed in areas to protect exposed artefacts from any further snow / ice ingress.

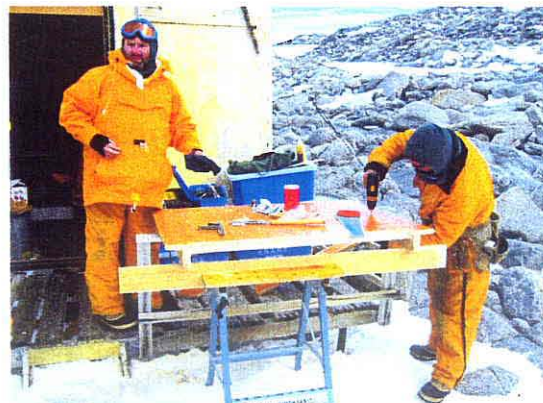
The cover to the west skylight to the Living Quarters had blown off during a strong wind event. Remnants of the cover were found at Penguin Knob. There was evidence of the impact of the cover on the southwest ridge of the Workshop. All fragments were within a small area suggesting the cover remained airborne for the approx. 200m before impacting.

Evidence clearly indicated that the screws used were not sufficiently long enough to bind into the fixing frame. It is noted that this cover included the original cover boards making it thicker than the remaining cover. The other covers were inspected and are securely fixed.

NEW COVER BEING FABRICATED

A new cover was fabricated and installed to match the other.

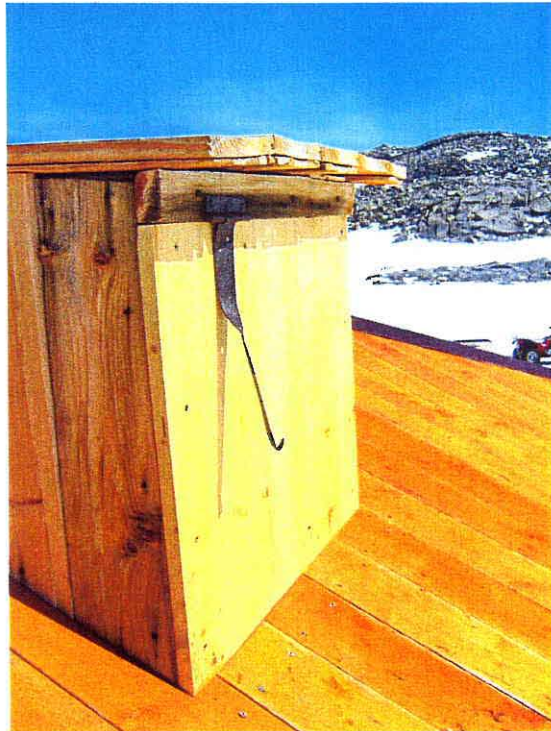
The dormer vent was identified as one source of snow / ice ingress to the workshop. Refer Section 4.2.1

COVER TO DORMER VENT IN PLACE

A cover was fabricated using 25mm t&g Baltic pine boards and fixed to the outside face of the vent and sealed with silicone. The cover was fixed to the outside on the grounds that sections of the vent, including the blades, were becoming fragile and the fixing not secure. The cover would protect this fabric.

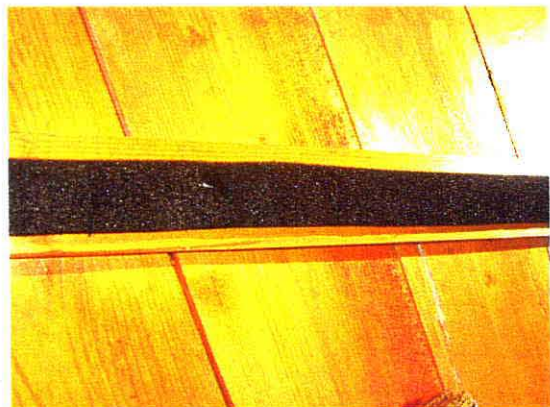
DETAIL OF COVER BATTEN AND FOAM STRIP BEFORE FIXING

A cover batten was fixed over the join for the full length of the north wall. The batten was fixed over a strip of bituminous impregnated foam and secured using stainless steel screws.

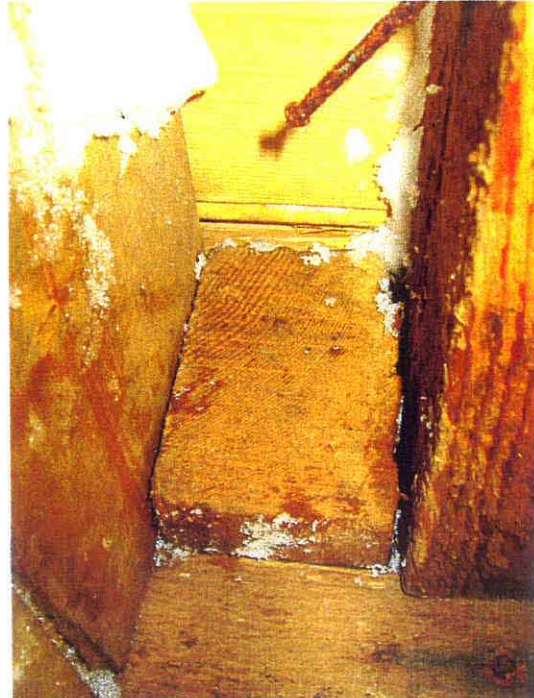
EXISTING BLOCK REPLACED

Bituminous impregnated foam blocks were installed into the far top corner between the sidewall and ceiling joist from inside the room. This plug was installed and can be removed with no damage to the existing fabric.

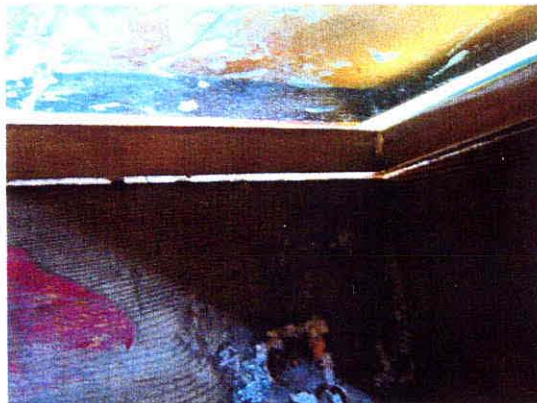
A gap was identified in the south skylight to the Living Quarters as the primary source of snow / ice ingress to the top of Mawson's Room. The cover and glazing panel removed and the gap sealed with silicone.

GAP IN SOUTH SKYLIGHT

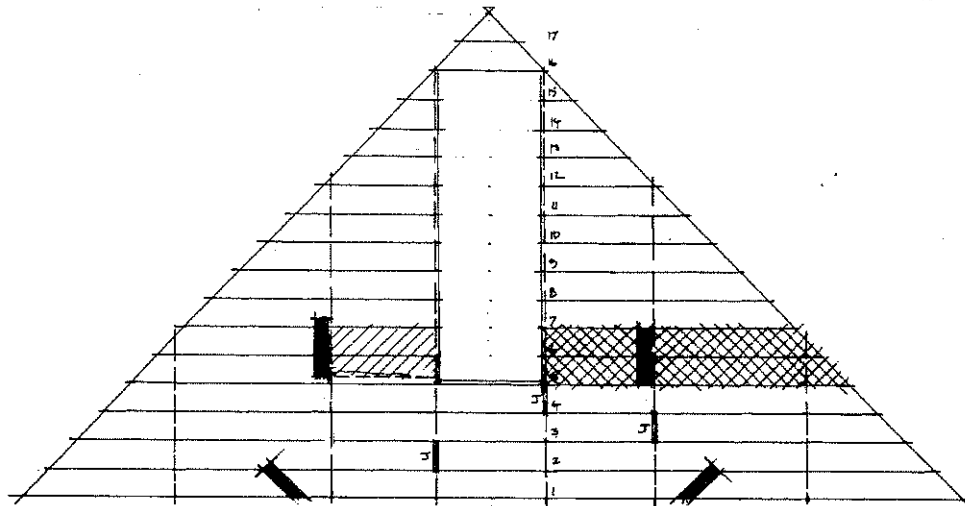
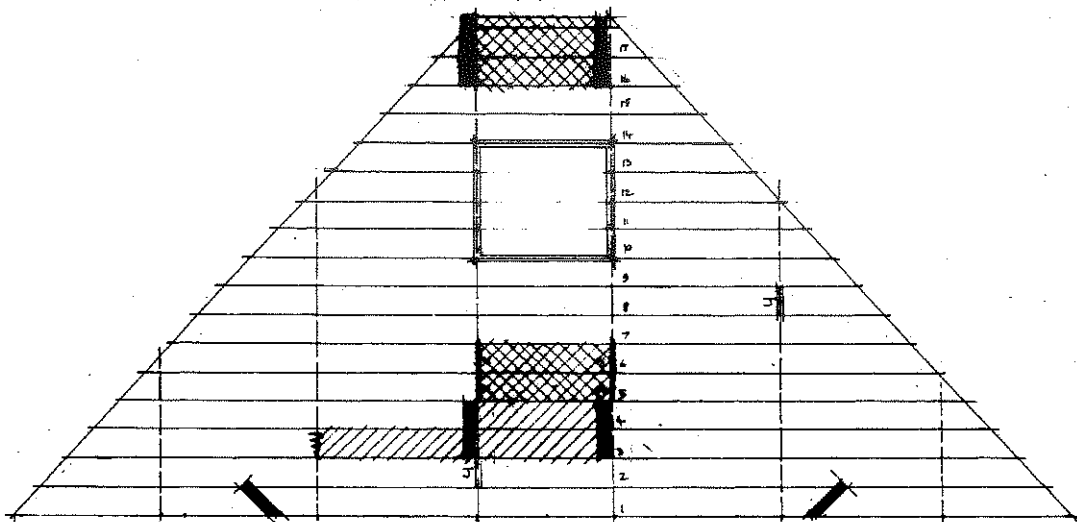
WORKSHOP CEILING – NORTH & WEST ELEVATIONS 01

CEILING BOARDS DISLODGED, RECOVERED FROM ICE AND REPAIRS.
-
